Minnewaska State Park Preserve Trail Assessment Report

May 2011

**New York State Office of Parks, Recreation and
Historic Preservation**

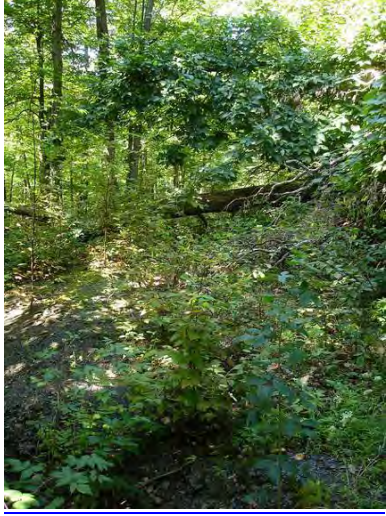
Awosting_PN10 9-2-09 Turnaround point of assessment

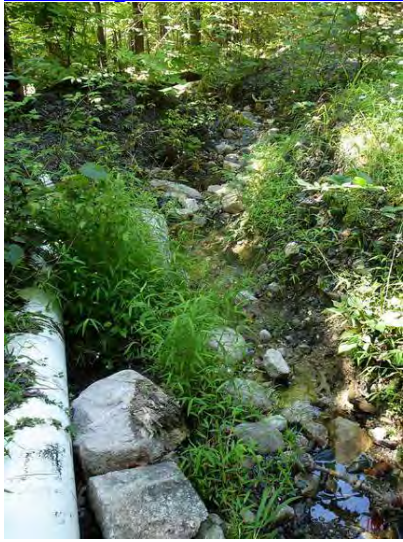
Awosting_PN9 9-2-09 Stream crossing and erosion

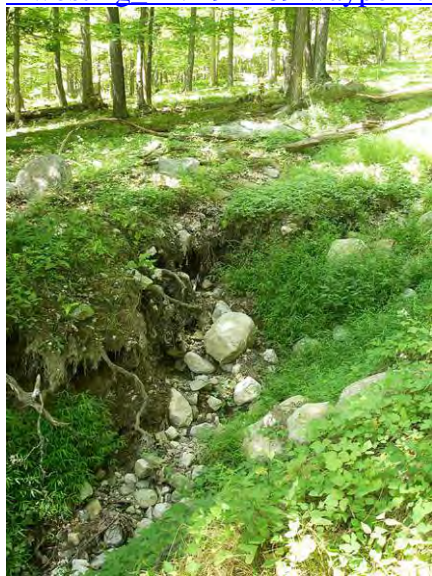
[Awosting_PN4 9-4-09 waypoint 16 serious erosion](#)

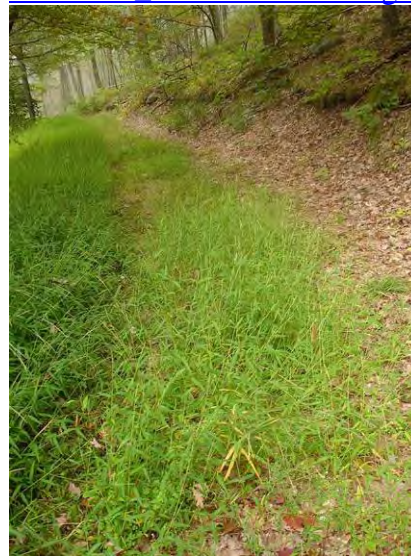
[MudPond PN1 9-22-09 stilt grass - not sure](#)

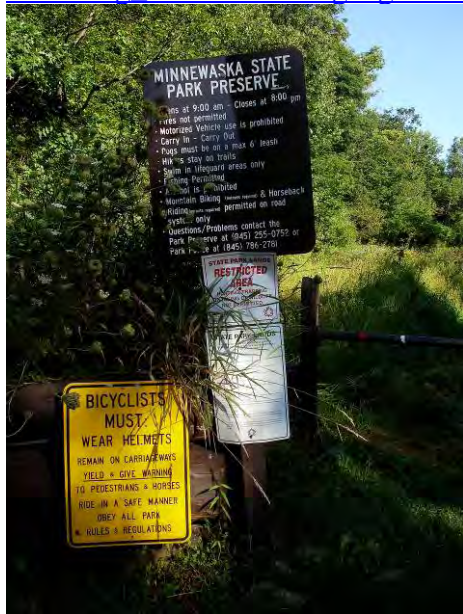
[Awosting PN1 9-2-09 Signage at AR gate](#)

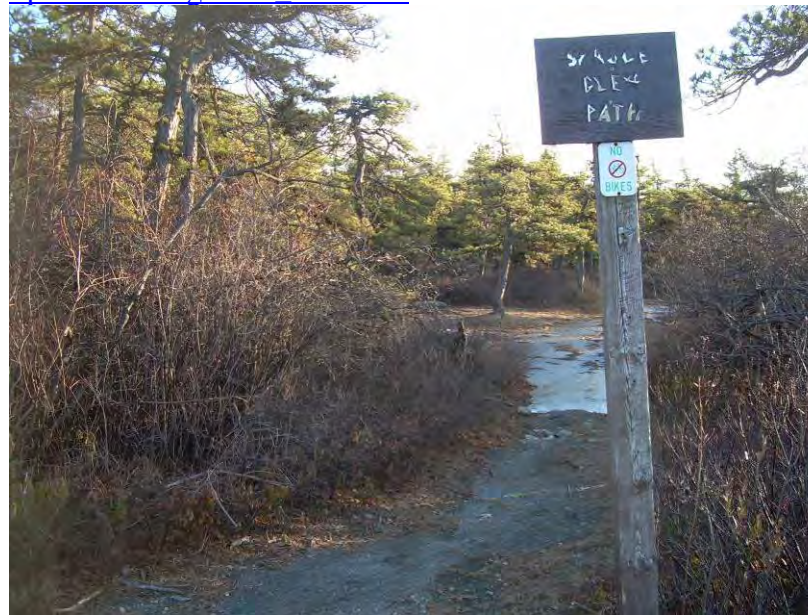
[SpruceGlenSignPN1 11-17-09](#)

Red Loop	6	6	Blazing	Worn	N/A	Blazing washed out. Illegible
Scenic Trail	7	1	Signage	N/A	Trailhead	Murray Hill Footpath to Mud Pond Scenic Trail/LP. ScenicTrailSignPN4_11-17-09
Scenic Trail	7	2	Signage	N/A	Insufficient	Signage Needed! Trail to left unmarked
Scenic Trail	7	3	Signage	N/A	N/A	Sign - Leave No Trace, Indicates entering private property
Spruce Glen	7	1	Signage	N/A	Insufficient	Stopped Here today, start of Spruce Glen Trail
Spruce Glen	7	2	Signage	N/A	Need Repair	End of trail, photo of existing sign. SpruceGlenSignPN1_11-17-09.jpg

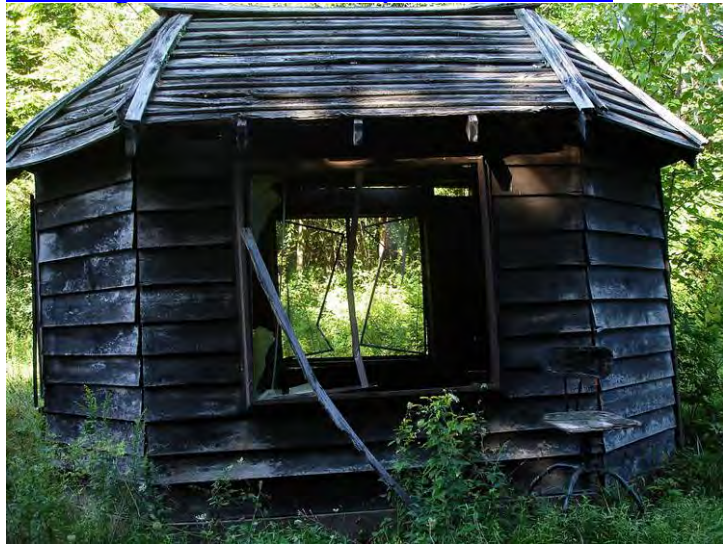
[Awosting PN2 9-2-09 Decrepit entrance booth](#)

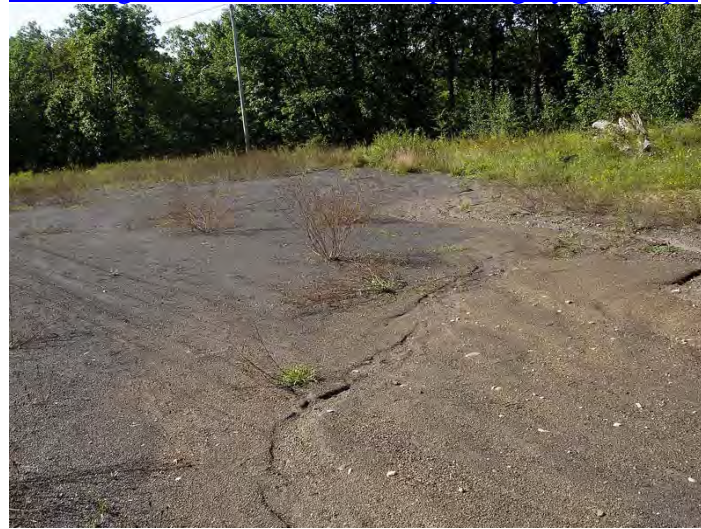
[Awosting PN5 9-2-09 Potential parking by gravel pit](#)

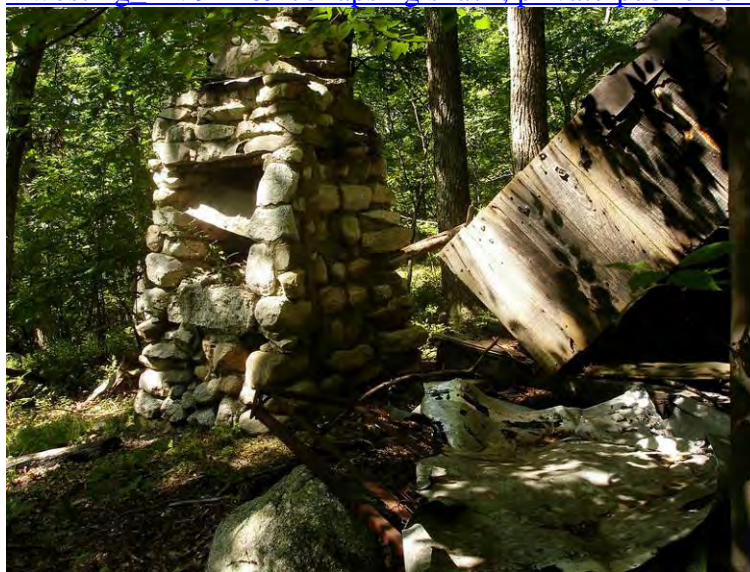
Awosting Woods Road 1	11	10	Culvert	Good	culvert near falls (south of road) Thoreau Falls
Awosting Woods Road 2	11	1	Additional comment		split turn left, great view over shale pit
Awosting Woods Road 2	11	2	Additional comment		Large rusty oil? tank. Awosting PN1 9-4-09 Waypoint 7 - oil tank
Awosting Woods Road 2	11	3	Additional comment		Old shack location. Go straight/veer left - gravel ends. To right - road is washed out and dead falls. Awosting PN 9-4-09 collapsing shack, private-public border ; Awosting PN 9-4-09 collapsing shack-private-public border

[Awosting_PN 9-4-09 collapsing shack, private-public border](#)

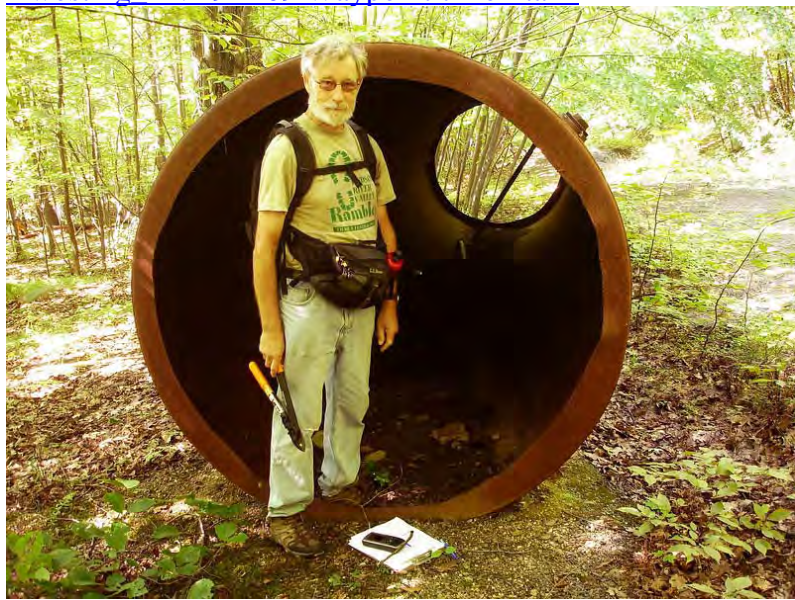
[Awosting_PN1 9-4-09 Waypoint 7 - oil tank](#)

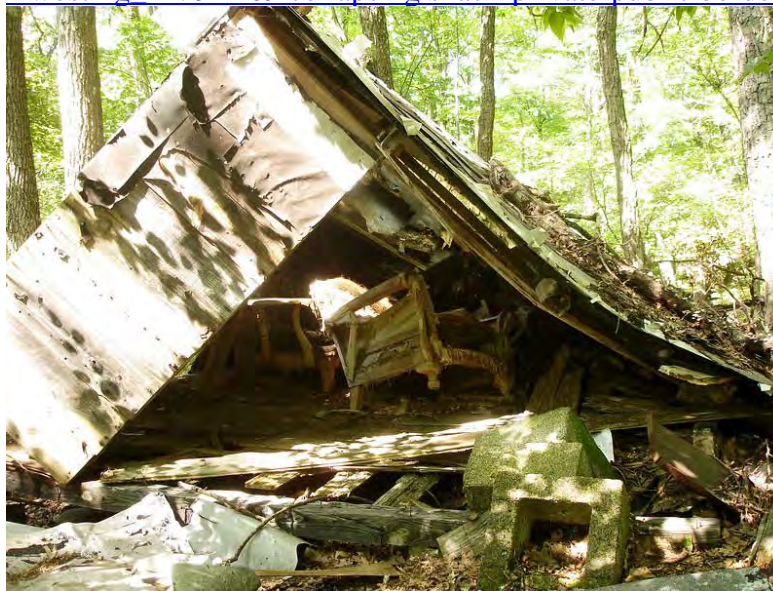
[Awosting_PN 9-4-09 collapsing shack-private-public border](#)
