Niagara Gorge Corridor

***Robert Moses Parkway Removal
Main Street to Findlay Drive
Niagara Falls, NY***

Appendix K - Asbestos Abatement Report

Subject: Contract No. D003554
Robert Moses Parkway North Corridor Project
BIN 1068229 and BIN 1039539
Asbestos Assessment Preliminary Investigation and Sampling Plan

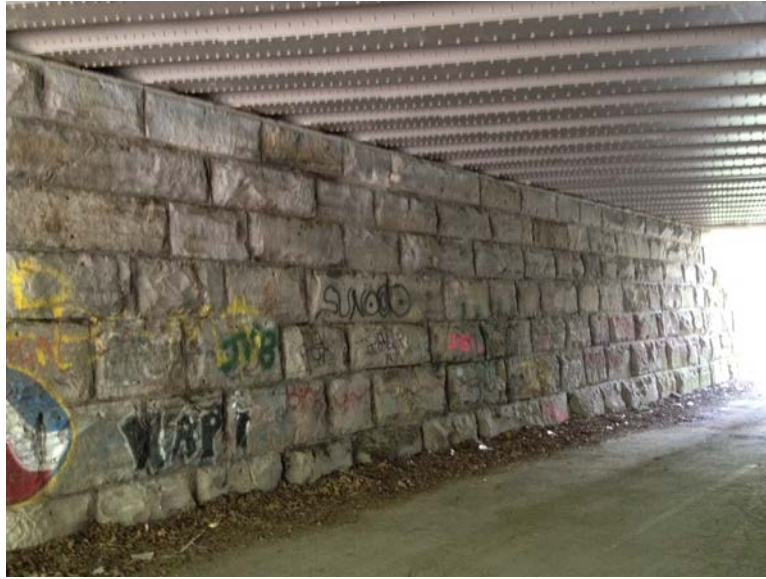
- A. BIN 1068229 (Robert Moses Parkway over Sewage Treatment Plant Access Road)
 1. **Bridge paint** – The grey bridge paint that was identified during the record plan review was not observed. The beige/tan bridge paint that was observed during the field inspection appeared to be relatively new and was likely applied on top of or as a replacement for the grey bridge paint.

10. **Abutment masonry stone pointing** – The abutment masonry stones have been repointed. The cementitious material could potentially contain asbestos.

Photo 1: BIN 1068229. View of beige/tan paint on underside of bridge and abutment masonry where pointing is located in between the stones.

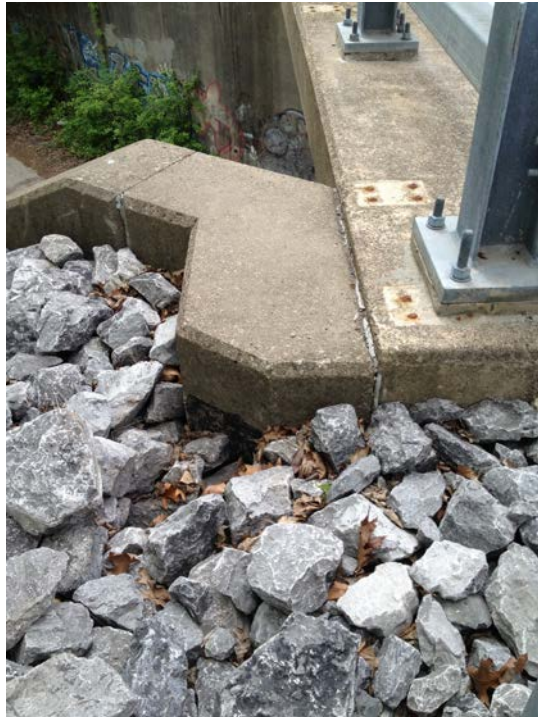
2. **Bituminous coating** – Black waterproof coating was observed on the backside of the exposed portion of the northeast concrete wing wall. It is presumed that this material is the bituminous coating that was identified in the record plans.

11. **Abutment wing wall caulk** – Caulking is located between the abutment and wing wall.
12. **Joint filler between abutment and wing wall** – There is joint filler present beneath the caulk and located between the abutment and wing wall.

Photo 2: BIN 1068229. View of waterproof coating on wing wall and caulk between abutment and wing wall. In addition, there is joint filler beneath the caulk.

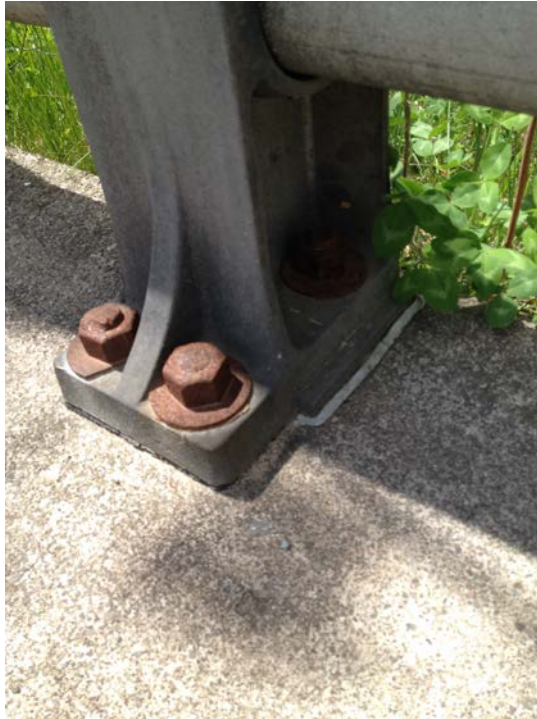
5. **Railing post pad** – The railing pads that were identified in the record plans were observed along the western railing only. The eastern railing is a different type of railing that does not appear to have pads installed beneath the railing posts. The holes where the original eastern railing posts were mounted within the concrete were observed during the bridge assessment and it appears that the pad associated with the former posts has been removed.

7. **Railing post caulk** – The railing post caulk that was identified in the bridge inspection report photographs was observed associated with the western railing only. The eastern railing is a different type of railing that does not have caulk associated with the railing posts. The holes where the original eastern railing posts were mounted within the concrete were observed during the bridge assessment and it appears that all of the caulk associated with the former posts has been removed.

Photo 3: BIN 1068229. View of railing post with the pad beneath the base and caulk around the perimeter of the base.

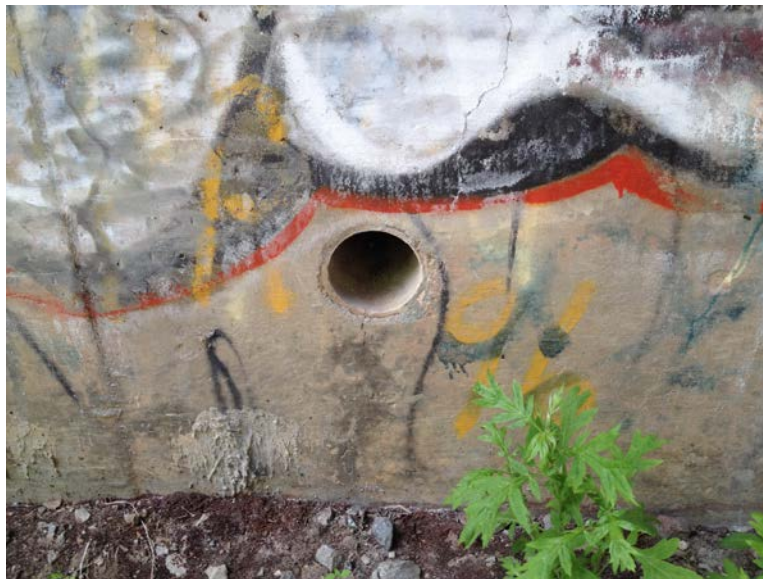
9. **Cementitious drain pipe** – Ten cementitious drain pipes that appear to be constructed out of transite were observed within the northeastern and southeastern wing walls approximately six inches above grade along the Sewer Treatment Access Road.

Photo 4: BIN 1068229. View of the cementitious drain pipe.

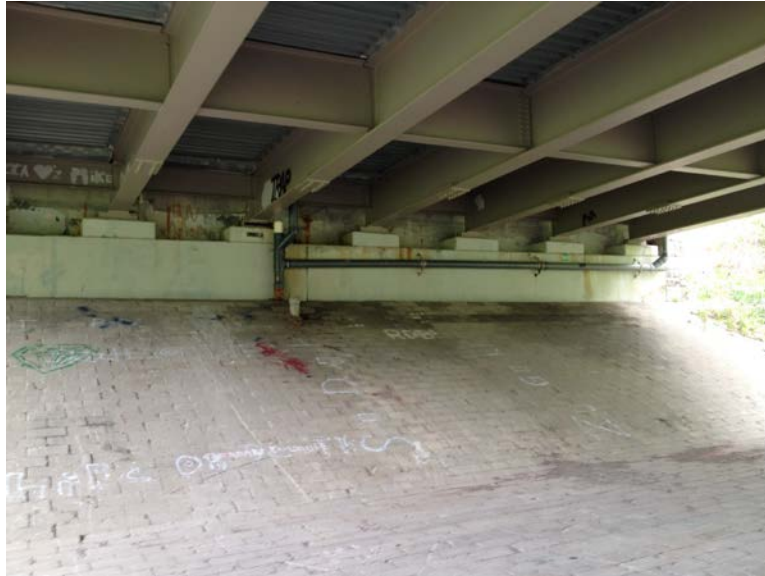
1. **Bridge paint** – The green/brown bridge paint that was identified during the record plan review was not observed. The beige/tan bridge paint that was observed during the field inspection appeared to be relatively new and was likely applied on top of or as a replacement for the green/brown bridge paint.

4. **Bearing pads** – Bearing pads were observed during the field inspection at the abutments and the piers.
5. **Masonry coating** – The concrete bearing pedestals of the abutment appear to be covered with a masonry coating.

Photo 5: BIN 1039539. View of the underside of the bridge showing the beige/tan paint on the girders, the concrete abutment with masonry coating, and bearing pads.

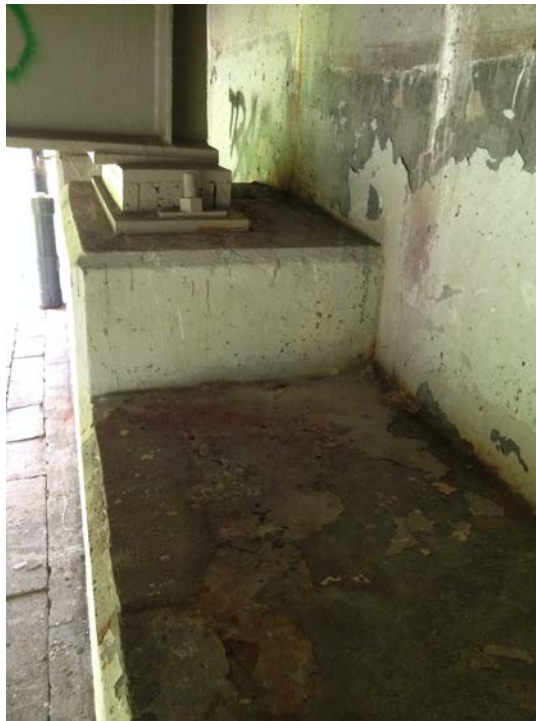
Photo 6: BIN 1039539. View of the concrete abutment, one concrete bearing pad with masonry coating, and a bearing plate with bearing pad.

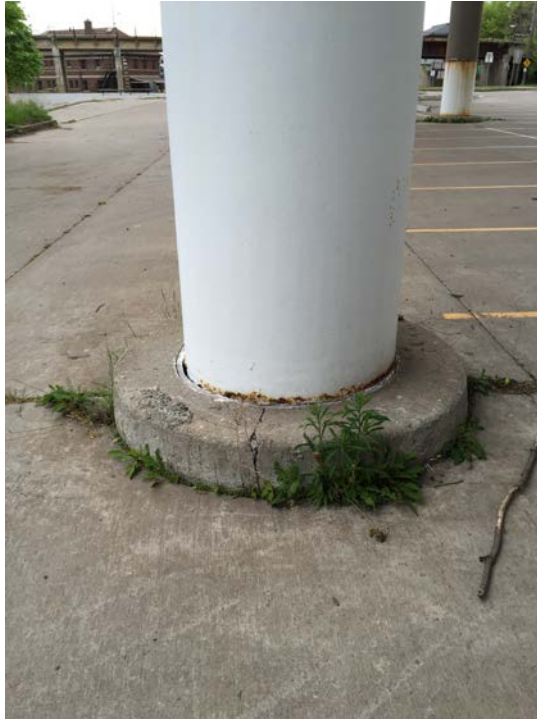
8. **Caulk at base of pier** – Caulking is located between the base of the piers and the concrete base pads.

9. **Joint filler at base of pier** – There is joint filler present beneath the caulk and located between the base of the piers and the concrete base pads.

Photo 7: BIN 1039539. View of the caulk located between the base of the pier and the concrete base pad.
