## **Diving Inspection Report**

Re: Underwater Investigation of the Poughkeepsie Railroad Bridge  
McLaren File No. 106158

BRIDGE DIVING INSPECTION AND CONDITION REPORT

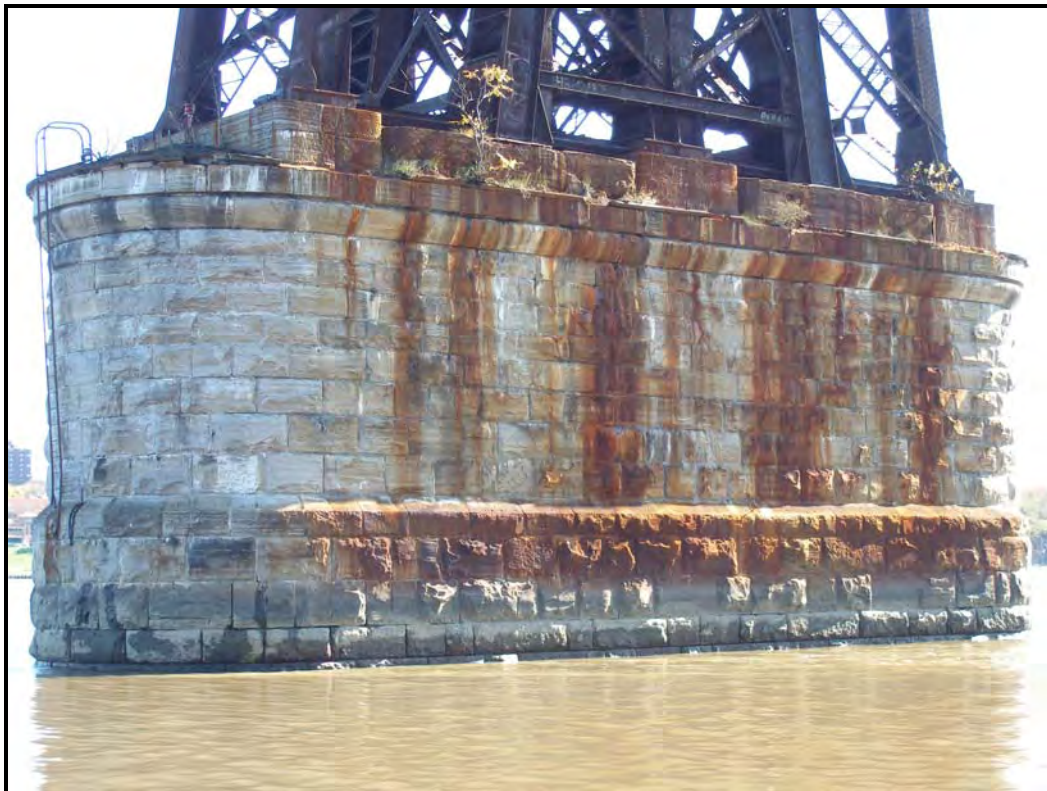
The stone masonry portion of the pier is generally in fair condition. Typical deficiencies include intermittent areas of missing mortar from between the joints, with penetration from 4 in. to 12 in. deep, and moderately spalled and loose coping stones on the south face of the pier. Moderate efflorescence and rust staining were also evident on the face of the masonry.

The timber cribbing and grillage typically exhibit moderate rot and loss of cross sectional area with gaps between the timbers averaging 1 in. to 2 in. wide. Intermittent penetrations into the gaps of the cribbing were taken and typically varied from 12 in. to over 3 ft deep. The outer layer of vertical timber sheeting is missing from around the entire pier. Intermittent missing pieces of 12 in by 12 in. timber cribbing were also observed. A significant horizontal void area was observed behind the outermost layer of the timber crib wall, extending along the east, south and west faces of the pier. The voids are located approximately 29 ft below the water surface and extend approximately 16 ft along the south face and 56 ft along the west face. The void in the timber cribbing is 2 ft high at the south west corner and tapers down to 2 in. as it progresses along the south and west elevations. Penetrations in the void varied from 3 ft to more than 6 ft deep. The maximum height of the void on the inside of the timber cribbing at the southwest corner is unknown.

Photo 2 – Pier 2 west and north elevation.

It is recommended to repair the void areas at Pier 2 and Pier 3 to stop the loss of fill from within the cribbing and restore structural integrity. These deficiencies are not an emergency or a structural stability issue at this time; however, the repairs are needed to provide long-term protection and insure stability. It is recommended that these repairs be completed within the next five years to prevent accelerated deterioration of the substructures. We strongly recommend that the deteriorated portions of Piers 2 and 3 be inspected on an annual basis until repairs are made, to arrest or respond to any sudden change of these conditions. It is our intent to avoid any dramatic increase in rehabilitation costs due to lack of attention. It is also recommended to perform an underwater inspection just prior to repair construction to confirm that the extent of deterioration has not changed.

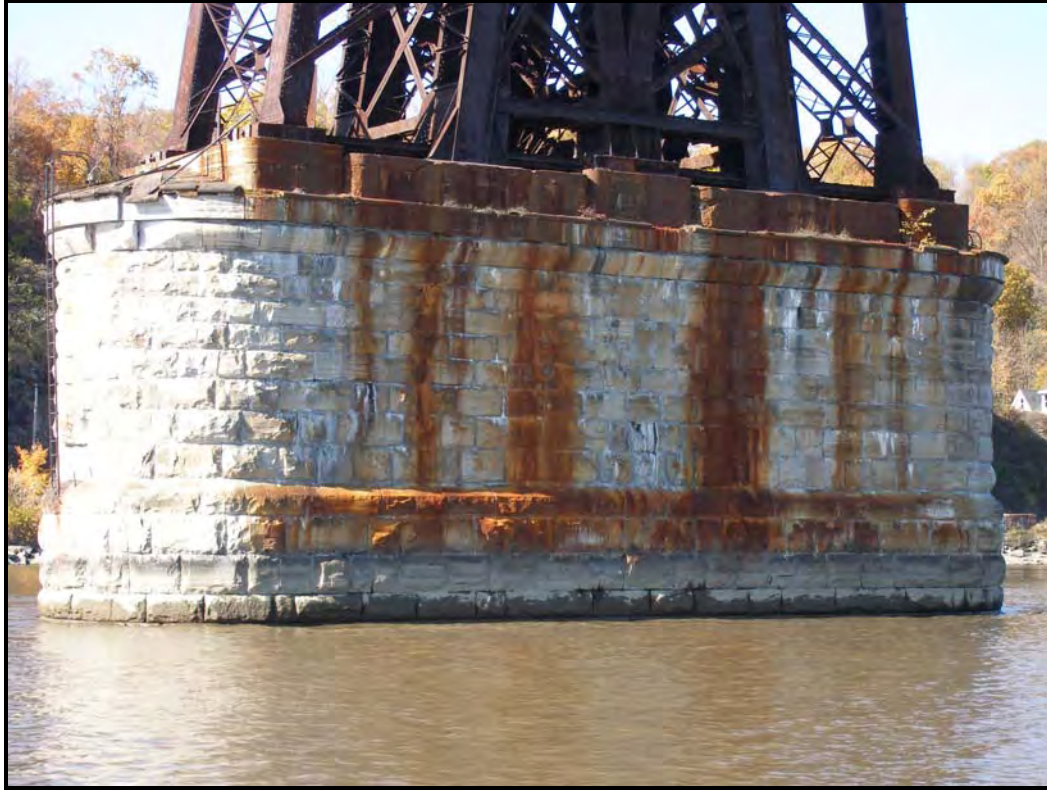
Photo 3 – Pier 2, south and east elevation.

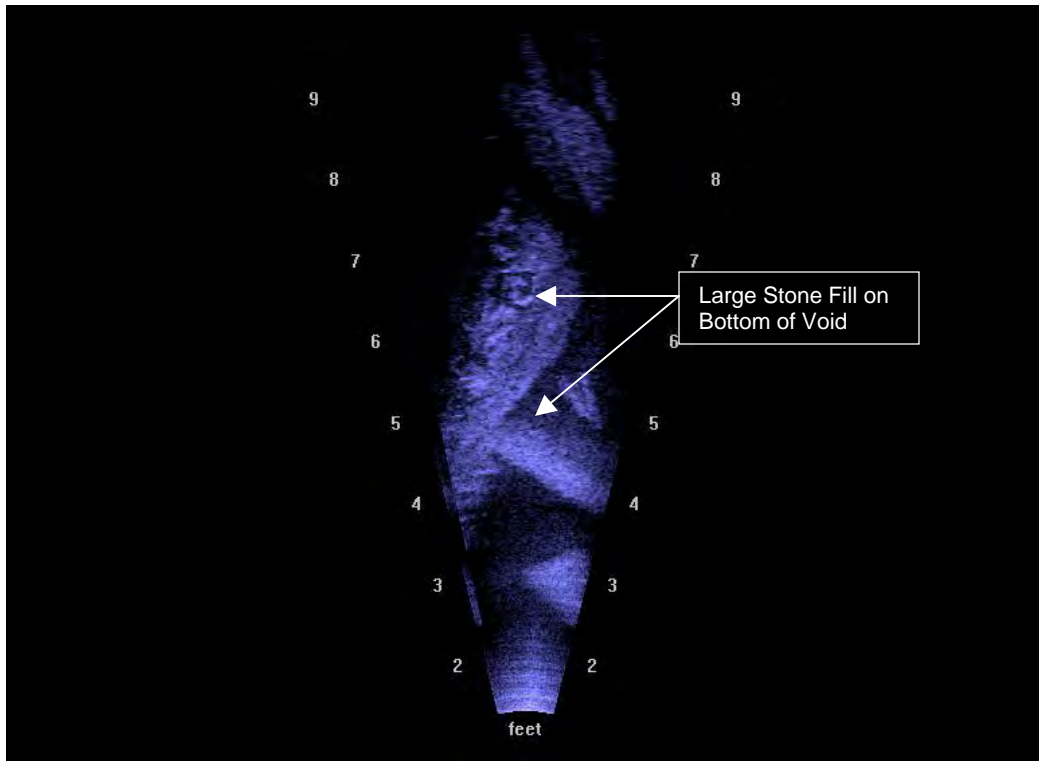
Additional investigation was performed to determine the depth of the void. A dive crew equipped with a "DIDSON" Sonar Camera performed a real time sonar survey of the void area. Interpretation of the sonar images revealed that only the outer layer of weighting pockets has been compromised revealing the stone fill (Photo 4). The inner timber wall and transverse ties appeared to be in place (Photo 5, and Photo 6). It was not possible to visually inspect or probe the timber on the interior pockets to determine their condition.

Photo 4 – Pier 2, west face, south end, sonar image from interior of the void showing large stone fill.

Typically repairs to the voids involve sealing the outer surface of the void by installing formwork or grout bags. The void area is then pumped full with concrete. Estimated construction cost for these repairs is approximately \$750,000 to \$1,500,000. After repairs have been completed the piers should be regularly inspected at five-year intervals to monitor the deterioration of the substructure elements and recommend any additional repairs.

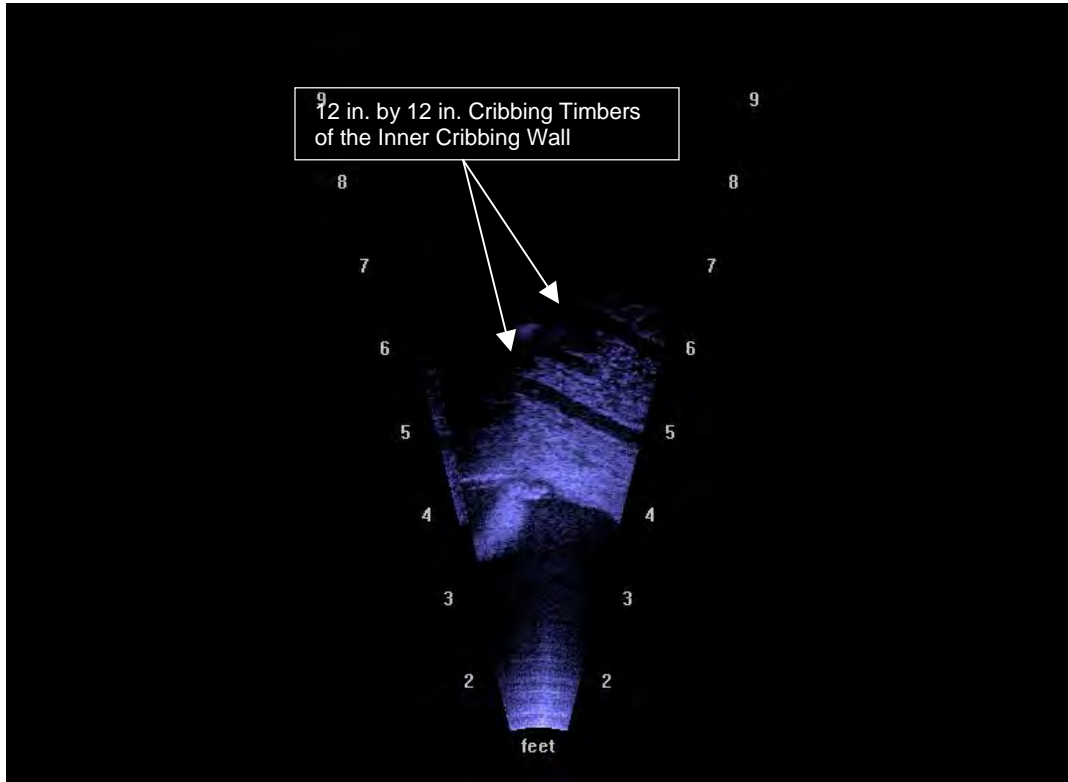
Photo 5 – Sonar image from interior of void showing inner wall timbers in place.

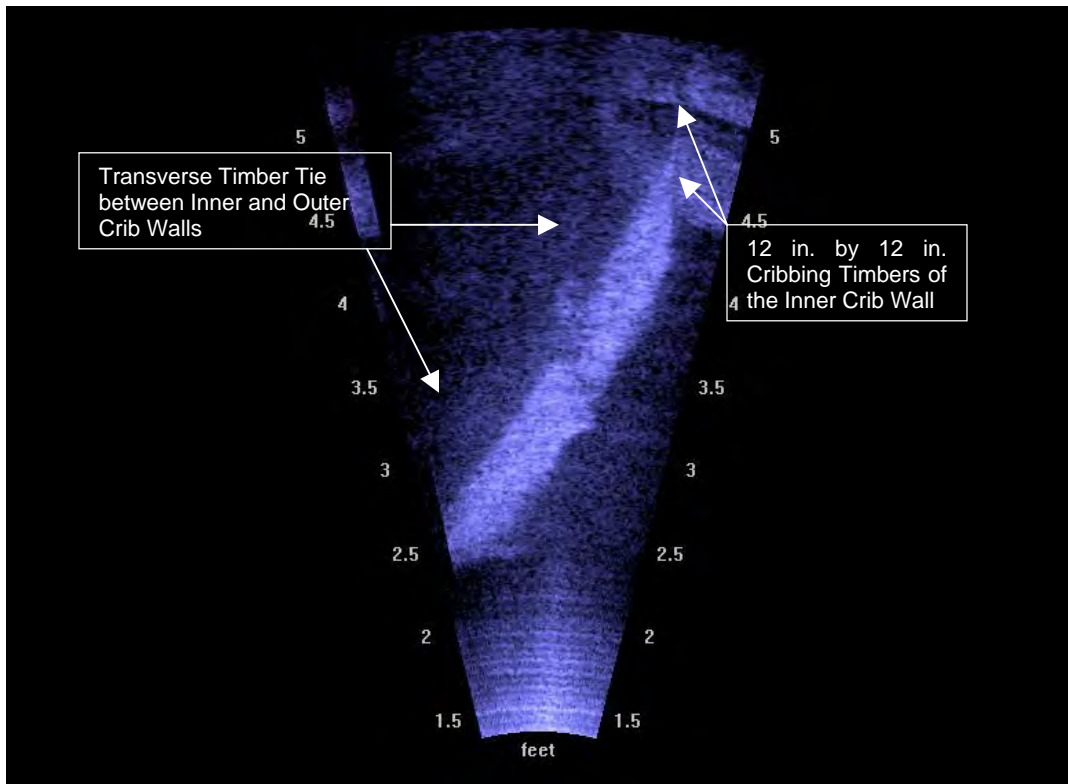
Photo 6 – Sonar image showing transverse timber tie and inner wall in place.

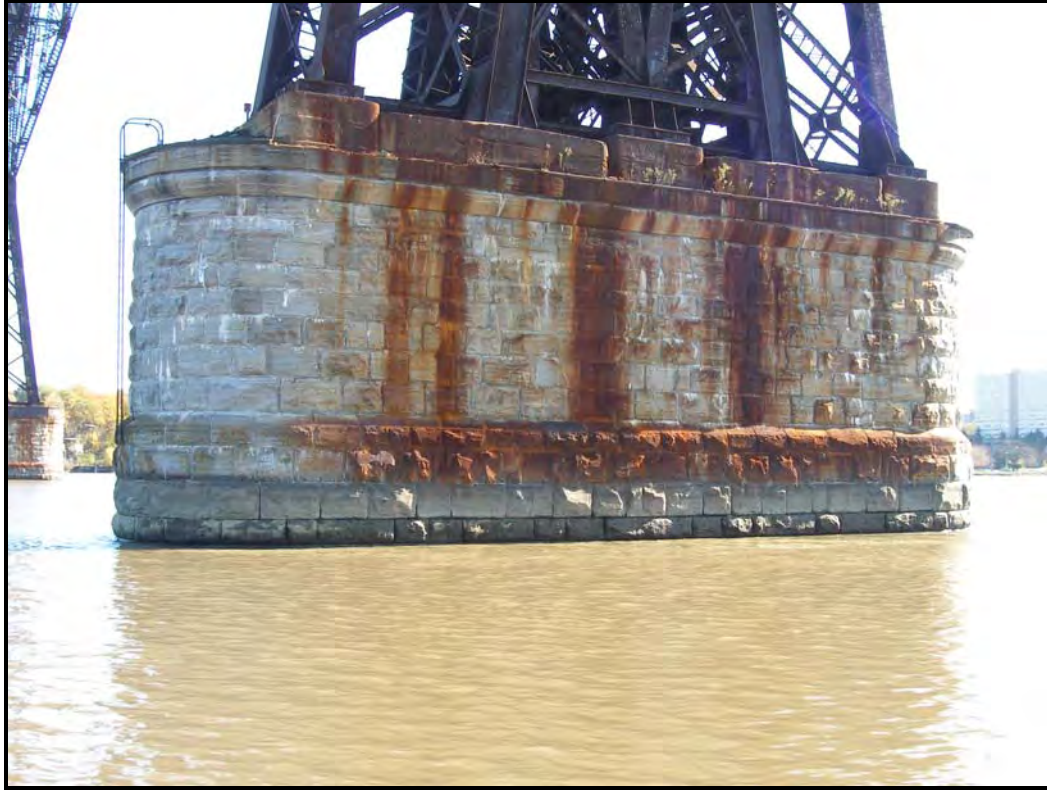
The stone masonry portion of the pier is generally in fair condition (Photo 7 and Photo 8). Typical deficiencies include intermittent areas of missing mortar from between the joints, with penetration from 2 in. to 14 in. deep. Moderate efflorescence and rust staining were also evident on the face of the masonry.

The timber cribbing and grillage typically exhibit moderate rot and loss of cross sectional area with gaps between the timbers averaging 1 in. to 2 in. wide. Intermittent penetrations into the gaps of the cribbing were taken and typically varied from 12 in. to over 4 ft deep. The outer layer of vertical timber sheeting is missing from around the entire pier. Minor areas of intermittent missing pieces of 12 in by 12 in. timber cribbing from the outer layer, up to 4 ft long were also observed.

Photo 7 – Pier 3, north and west elevation of the pier.

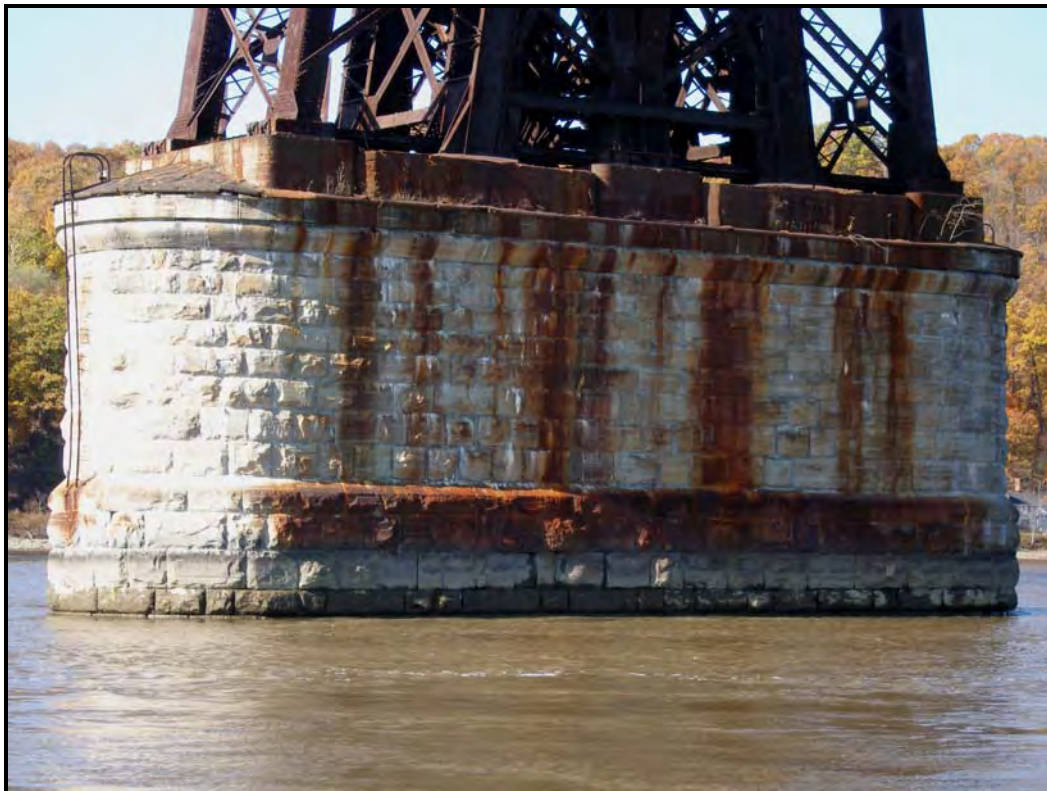
Photo 8 – Pier 3, south and east face of the pier.

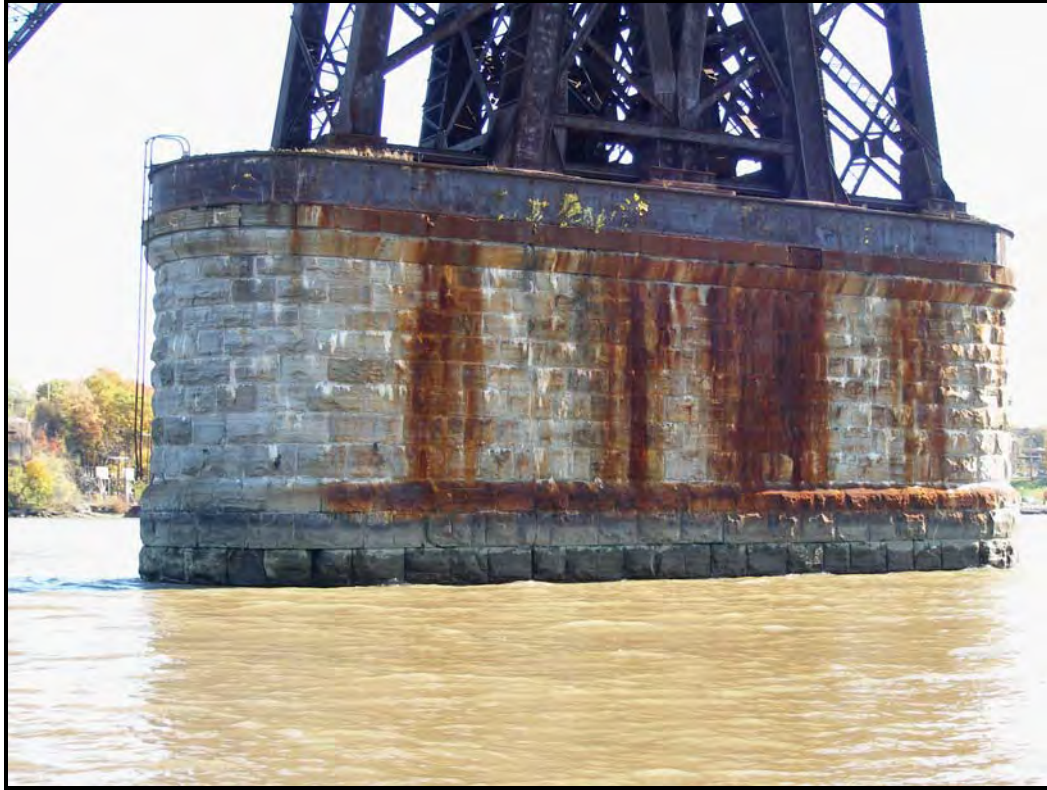
Constructions of the pier substructural elements are as described above under "**Typical Substructure Construction**". The stone masonry portion of the pier is generally in fair condition (Photo 9 and Photo 10). Typical deficiencies include intermittent areas of missing mortar from between the joints, with penetration from 4 in. to 16 in. deep.

The timber cribbing and grillage typically exhibit moderate rot and loss of cross sectional area with gaps between the timbers averaging 1 in. to 2 in. wide. Intermittent penetrations into the gaps of the cribbing were taken and typically varied from 12 in. to 2 ft deep. The outer layer of vertical timber sheeting is missing from around the entire pier. Minor areas of intermittent missing pieces of 12 in by 12 in. timber cribbing from the outer layer were also observed.

Photo 9 – Pier 4, north and west elevation of the pier.

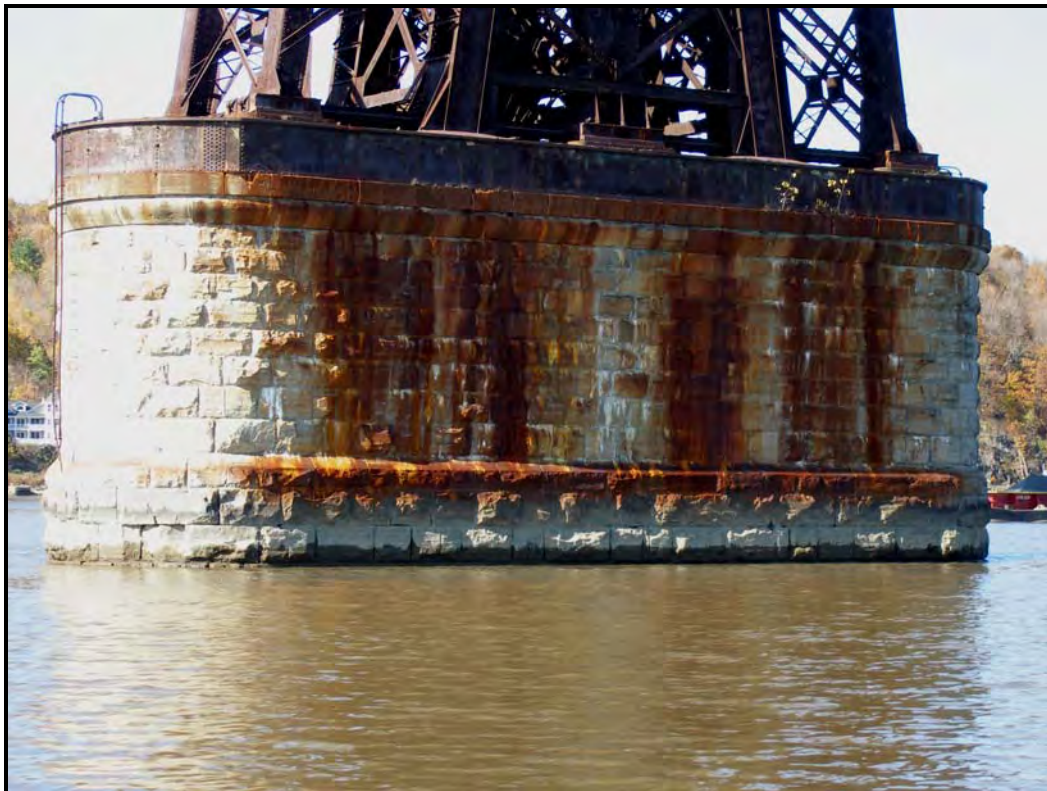
Photo 10 – Pier 4, south and east elevation of the pier.

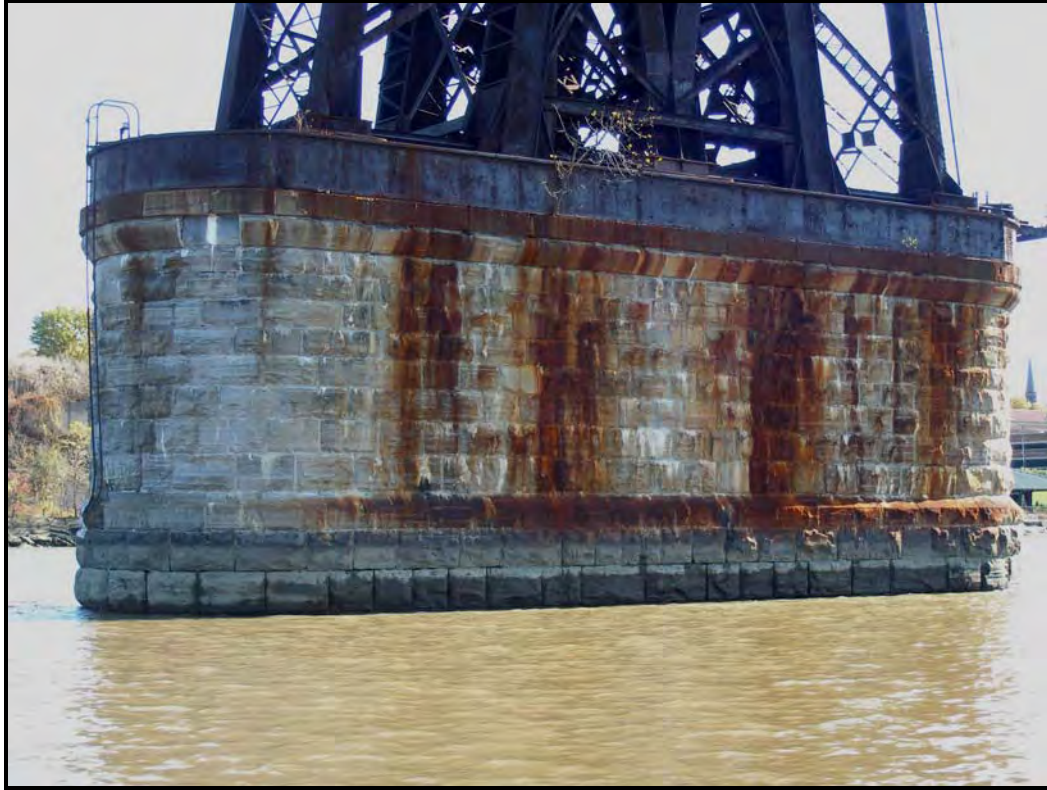
The stone masonry portion of the pier is generally in fair condition. Typical deficiencies include intermittent areas of missing mortar from between the joints, with penetration from 2 in. to 12 in. deep. Moderate efflorescence and rust staining were also evident on the face of the masonry.

The timber cribbing and grillage typically exhibit moderate rot and loss of cross sectional area with gaps between the timbers averaging 1 in. to 2 in. wide. Intermittent penetrations into the gaps of the cribbing were taken and typically varied from 12 in. to over 3 ft deep. The outer layer of vertical timber sheeting is missing from around the entire pier. Minor areas of intermittent missing pieces of 12 in by 12 in. timber cribbing from the outer layer, were also observed.

Photo 11 – Pier 5, north and west elevation of the pier.

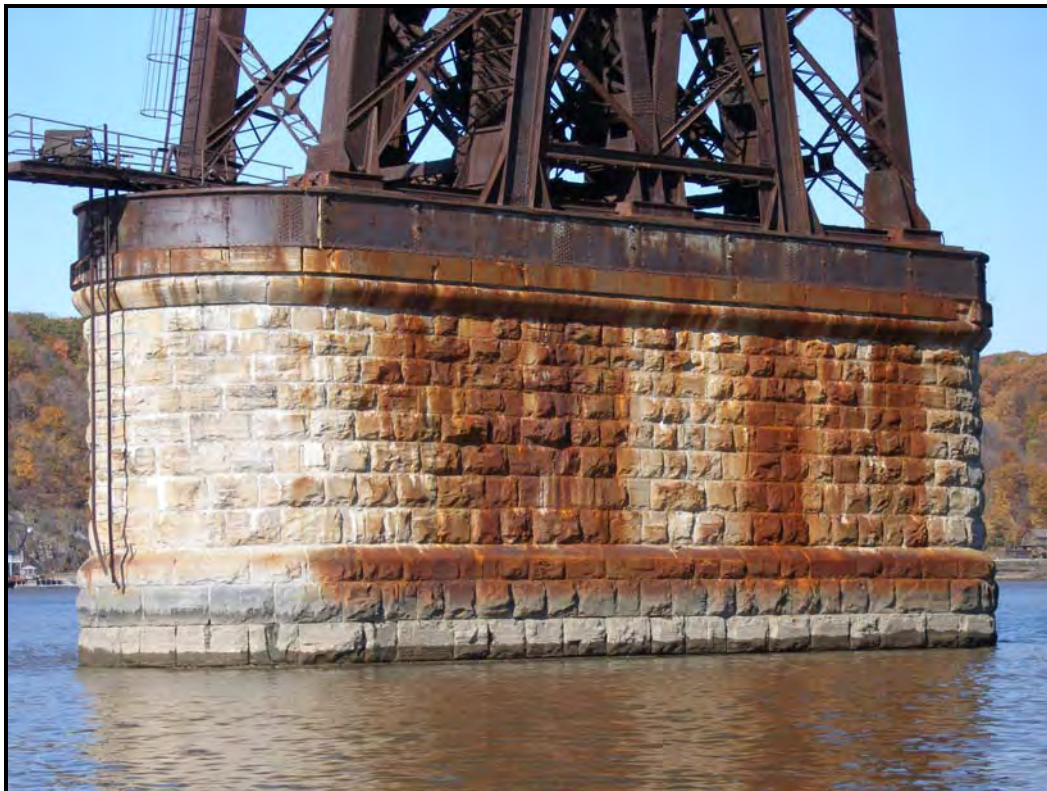
Photo 12 - Pier 5, south and east elevation of the pier.

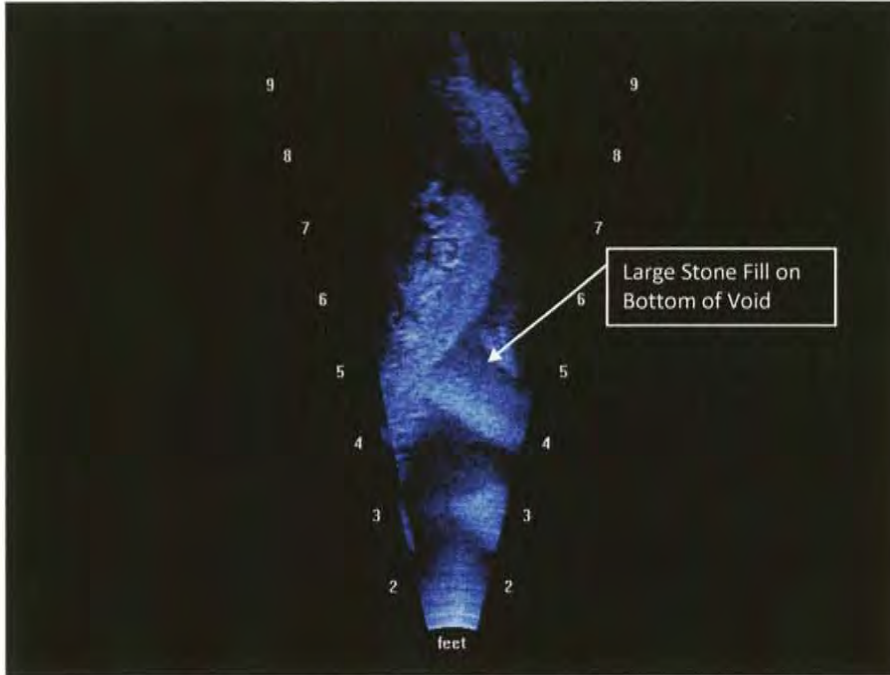
PHOTO NO.: 13  
LOCATION: \_\_\_\_\_  
Pier 2

SPAN NO. & UNIT CODE	RATING ITEM	RATING	REMARKS
002PRR	24	3	Voids - Voids created due to loss of ballast stone from outer timber cribwall.
			Void measures up to 2 ft high at the southwest corner, and extends 56 ft to the north along the west face, and 16 ft along the south face. Penetration into the void is greater than 6 ft.
	25	4	Holes - Several intermittent holes through the outer timber cribwall.
			Holes measure up to 1 ft high by 1 ft wide with penetration up to 4 ft.
	26	4	Structural Damage - Missing and rotted outer cribwall timbers on the south and west faces of the pier.
	27	4	Non-structural damage - loss of ballast stone from outer cribwall.
	28	4	Displacement - Several horizontal timbers are displaced up to 1 ft vertically.
	29	4	Missing Elements - cribwall is missing original layer of vertical timber sheathing.
	30	3	Loss of fill - Loss of balast stone fill in outer cribwall layer.
	34	9	Structural cracks - Concrete elements are covered by stone masonry veneer or timber cribwall.

DESCRIPTION: \_\_\_\_\_  
Didson Sonar image  
of void area on west  
face of pier. Note  
large stone fill.

REFERENCES: \_\_\_\_\_  
BR356c - Item 24  
Rated - 3

Repair voids within the timber grillage to prevent loss of fill.  
Repoint stone masonry joints.

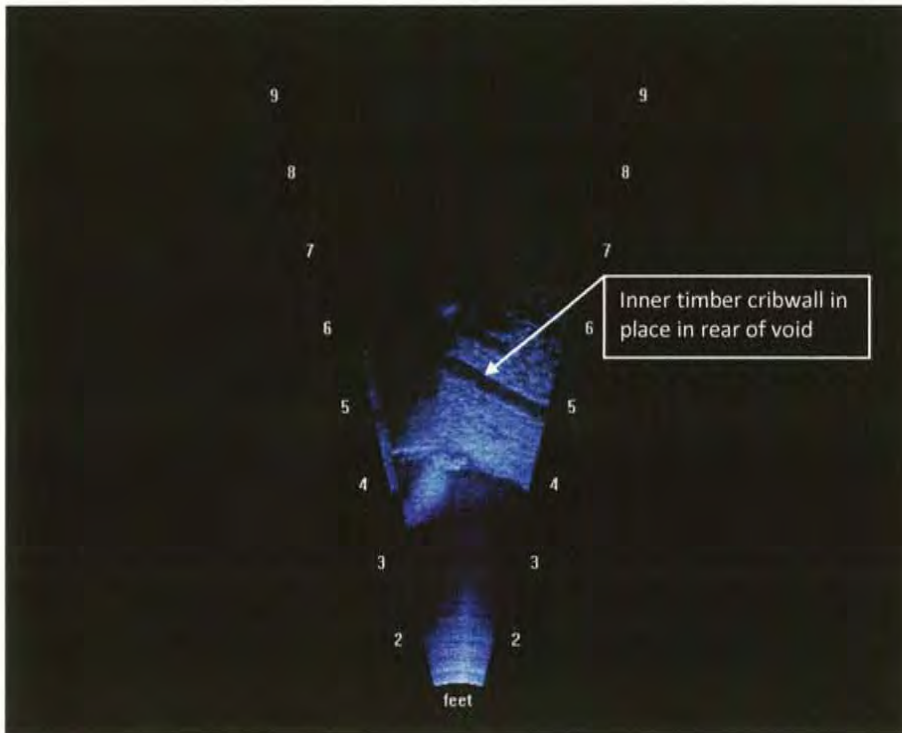
PHOTO NO.: 14  
LOCATION: \_\_\_\_\_  
Pier 2

DESCRIPTION: \_\_\_\_\_  
Didson Sonar image  
of void area on west  
face of pier. Note  
inner timber cribwall  
still intact.
