PHASE 1B CULTURAL RESOURCES INVESTIGATION FOR THE PHASES I-IV PRELIMINARY DESIGN AND DESIGN APPROVAL DOCUMENT

NIAGARA GORGE CORRIDOR -- ROBERT MOSES PARKWAY REMOVAL PROJECT , MAIN STREET TO FINDLAY DRIVE, NIAGARA FALLS, NEW YORK

**PIN 5757.121
(OPRHP Project Review 15PR04311)**

April 2016

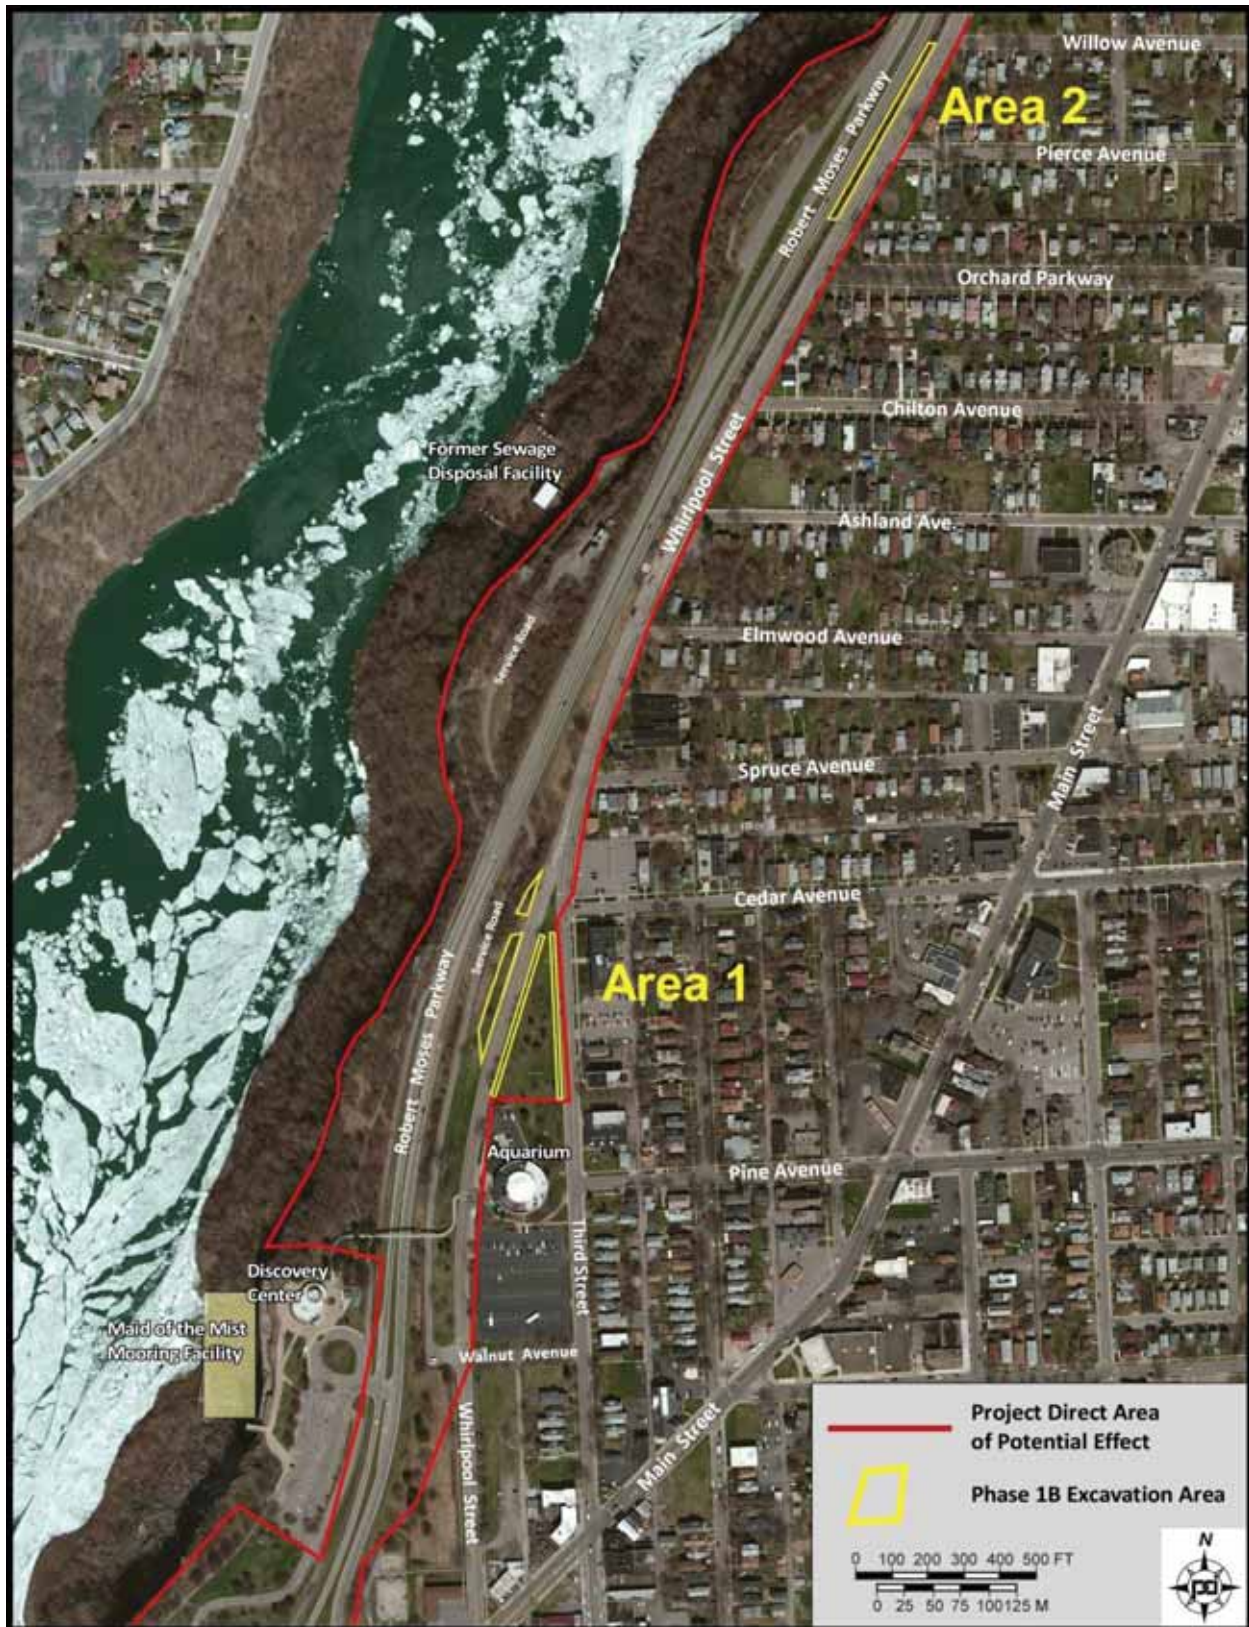
Figure 1.3. Southern archaeological survey areas depicted on a recent aerial photograph (after Google 2014).

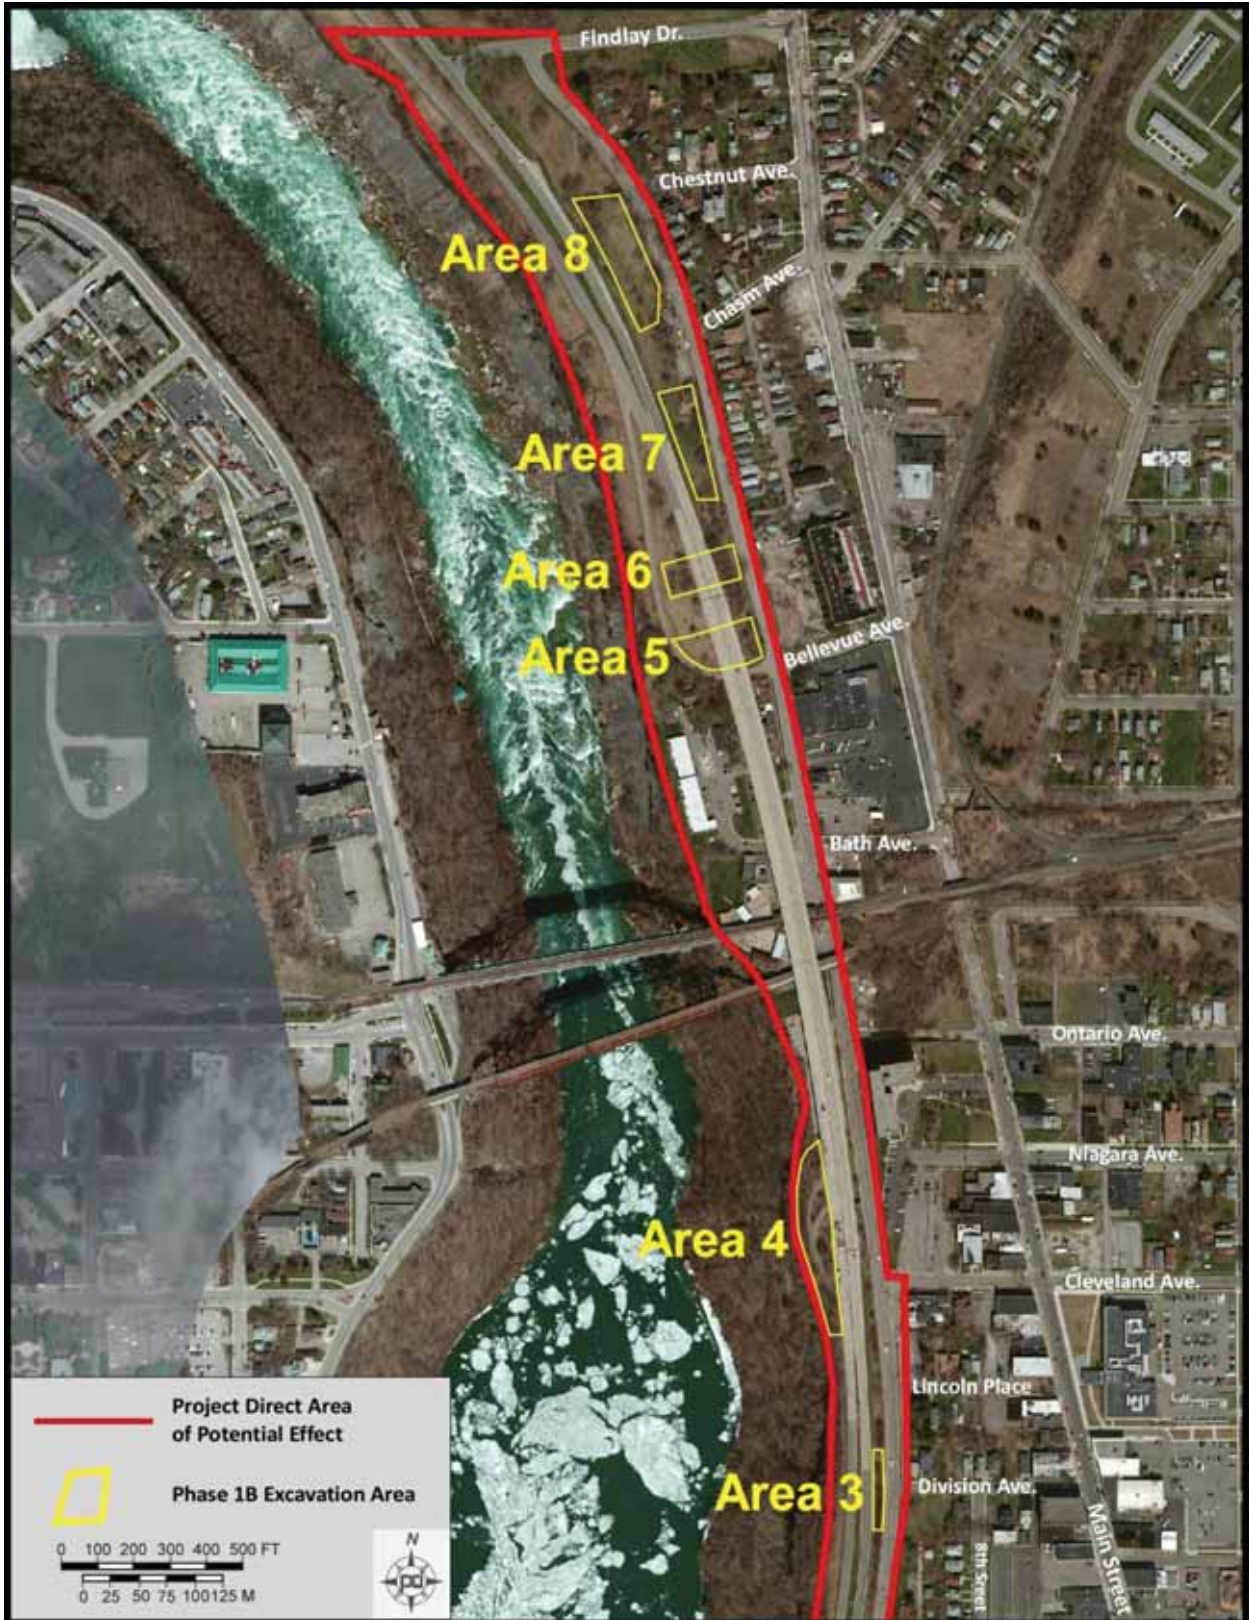
Figure 1.4. Northern archaeological survey areas depicted on a recent aerial photograph (after Google 2014).

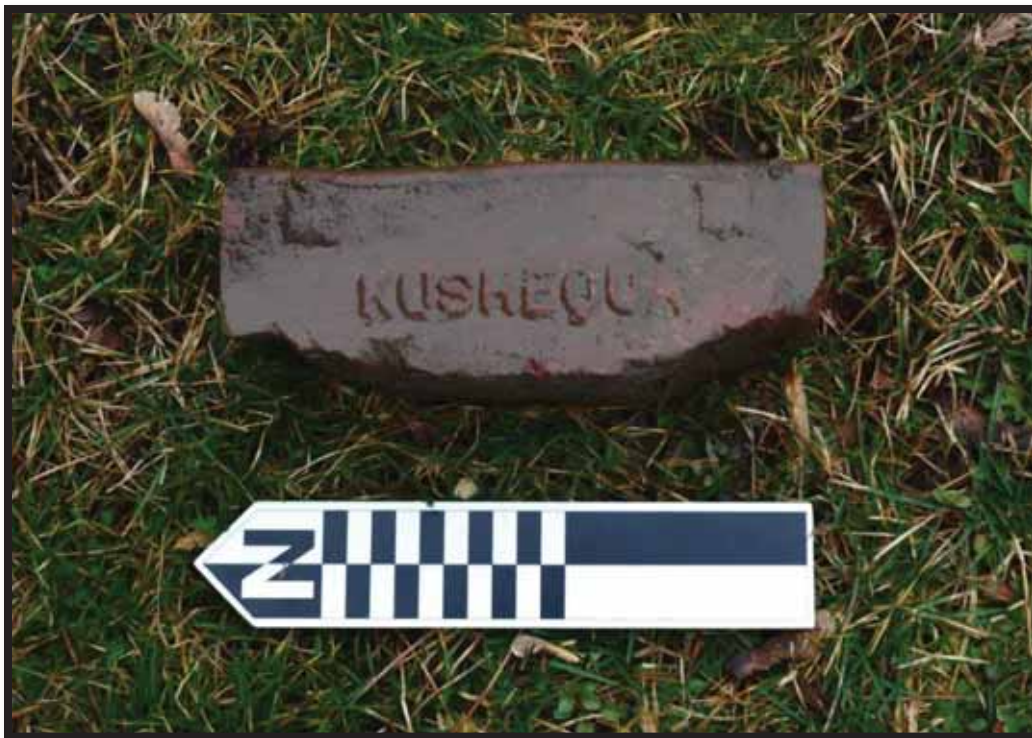
SurveyFigure 2.2. Large brick fragment with a maker's mark reading "KUSHEQUA" from Survey Area 1 STP 2.5 (PCI 2016).

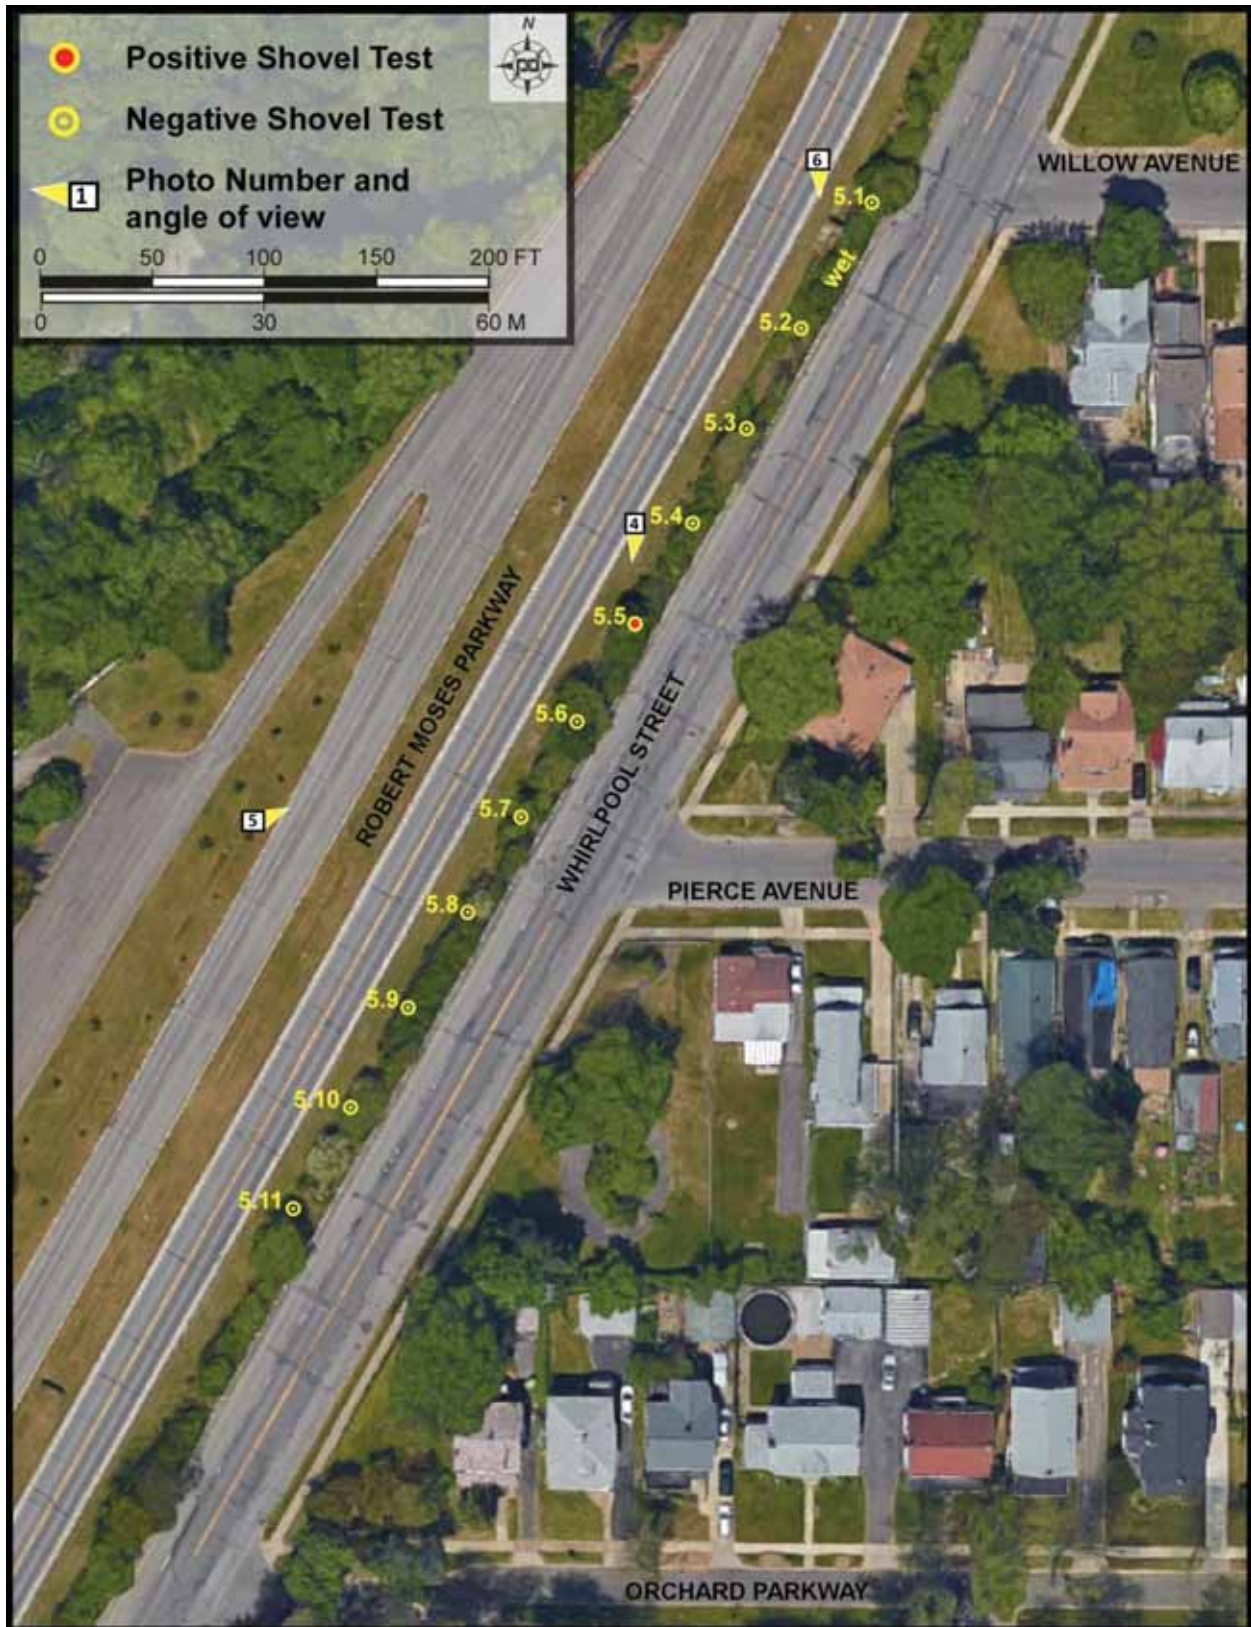
Figure 2.3. Survey Area 2 showing shovel test pits and photograph locations and directions (aerial: Google 2016).

Area 2. Survey Area 2 is a narrow (ca.-6-meter-wide), 160-meter-long area between Whirlpool Street and the Robert Moses Parkway west of Pierce Avenue (Figure 2.3). Roughly the southeastern half of the survey area covers terrain that slopes steeply downward six to eight feet from the northwest side of Whirlpool Street to the level of the shoulder along the east side of the parkway (Appendix A: Photographs 4 and 5). The steep slope is covered with dense brush, small amounts of tall grasses, and several medium-age deciduous trees; vegetation on the parkway shoulder is entirely low-cut grasses. Indications of below-ground disturbance include several road signs along the parkway and a short traffic barrier / fence along the west side of Whirlpool Street. Beyond this, it is highly probable that much of the survey area was been graded during the construction of the parkway. The steep slope along Whirlpool Street was also heavily littered with bottles and other trash. At the time of the field investigation, standing water covered parts of the northeastern-most 15 meters of the survey area (Appendix A: Photograph 6).

The field investigation at Area 2 included 11 tests dug at a 15-meter interval along Transect 5. Soils in the STPs were fairly consistent and included a 10-to-35-cm-thick layer of dark grayish brown clay loam that was sometimes mottled with brown and yellowish brown clay (Stratum 1) that overlaid an horizon of mottled reddish brown and yellowish brown clay loam (Stratum 2) which, in five tests, overlaid a layer of strong brown to reddish brown clay loam (Stratum 3). Gravel was noted throughout all the tests. The STPs were dug to an average total depth of 42.3 cm. The presence of the gravel in the clay indicates the soils in the survey area have been disturbed (perhaps deposited), likely during the construction of the parkway.

One artifact was found in the Survey Area 2 shovel tests: a piece of an oyster shell from Stratum 1 in STP 5.5. The shell was found with a piece of plastic in disturbed soils and therefore lacks its depositional context and has no archaeological value. No pre-contact period artifacts were found, nor were any pre-contact or historical-period features identified.

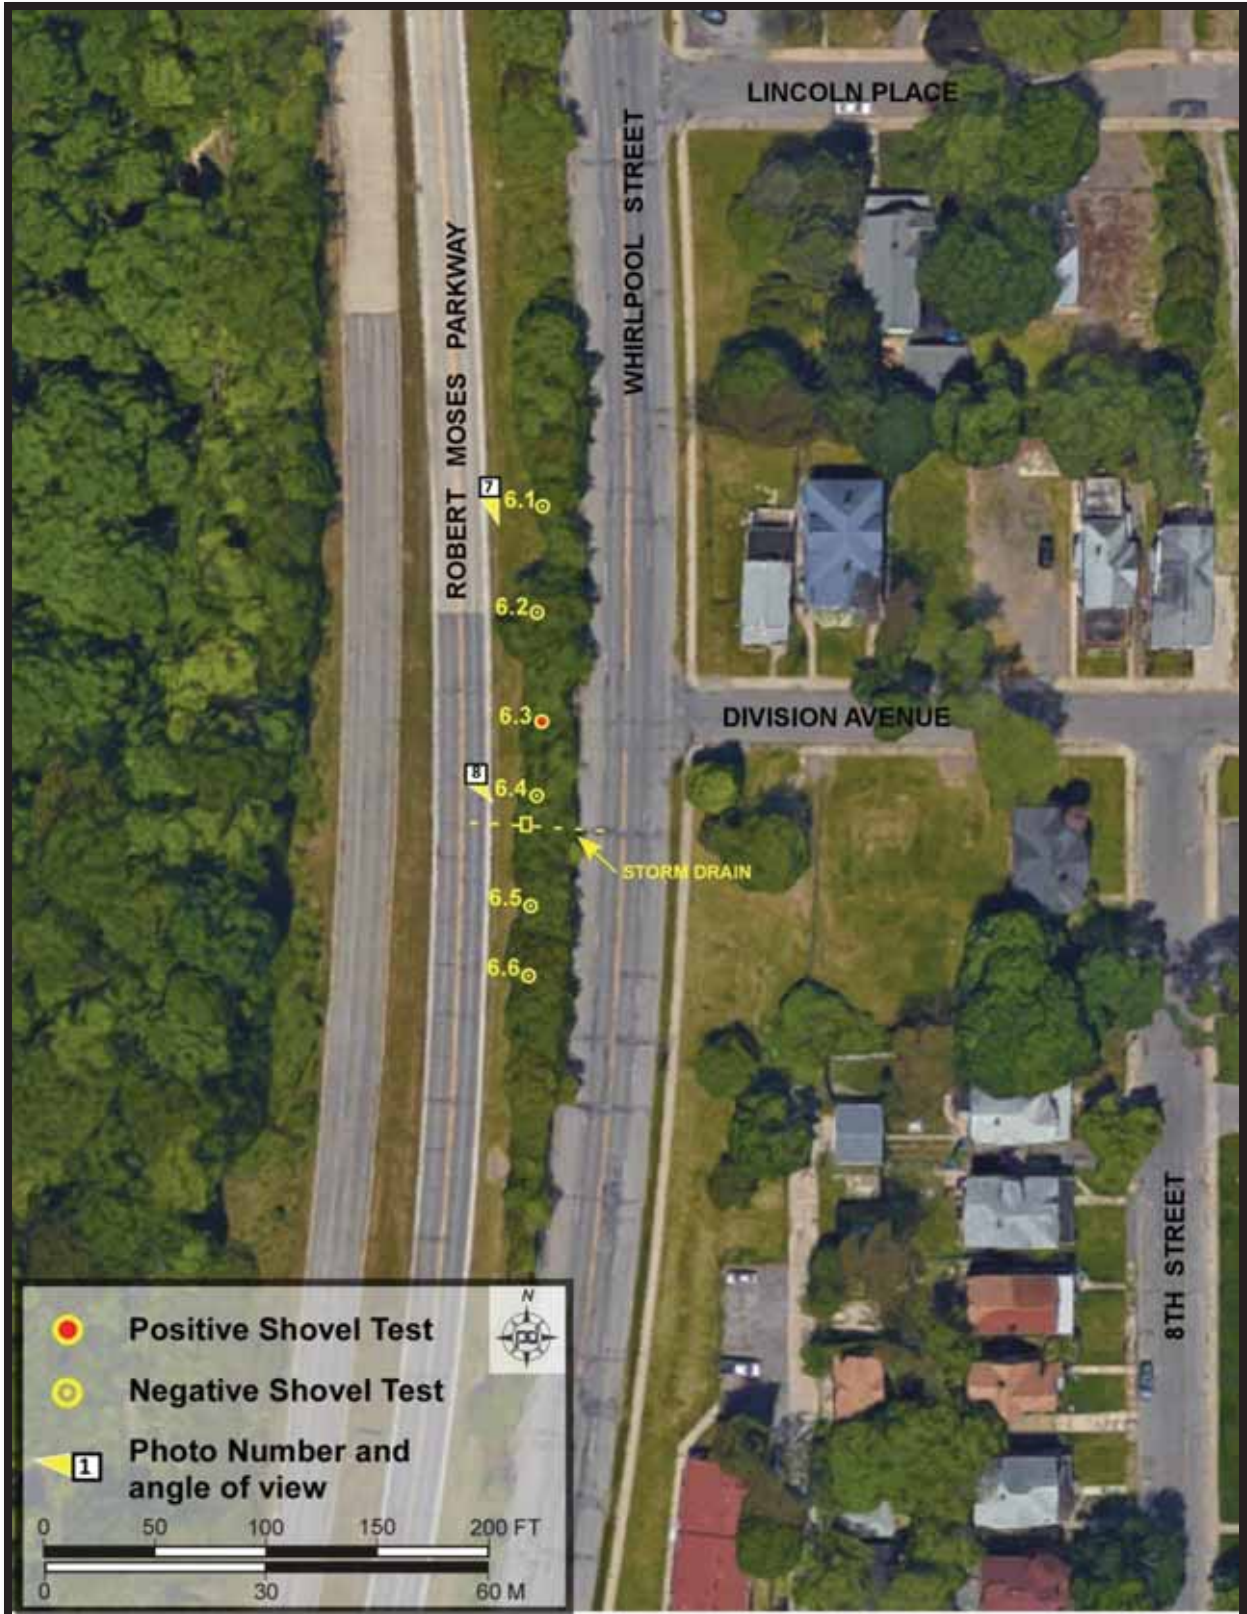
Figure 2.4. Survey Area 3 showing shovel test pits and photograph locations and directions (aerial: Google 2016).

The Survey Area 3 field investigation included a total of six shovel tests dug at a 15-meter interval along Transect 6. The STPs were dug to a total average depth of 37.3 cm. Their soils had the same characteristics as those in Area 2: three strata of clayey soils with gravel throughout, qualities that indicate the area was disturbed during the construction of the parkway.

With the exception of a piece of asphalt from Stratum 2 in STP 6.3, no cultural remains were found in Survey Area 3.

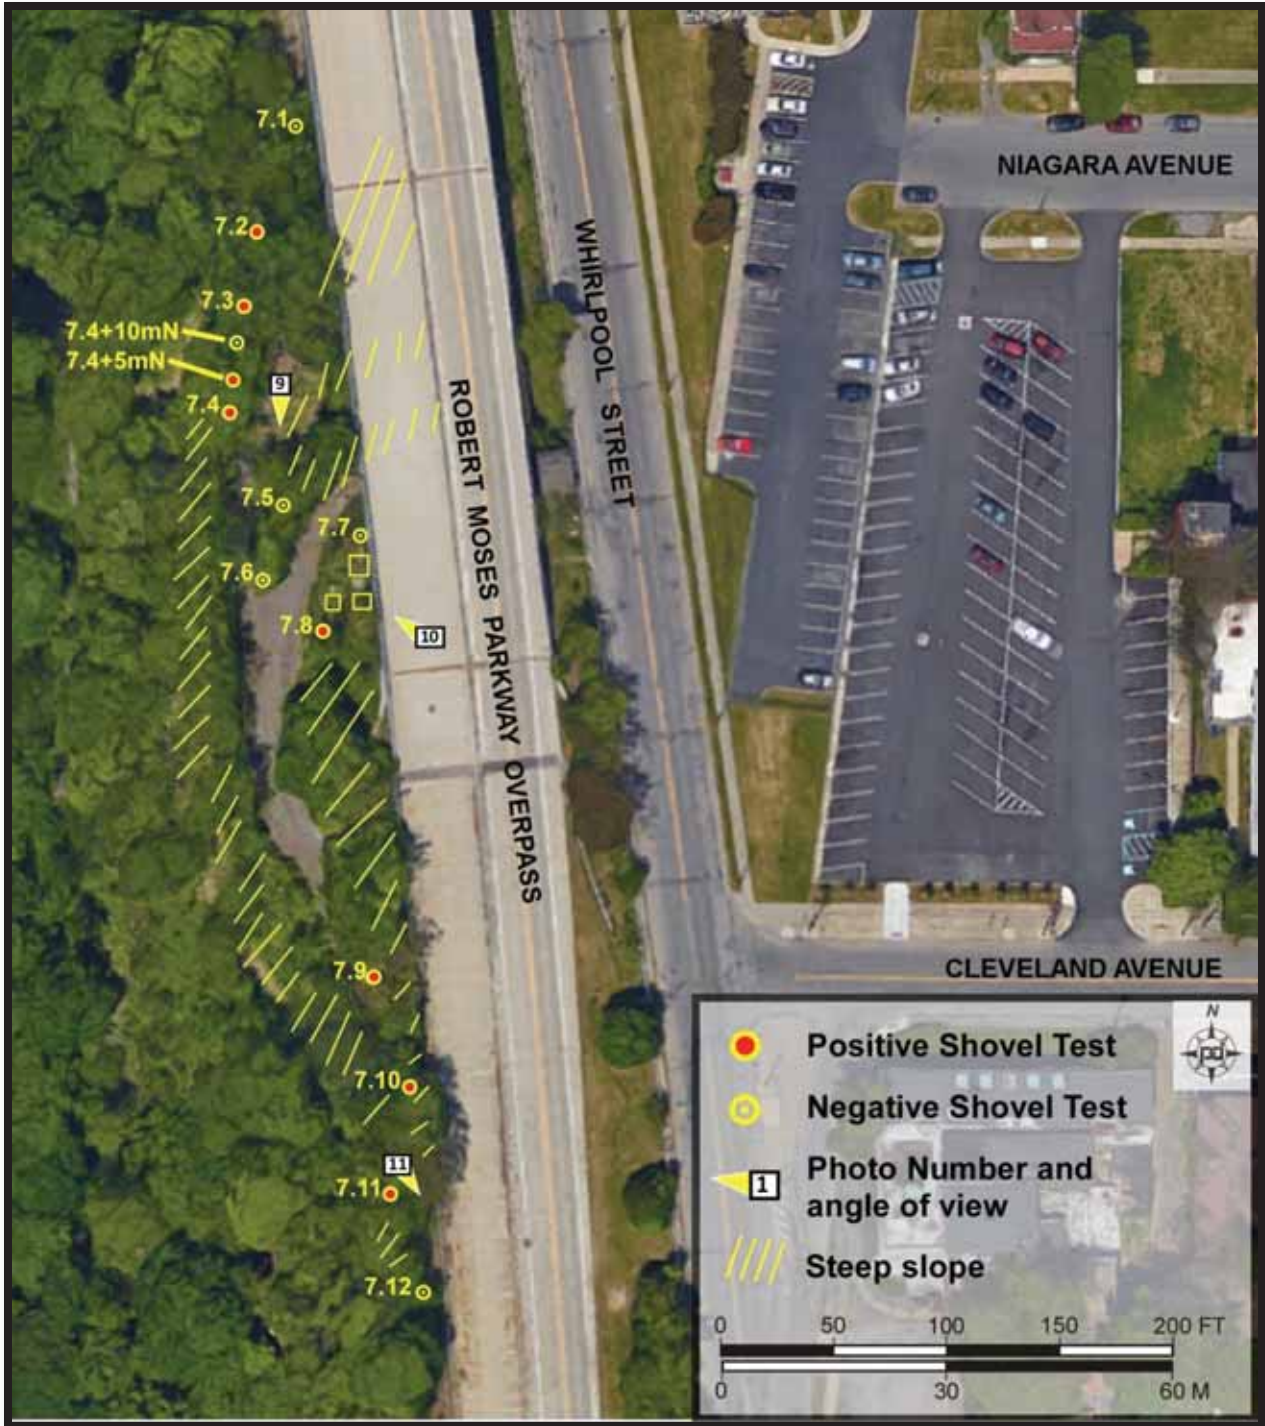
Figure 2.5. Survey Area 4 showing shovel test pits and photograph locations and directions (aerial: Google 2016).

Survey Area 4. Survey Area 4 is a 1.1-acre area along the west side of, and partially beneath, an elevated portion of the Robert Moses Parkway west of Niagara and Cleveland Avenues (Figure 2.5). It is crossed by several single-lane, abandoned asphalt-paved roads and is bounded to the west by an gravel-paved trail along the edge of the Niagara Gorge. Much of the area between the asphalt roads is steep, consistent with grading. Other indications of below-ground disturbances include the pylons for the elevated parkway, several guardrails, well and storm sewer manholes, and a concrete block pavement, which covers a part of the area beneath the parkway (Appendix A: Photographs 9 to 11). Only roughly 20 percent of the survey area was not either steep or covered with pavement. At the time of the field investigation, vegetation included young to medium-age deciduous trees, low uncut grasses, and moderate amounts of brush.

The field investigation at Area 4 included 14 tests along Transect 7, which were distributed across the testable portions of the survey area at a variety of intervals. The STPs were dug to an average total depth of 36.6cm. The shallowest soils identified in the tests were broadly similar across the area and typically consisted of dark grayish brown to very dark grayish brown silty loam that was sometimes mottled with material from underlying strata and that ranged from 10 to 40 cm in thickness. The topsoil overlaid one to two additional soil strata / lenses with characteristics that varied across the survey area (two soils were noted in eight STPs and three were identified in three tests, nos. 7.2, 7.6, and 7.7; the remaining three STPs – 7.1, 7.9, and 7.12 – were terminated due to rock impasses before a second soil layer was found). Underlying soils included: yellowish brown silt loam; strong brown sandy clay loam; reddish brown clay loam; light gray sandy silt; and reddish brown sand. These highly variable characteristics suggest that at least parts of the survey area had been disturbed.

Items consistent with episodes of construction and demolition, including asphalt fragments and large quantities of brick were found in four tests (asphalt was found in STPs 7.9 and 7.10 and brick in STPs 7.8 and 7.4+5mN) and crushed gravel, possibly related to the area's roads and trails was noted four tests (nos. 7.1, 7.2, 7.8, 7.9). Besides the bricks, architectural artifacts were limited to a pair of wire nails found in the topsoil of STP 7.4+5mN. A total of three domestic (i.e., Kitchen group) artifacts were found in STPs 7.3 and 7.4, which did not contain obvious indications of episodes of demolition or architectural materials. Two of the items, a piece of annular whiteware and an undecorated ironstone rim fragment, were from STP 7.4 and the other, a piece of plain ironstone, was from STP 7.3. Both shovel tests were in a confined testable area measuring roughly 17 meters by 4 meters and bounded by steep terrain; a pair of additional STPs was dug between them, in the only available investigable terrain. With the exception of the aforementioned wire nails and brick fragments from STP 7.4+5mN, neither test contained artifacts. Given the small size of the testable area around STPs 7.3 and 7.4, it is highly unlikely that undetected potentially archaeologically-productive deposits of artifacts are present. The area around the tests does not merit further archaeological investigation. Non-architectural artifacts found elsewhere in the survey area were limited to two pieces of coal from STP 7.2 and a fragment of terracotta, possibly from a large plant pot, found in STP 7.8 in soil that also contained large amounts of brick fragments, gravel, and iron slag. No pre-contact period artifacts were found in Survey Area 4, nor were any pre-contact or historical-period features identified.

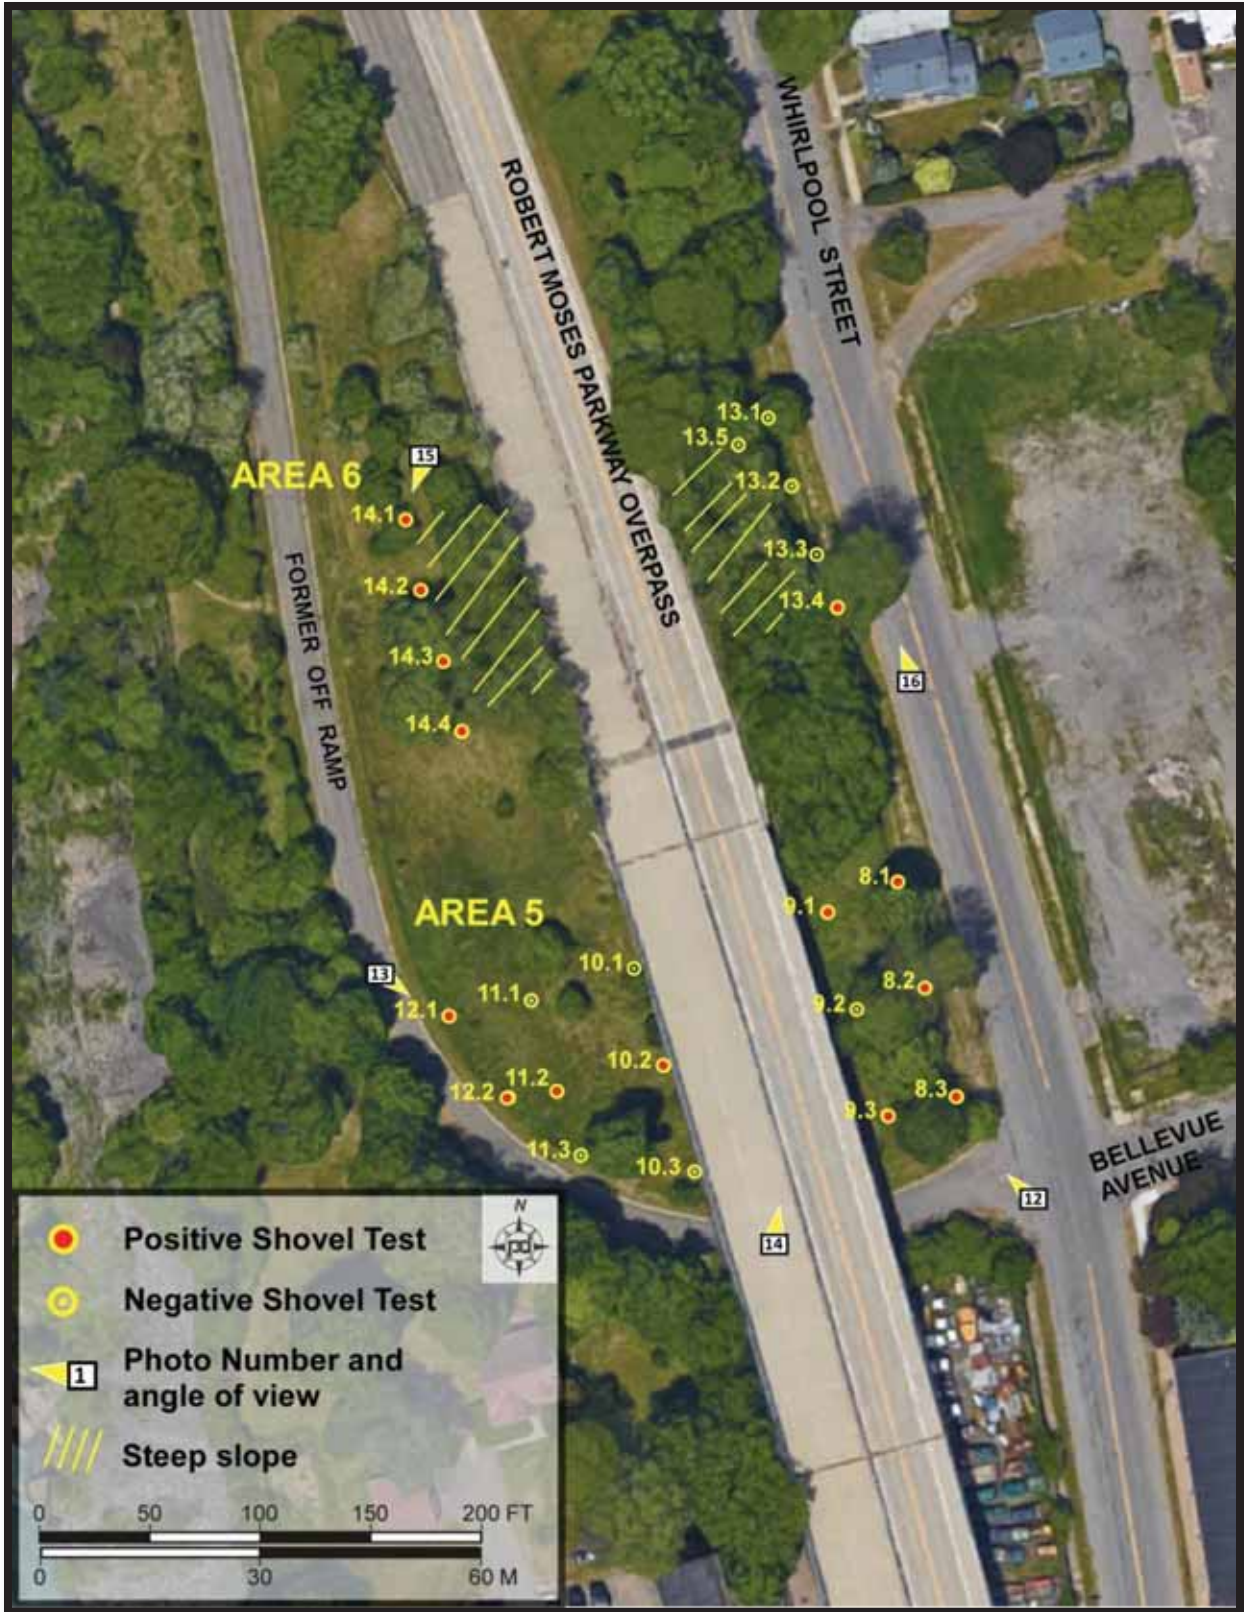
Figure 2.6. Survey Areas 5 and 6 showing shovel test pits and photograph locations and directions (aerial: Google 2016).

Survey Area 5. Survey Area 5 is a .5-acre area that straddles an elevated portion of the Robert Moses Parkway northwest of the intersection of Whirlpool Street and Bellevue Avenue (Figure 2.6). At the time of the field investigation, vegetation included tall grasses, moderate low brush, and several mature deciduous trees (Appendix A: Photographs 12 and 13). Visible indications of below-ground disturbances were limited to street signs, a concrete block-paved surface beneath the elevated portion of the parkway and several parkway support pylons (Appendix A: Photograph 14; see Photograph 12).

The investigation at Area 5 included 14 STPs dug along 5 transects (Transects 8 to 12) at a 15-meter (or shorter) interval that were dug to an average total depth of 46.6 cm BGS. As in Survey Areas 1 and 4, the shallowest soils in the tests were roughly consistent across the survey area and comprised dark brown to very dark grayish brown clay loam 10 to 37 cm in thickness. The underlying soils were highly variable and included lenses of strong brown silt loam, brown silty clay, yellowish brown and dark grayish brown silty clay loam, reddish brown and strong brown sandy clay loam, reddish brown clay, and yellowish red sand. Five tests (nos. 8.2, 9.2, 10.2, 10.3, and 11.1) had layers of mixed soils. The highly variable qualities of the soils in the survey area are consistent with disturbances from episodes of demolition and construction.

Large quantities of brick were noted in two tests (nos. 8.2 and 12.1); mortar was found in STP 9.3; and crushed stone, which may have been related to the construction of the parkway and the nearby off-ramp, was identified in four STPs (nos. 8.2, 9.2, 12.1, and 12.2). A total of four other items likely related to building demolition were found in three tests and included: a piece of cut wood and a sewer pipe fragment from STP 8.2; a piece of flat glass in STP 11.2; and a fragment of bathroom porcelain in STP 12.2. Iron slag was noted in four STPs (nos. 8.3, 9.3, 11.2, and 12.1); pieces of coal were found in three tests (nos. 8.3, 9.3, and 11.2); and coal ash was identified in STP 9.3. Eight domestic (Kitchen group) items were also found, including: a piece of blue shell-edge whiteware from STP 8.2; a fragment of milk glass from STP 10.2; a fragment of hotel ware, a piece of brown-and-tan style stoneware a clear glass fragment of unidentifiable form from STP 11.2; a piece of salt-glazed stoneware, a fragment of clear container glass, and a fragment of amber container glass (which may be modern) from STP 12.2. One artifact was found that was unidentifiable as to artifact class: a piece of sheet iron from STP 12.1. Finally, ten oyster shell fragments were also found in three STPs (one piece was in STP 8.1; eight were in 11.2; and one was in STP 12.1). The volume of artifacts found in the survey is best characterized as light to moderate and no distinct deposits of items were noted. Because of this, along with the disturbed qualities of soils at the survey area, the assemblage has no archaeological research potential and not additional investigation of it is warranted. No pre-contact period artifacts were found, nor were any pre-contact or historical period features of any kind identified.

Survey Area 6. Survey Area 6 covers roughly .4 acres along the Robert Moses Parkway about 35 meters north of Survey Area 5 (see Figure 2.6). Approximately three-quarters of its surface is covered with a steep-sided embankment for the parkway (Appendix A: Photographs 15 and 16). With this exception, indications of below-ground disturbance were limited to several street signs. Vegetation on the east side of the parkway embankment included dense brush and medium-age deciduous trees (Appendix A: Photograph 15), while flora its west side as primarily tall grasses with small amounts of young deciduous trees (Appendix A: Photograph 16). The remainder of the survey area was covered with tall grasses.

A total of two historical artifacts were collected from the tests east of the parkway: a piece of undecorated ironstone from STP 13.1 and a piece of aqua container glass from STP 13.4. Several pieces of modern clear container glass were noted near the top of test 13.4, an STP that also contained large amounts of crushed stone and iron slag. Crushed stone was also present in STP 13.5. Just one historical artifact was collected from the tests west of the parkway: a piece of copper tubing that may be a vehicle part that was found in the topsoil of STP 14.2. Asphalt fragments were found in two contexts along Transect 14: the topsoil in STP 14.1 and the lower soil layer in STP 14.3, the latter of which also contained numerous fragments of brick, coal, and mortar. Modern clear container glass was found in the topsoil in STPs 14.2 and 14.4. The materials found along the two Area 6 Transects have no archaeological value. The soils in the Transect 13 tests have been disturbed and the artifacts they contained have no depositional context; although the soils along Transect 14 were not as obviously disturbed, the presence of asphalt fragments and large numbers of bricks in the lower soil stratum indicate at least part of that area has also been disturbed. There were also no instances along Transect 14 where non-architectural artifacts were found exclusive architectural items. No pre-contact period artifacts were found in Survey Area 6, nor were any pre-contact or historical period features of any kind identified.

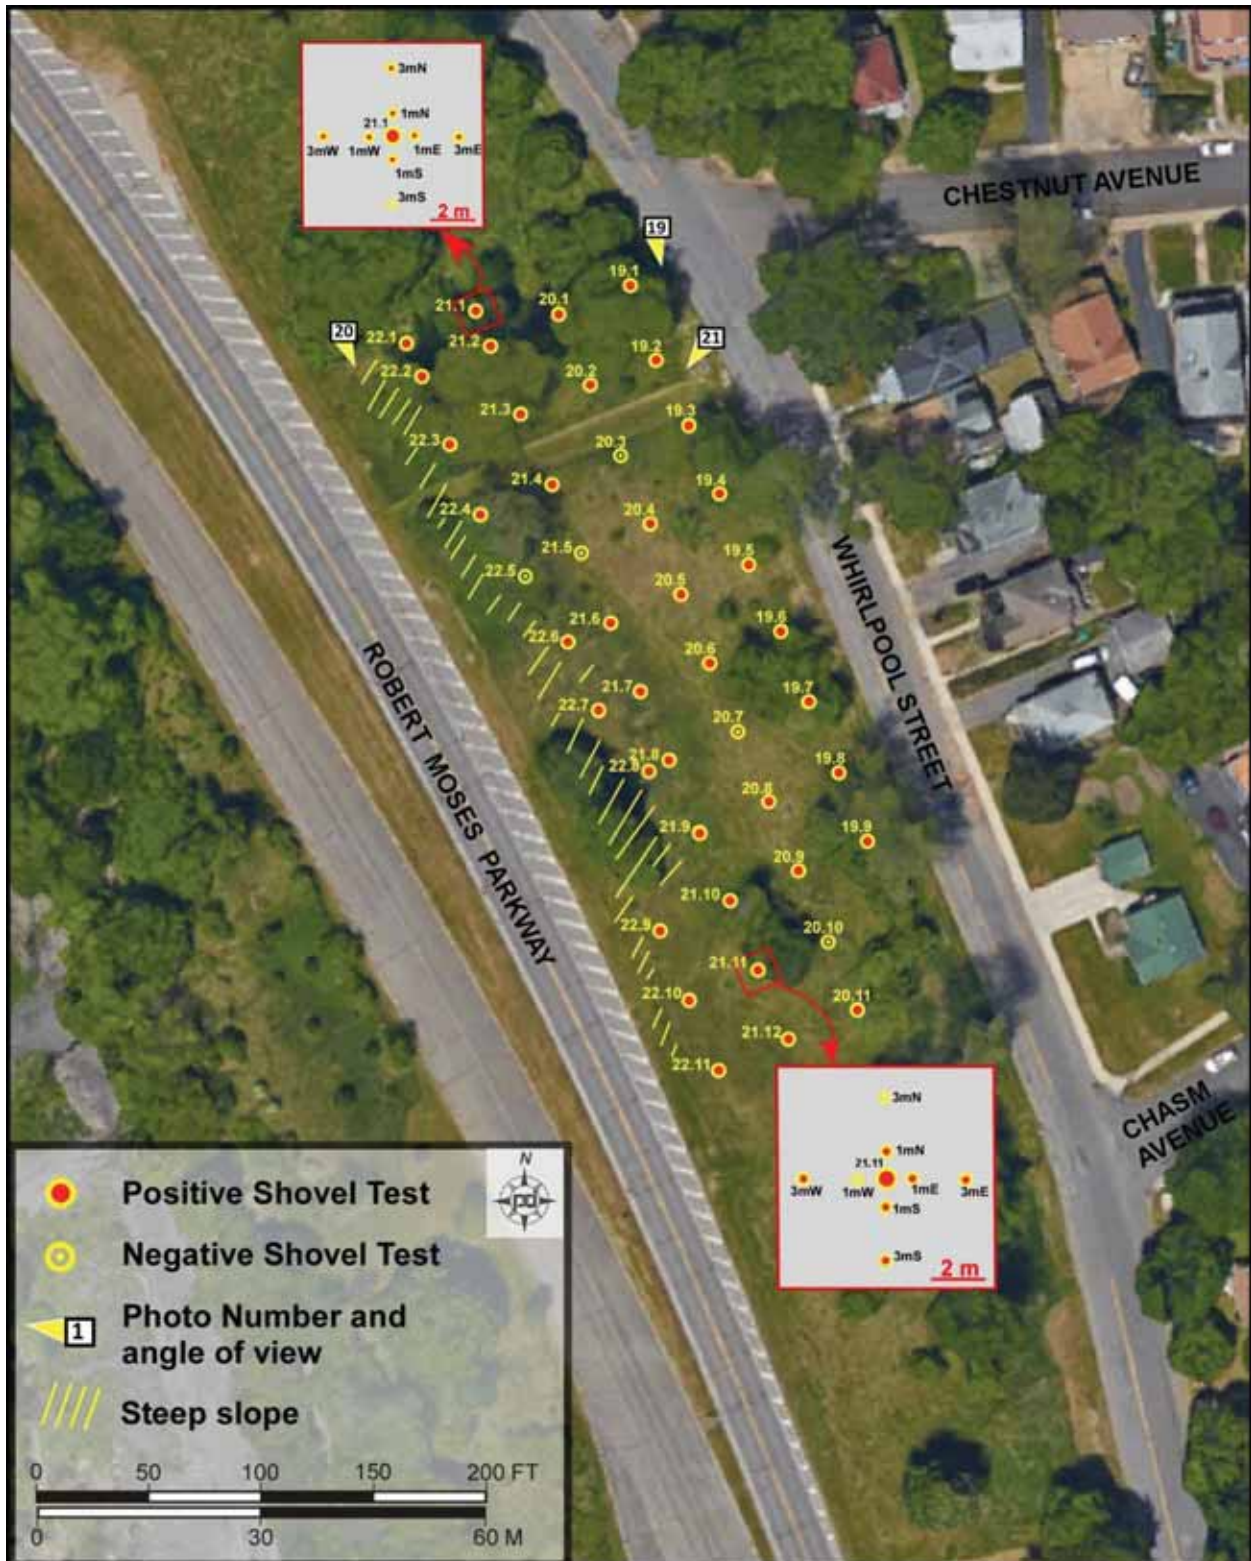
Figure 2.8. Survey Area 8 showing shovel test pits and photograph locations and directions (aerial: Google 2016).

The field investigation at Area 8 included 59 STPs; 43 of the tests were dug along Transects 19 to 22 at a 10-meter interval (or less) and the remaining 16 were radial STPs (nos. 21.1 and 21.11) dug around a pair of tests in which domestic artifacts were found in contexts exclusive of demolition debris.

Artifacts found in the STPs are also generally consistent with a setting that has been subjected to episodes of construction and demolition. Large numbers of brick fragments were found in soils below the topsoil in fifteen of the Area 8 tests and mortar was found in the lower soils of an additional two STPs. Asphalt fragments were noted below the topsoil in five of the tests, three of which contained neither brick nor mortar. A total of 21 architectural artifacts were collected from fifteen of the area's STPs, including: ten pieces of flat glass (one of which was frosted 'privacy' glass); and 11 nails (of which four are wire nails, three are cut, two are too corroded to determine their types, one is a wire roofing nail, and one is a cut spike). A fragment of a welding rod was also found. Finally, three tests contained large amounts of gravel, which may have been related to pavement.

Thirty-three non-architectural items were collected from 17 of the Area 8 STPs, including: five pieces of ironstone (none decorated); two fragments of porcelain (one from a cup and one from a plate – neither of which is decorated); two pieces of stoneware (one is from a ginger beer bottle and the other is from a salt-glazed vessel); four whiteware fragments (three of which refit and are from a flow blue plate and one has a blue transfer-print design but is too small to

determine its vessel's type); eight pieces of container glass (of which three are aqua, three are clear, and two are green); two crown bottle cap pieces (which are probably from the same cap); a fragment from a terracotta flower pot; a molded plastic toy soldier; three cut mammal bone fragments; and five fragments of a red glass vehicle light lens. A further six items were also collected, but that could not be classified as to function: a piece of milk glass; four unidentifiable iron fragments; and a piece of heavy gauge sheet plastic. Four of the artifacts were found in the topsoil of a single STP, no. 21.7, a context that also yield modern material (amber bottle glass) and an architectural item (a nail). With this exception, the remaining artifacts were fairly evenly distributed across the survey area. Other cultural materials noted in the survey area include: iron slag noted in 11 STPs; coal, found in 28 tests; and coal ash, which was present in 9 STPs.

Two tests, STPs 21.1 and 21.11, yielded historical domestic material found exclusive of architectural materials: a piece of clear container glass was found below the topsoil in STP 21.1 and STP 21.11 contained the flow-blue plate fragments and one of the porcelain pieces. The areas around each context were tested with eight STPs. None yielded additional artifacts from contexts that did not also contain architectural items, nor were any artifact deposits identified.

No pre-contact period artifacts were found at Survey Area 8, nor were any pre-contact or historical period features of any kind identified. Although moderate numbers of historical-period items were found across the survey area, they do not have context and therefore have no archaeological value.

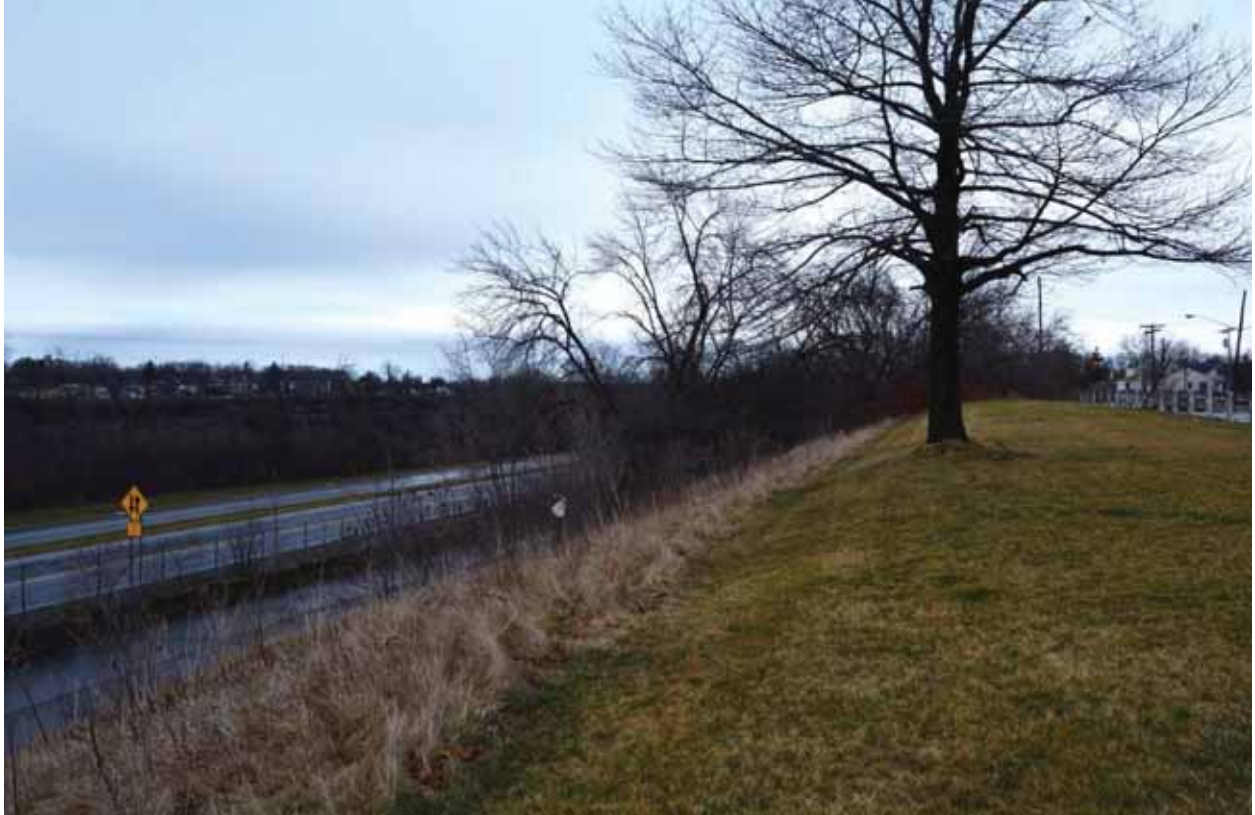
Photograph 1. The western portion of Survey Area 1, facing northeast (Panamerican 2016).

Survey Area 1. Survey Area 1 includes four testable locations totaling .8 acres along the shoulders of Third and Whirlpool Streets north of the Aquarium of Niagara (Figure 2.1). It is bounded by Third Street to the east and the steep slope down to the pump station access road to the west (Appendix A: Photograph 1). Nearly all of Area 1 is publicly-accessible open space which, at the time of the field investigation, was covered with a low-cut lawn and several deciduous trees and decorative bushes (Appendix A: Photograph 2). A small area near its north edge was less-well maintained and had tall grasses, moderate-density underbrush, and several immature deciduous trees (Appendix A: Photograph 3). Visible indications of below-ground disturbances included a row of utility poles along the west side of Third Street and a short traffic barrier / fence along the west edge of Whirlpool Street (see Appendix A: Photographs 2 and 3).

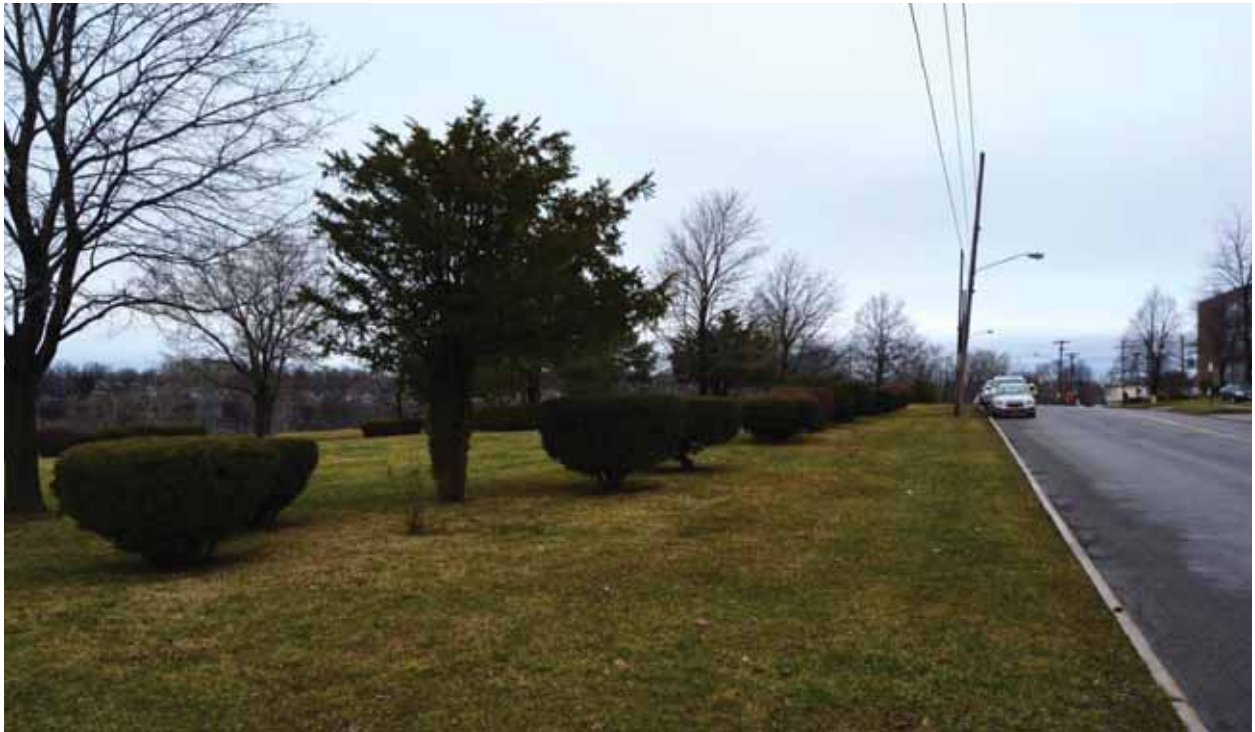
Photograph 2. Open space in the part of Survey Area 1 west of Third Street, facing northwest (Panamerican 2016).

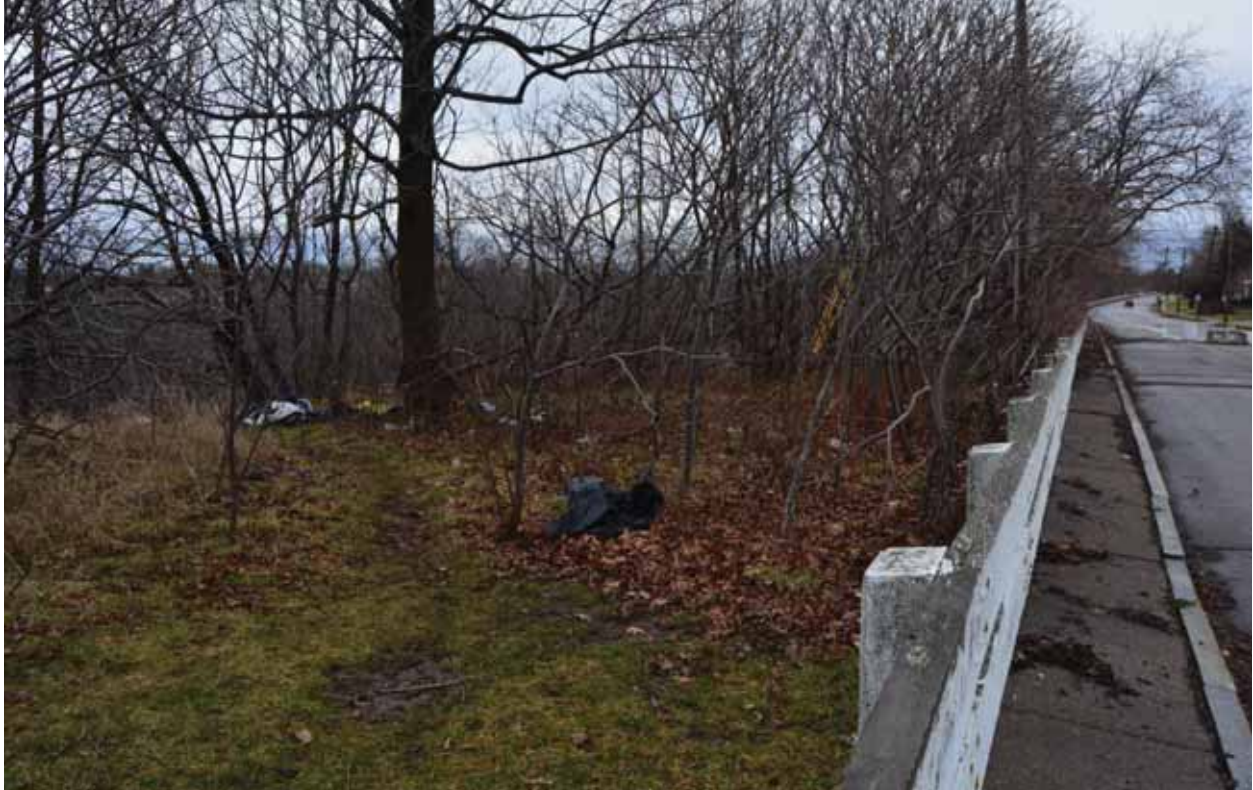
Photograph 3. Typical vegetation and surface conditions in the northern part of Survey Area 1, facing north (*Panamerican 2016*).
