PHASE 1B CULTURAL RESOURCES INVESTIGATION FOR THE PHASES I-IV PRELIMINARY DESIGN AND DESIGN APPROVAL DOCUMENT

NIAGARA GORGE CORRIDOR -- ROBERT MOSES PARKWAY REMOVAL PROJECT , MAIN STREET TO FINDLAY DRIVE, NIAGARA FALLS, NEW YORK

**PIN 5757.121
(OPRHP Project Review 15PR04311)**

April 2016

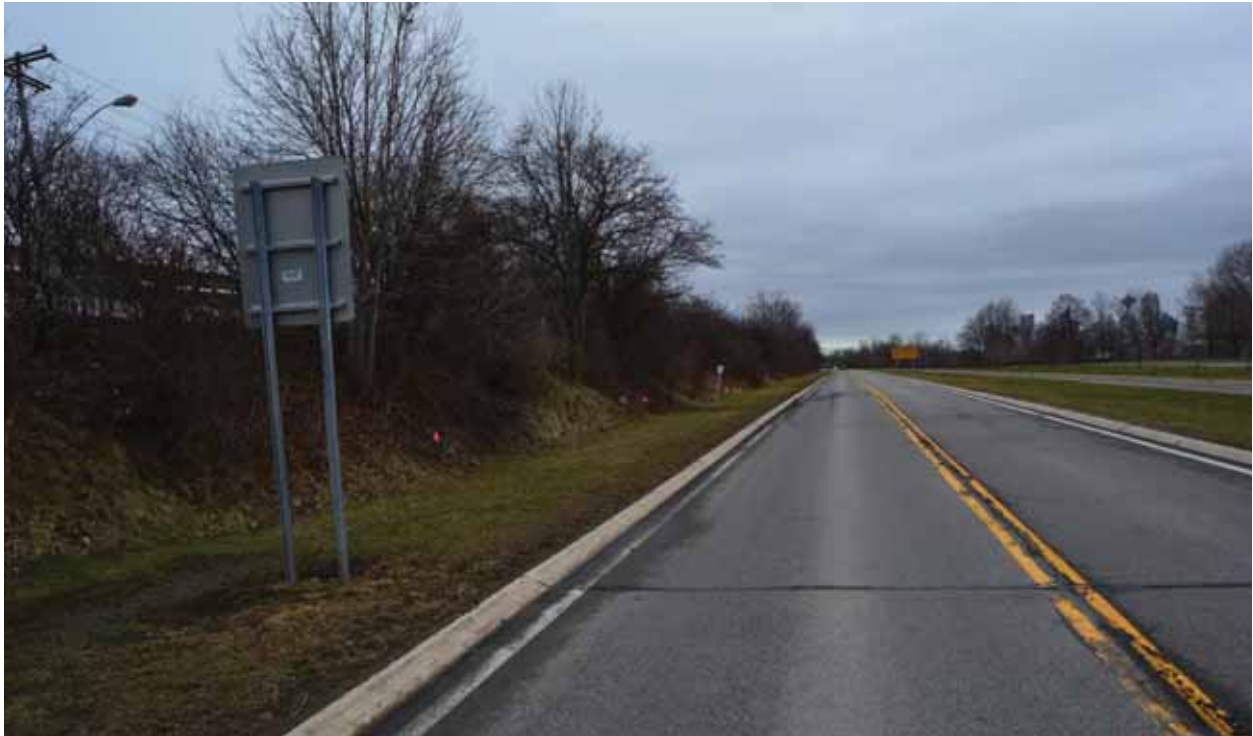
Photograph 4. The southern half of Survey Area 2 from near STP 5.4, facing southwest (*Panamerican 2016*).

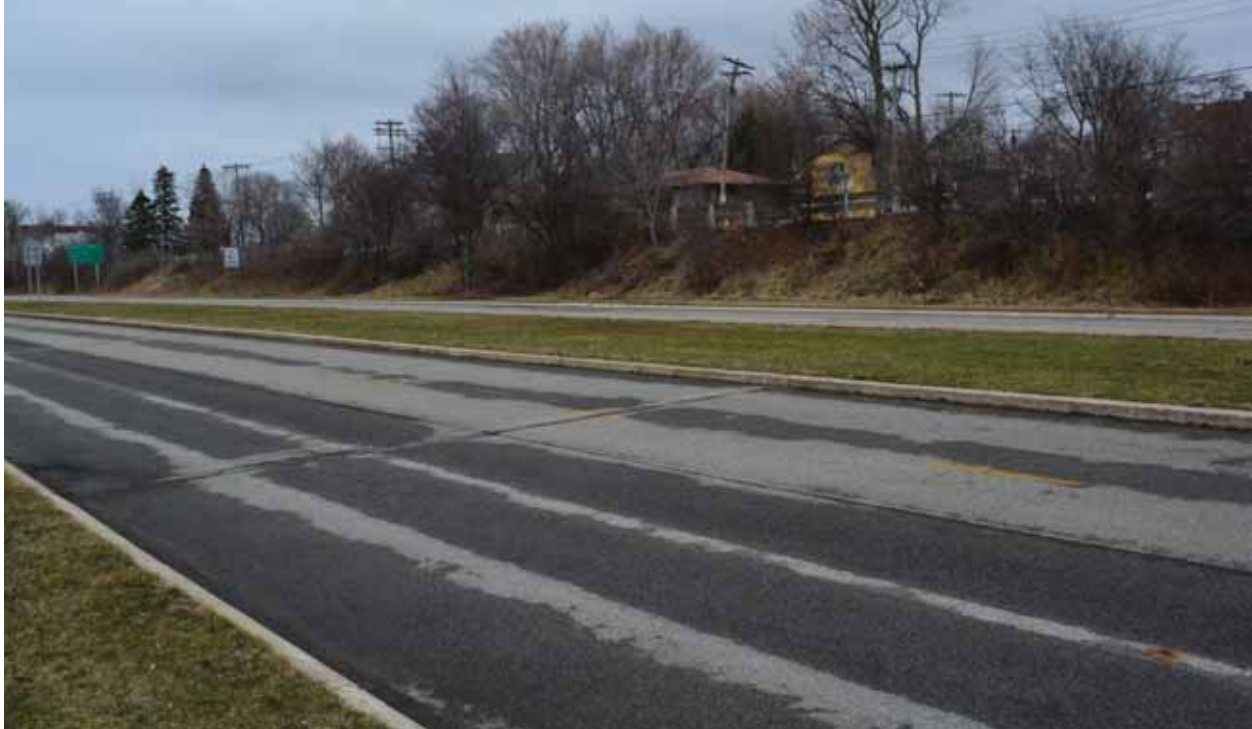
Photograph 5. Survey Area 2 from the west side of the Robert Moses Parkway, facing northeast (Panamerican 2016).

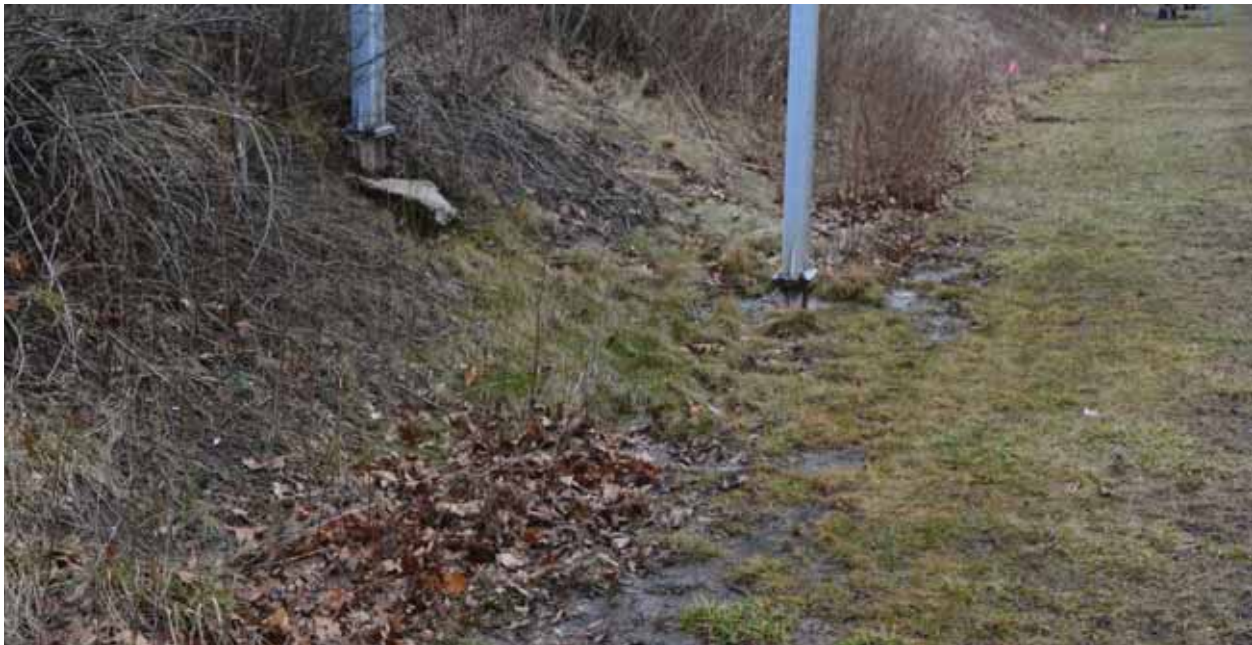
Photograph 6. Standing water and wet surface conditions in the northern portion of Survey Area 2, facing south (Panamerican 2016).

Area 2. Survey Area 2 is a narrow (ca.-6-meter-wide), 160-meter-long area between Whirlpool Street and the Robert Moses Parkway west of Pierce Avenue (Figure 2.3). Roughly the southeastern half of the survey area covers terrain that slopes steeply downward six to eight feet from the northwest side of Whirlpool Street to the level of the shoulder along the east side of the parkway (Appendix A: Photographs 4 and 5). The steep slope is covered with dense brush, small amounts of tall grasses, and several medium-age deciduous trees; vegetation on the parkway shoulder is entirely low-cut grasses. Indications of below-ground disturbance include several road signs along the parkway and a short traffic barrier / fence along the west side of Whirlpool Street. Beyond this, it is highly probable that much of the survey area was been graded during the construction of the parkway. The steep slope along Whirlpool Street was also heavily littered with bottles and other trash. At the time of the field investigation, standing water covered parts of the northeastern-most 15 meters of the survey area (Appendix A: Photograph 6).

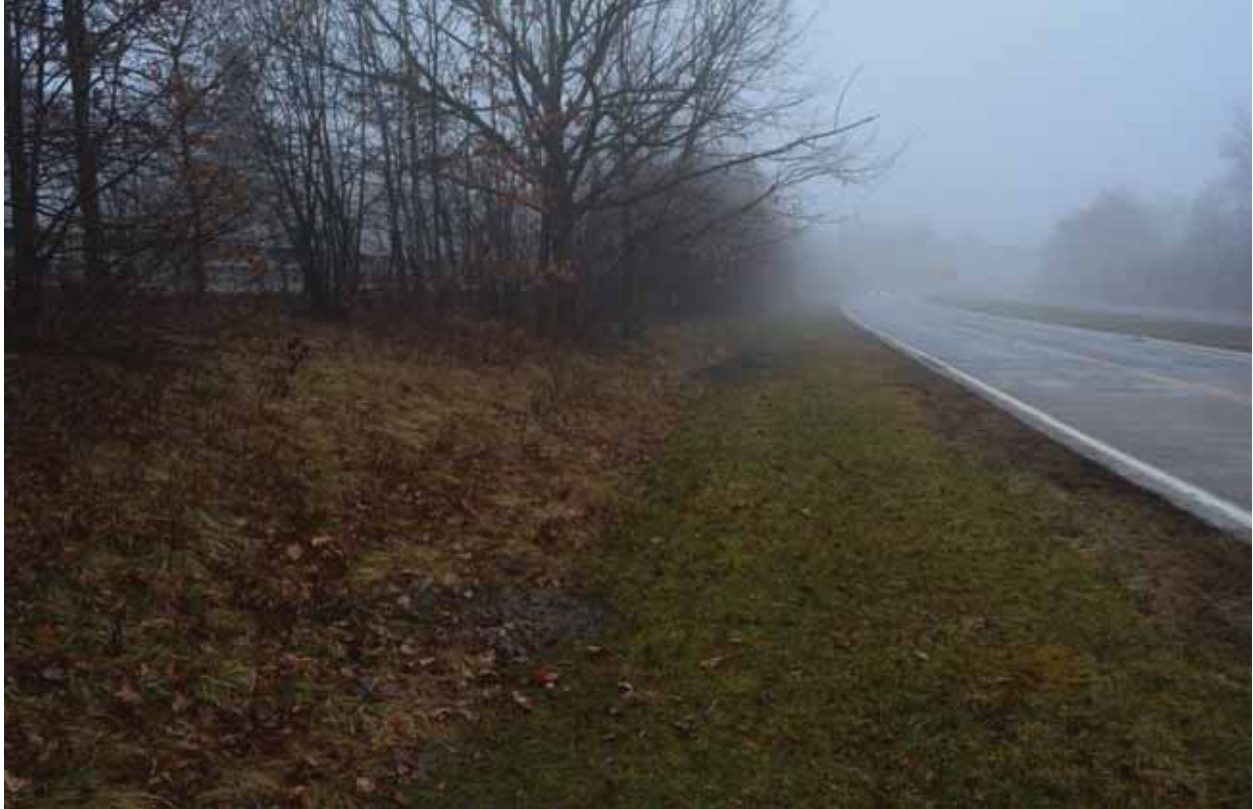
Photograph 7. Survey Area 3 from its north end, facing south (*Panamerican 2016*).

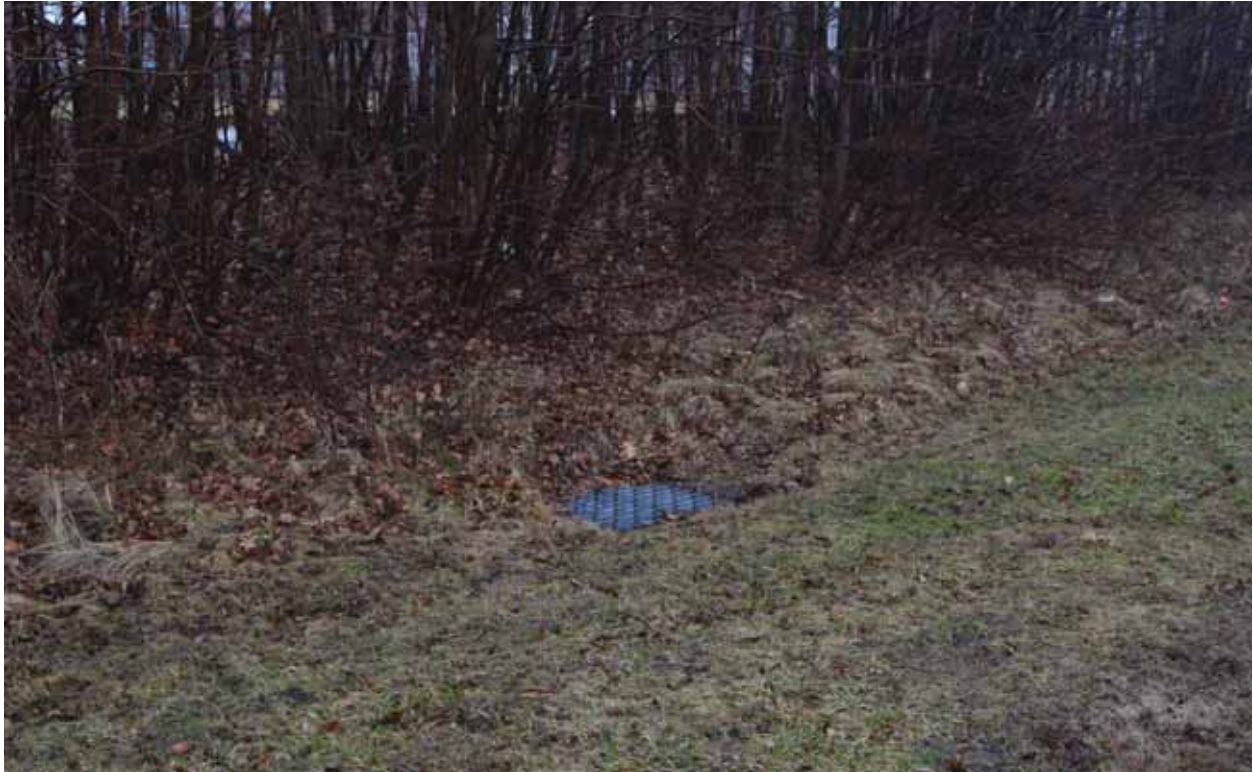
Photograph 8. Storm drain opening in Survey Area 3, facing southeast (*Panamerican 2016*).

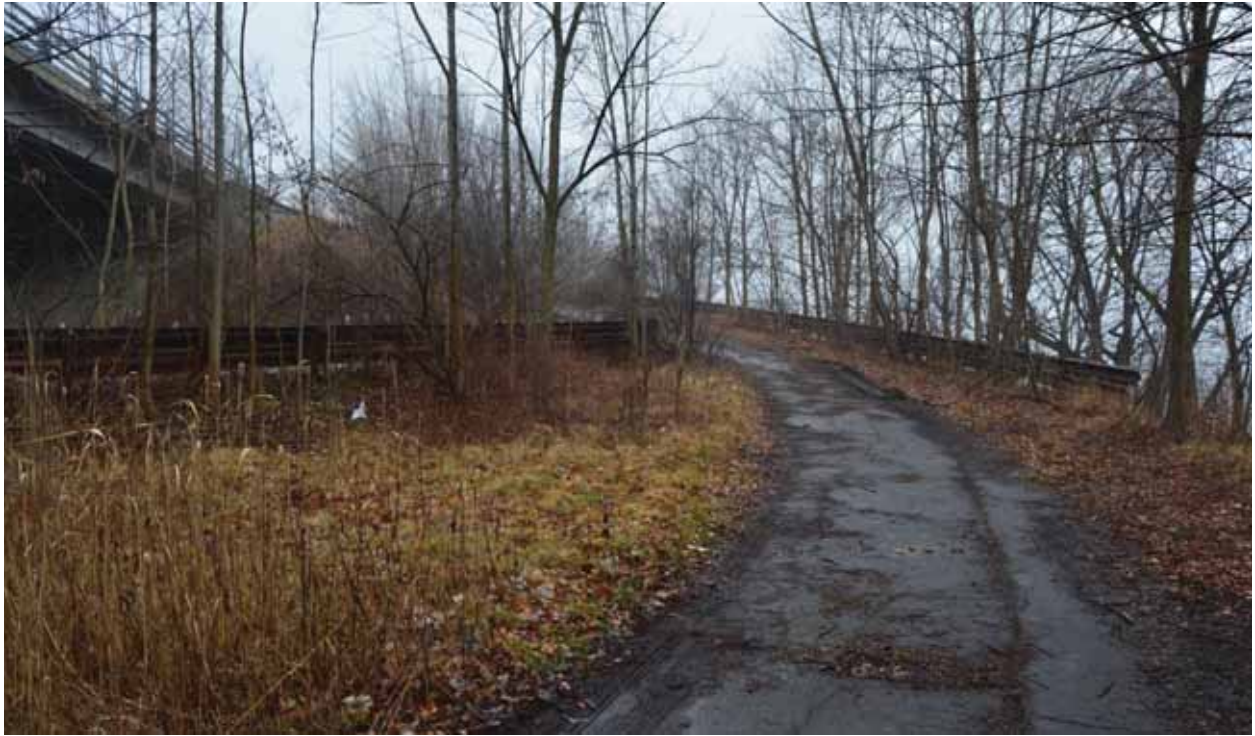
Photograph 9. Steep terrain and asphalt-paved roads in the eastern half of Survey Area 4, facing south (Panamerican 2016).

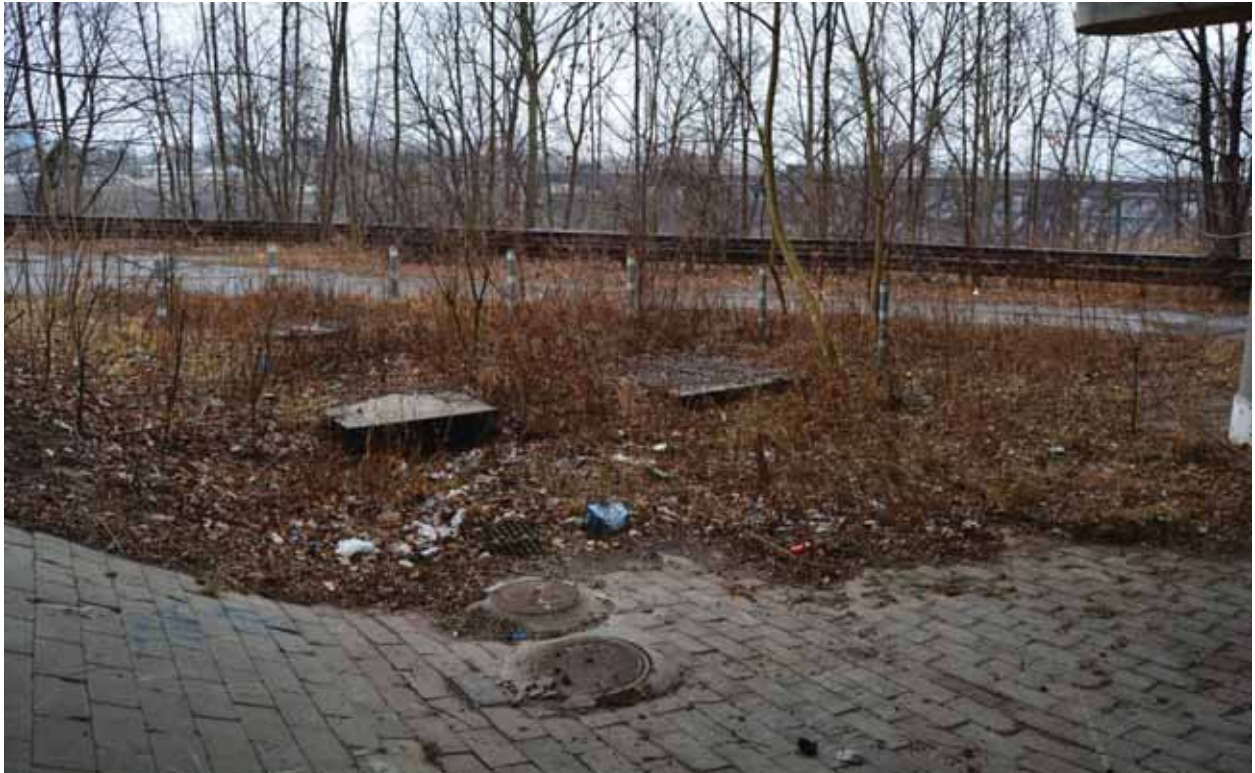
Photograph 10. Utilities, guardrails, and paved surfaces in Survey Area 4, facing northwest (Panamerican 2016).

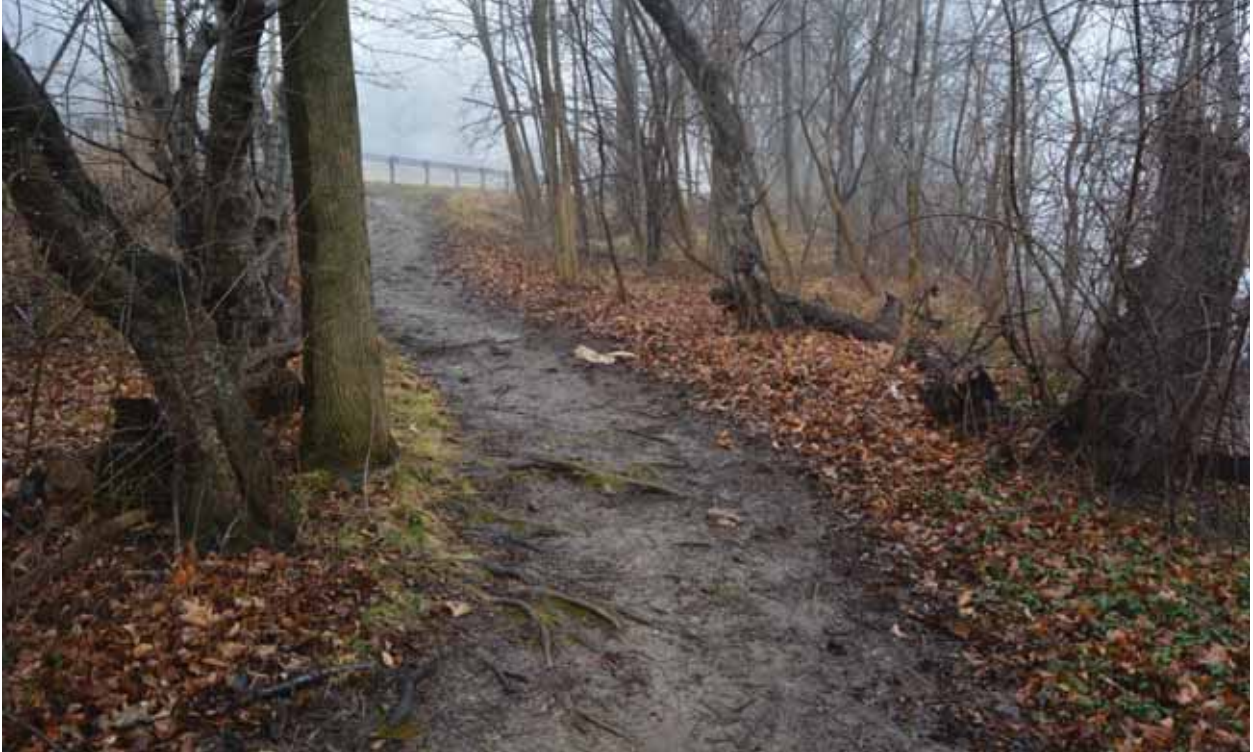
Photograph 11. Surface conditions in the south portion of Survey Area 4, facing southeast (Panamerican 2016).

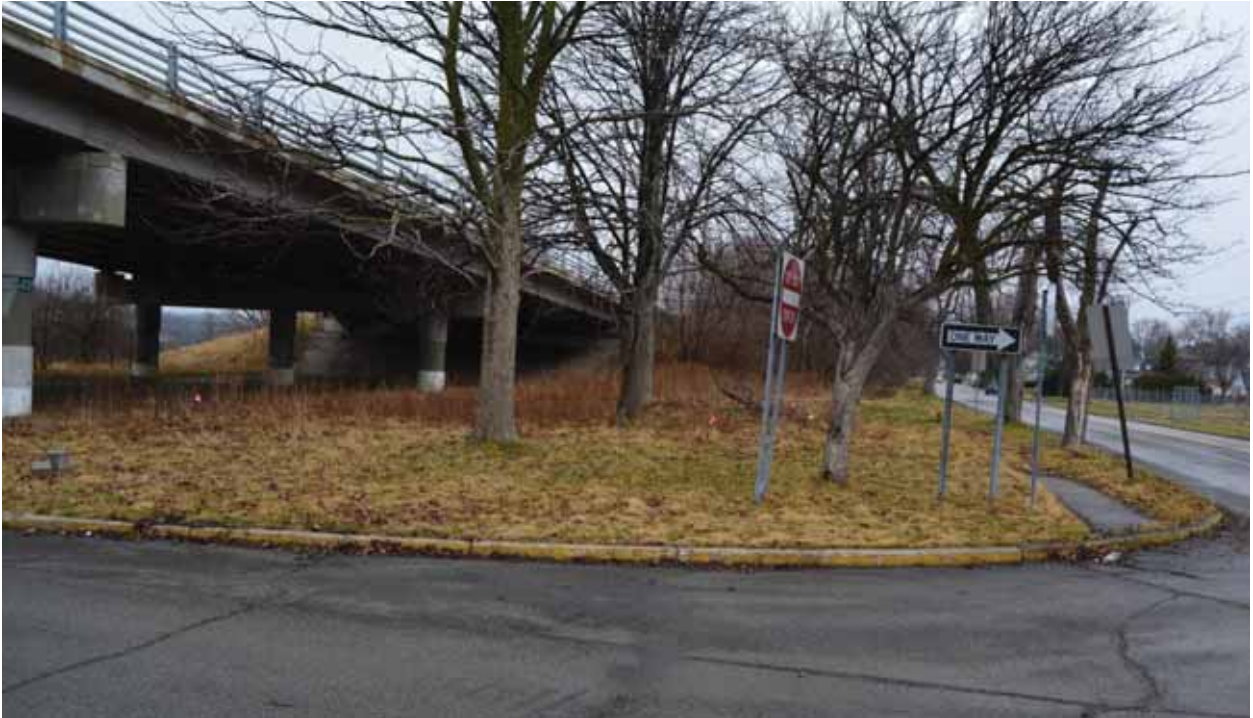
Photograph 12. Surface conditions in the eastern part of Survey Area 5, facing northwest (Panamerican 2016).

Survey Area 5. Survey Area 5 is a .5-acre area that straddles an elevated portion of the Robert Moses Parkway northwest of the intersection of Whirlpool Street and Bellevue Avenue (Figure 2.6). At the time of the field investigation, vegetation included tall grasses, moderate low brush, and several mature deciduous trees (Appendix A: Photographs 12 and 13). Visible indications of below-ground disturbances were limited to street signs, a concrete block-paved surface beneath the elevated portion of the parkway and several parkway support pylons (Appendix A: Photograph 14; see Photograph 12).

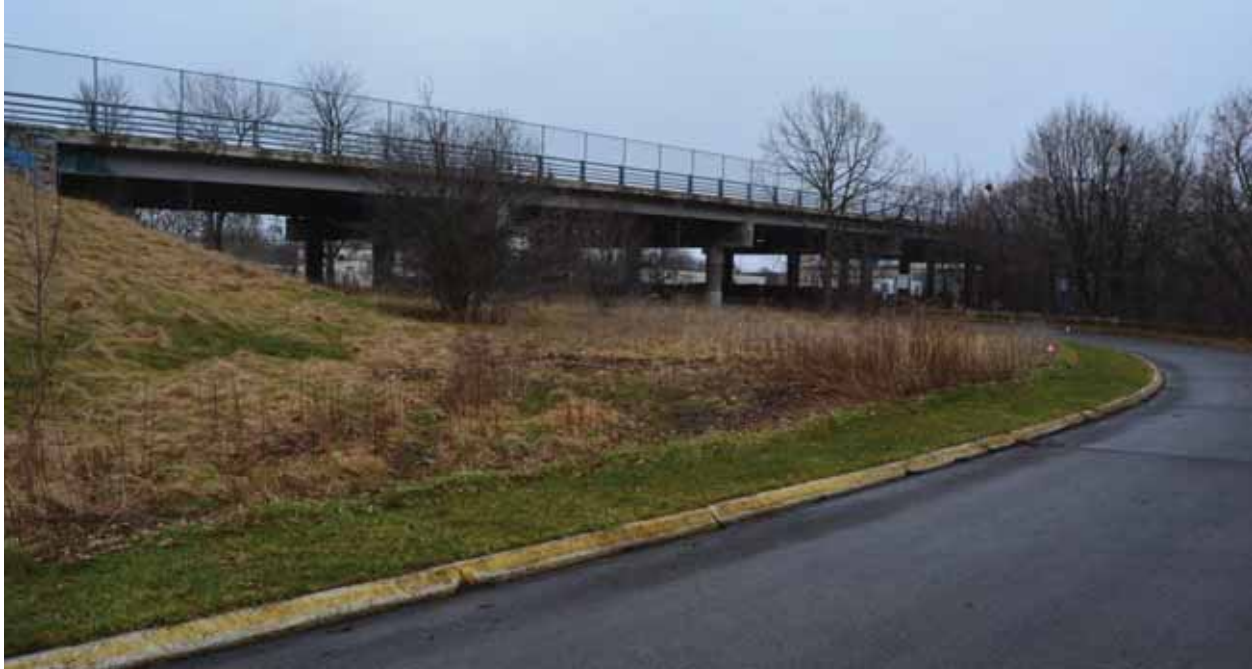
Photograph 13. Surface conditions in the western part of Survey Area 5, facing southeast (Panamerican 2016).

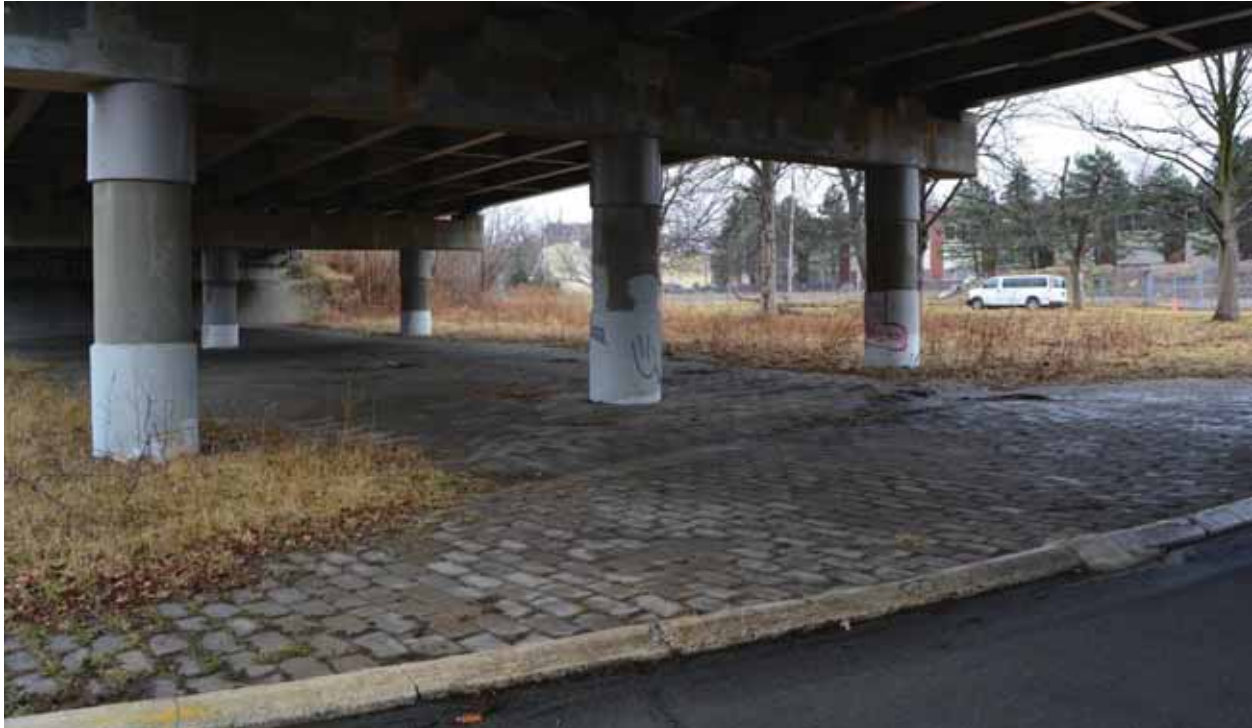
Photograph 14. Pylons and concrete-block paved surface beneath the Robert Moses Parkway in Survey Area 5, facing northeast (Panamerican 2016).

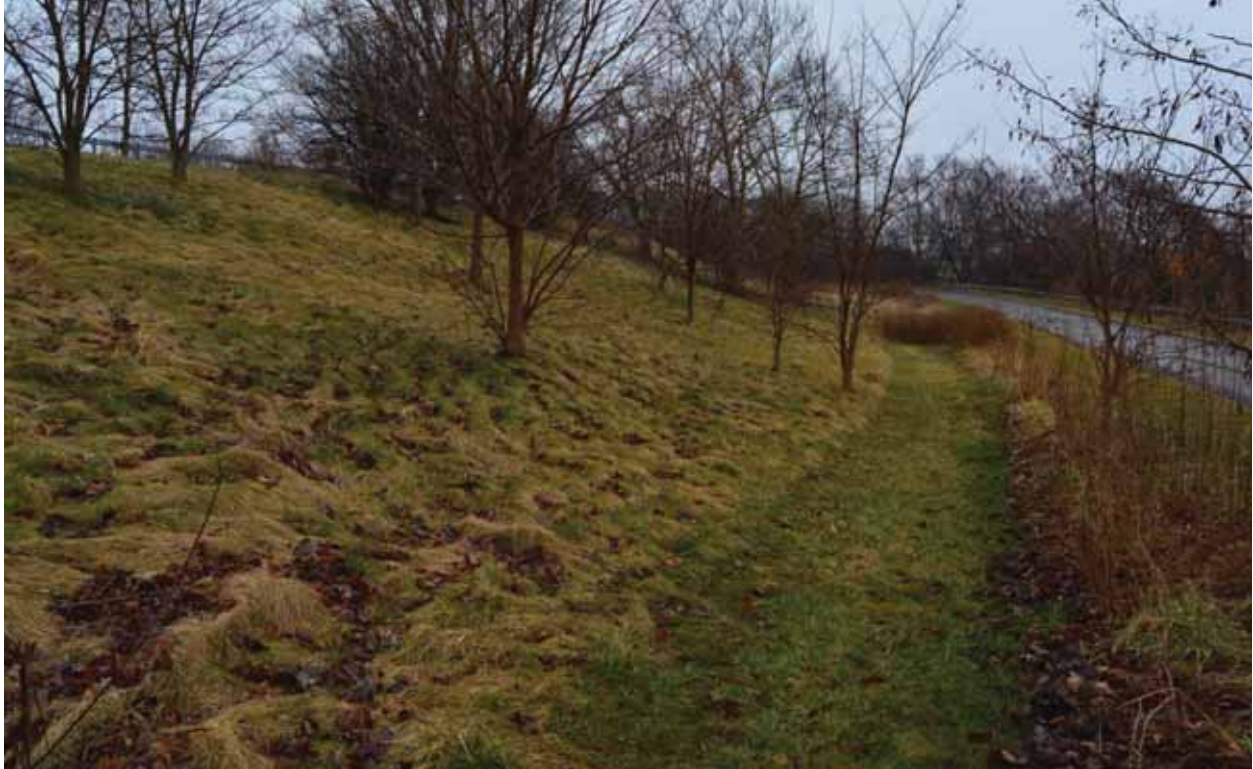
Photograph 15. Surface conditions in Survey Area 6 west of the Robert Moses Parkway, facing southeast (Panamerican 2016).

Survey Area 6. Survey Area 6 covers roughly .4 acres along the Robert Moses Parkway about 35 meters north of Survey Area 5 (see Figure 2.6). Approximately three-quarters of its surface is covered with a steep-sided embankment for the parkway (Appendix A: Photographs 15 and 16). With this exception, indications of below-ground disturbance were limited to several street signs. Vegetation on the east side of the parkway embankment included dense brush and medium-age deciduous trees (Appendix A: Photograph 15), while flora its west side as primarily tall grasses with small amounts of young deciduous trees (Appendix A: Photograph 16). The remainder of the survey area was covered with tall grasses.

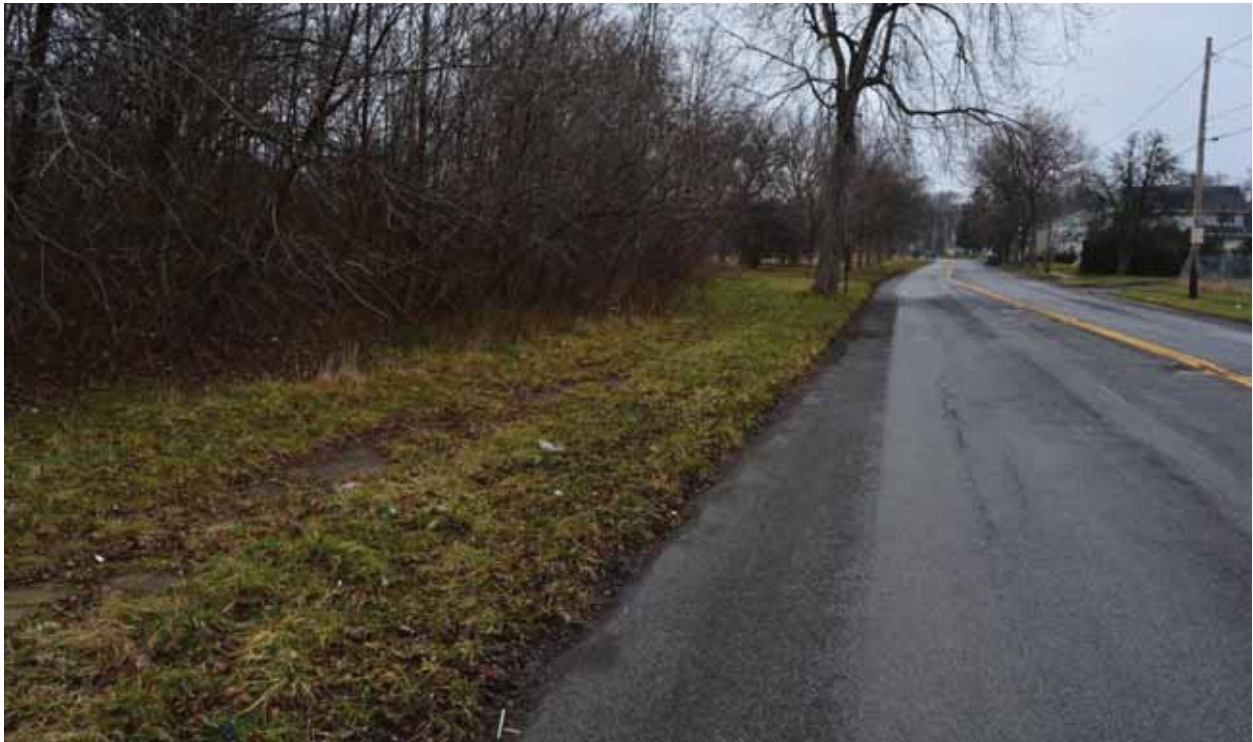
Photograph 16. Surface conditions in the part of Survey Area 6 east of the Robert Moses Parkway, facing northwest (Panamerican 2016).

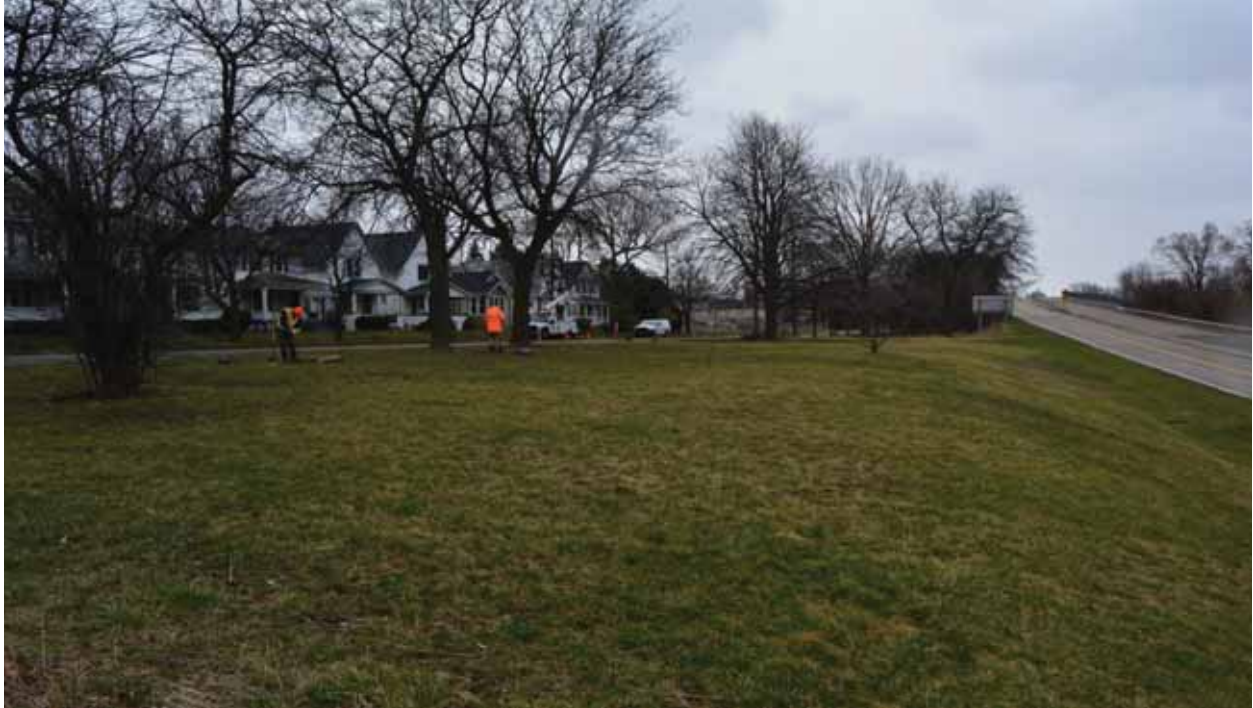
Photograph 17. Survey Area 7 from the northwest, facing southeast (Panamerican 2016).

Survey Area 7. Survey Area 7 is a .4-acre area between Whirlpool Street and the Robert Moses Parkway approximately 45 meters north of Survey Area 6 (Figure 2.7). It comprises publicly-accessibly parkland covered with low-cut grass and several mature deciduous trees (Appendix A: Photographs 17 and 18). Much of it is on level terrain, but the ground surface along its western periphery drops up to six feet to the level of the Robert Moses Parkway shoulder to the west. With the exception of this steep area and the shoulder, which have probably been subjected to grading, the only indications of below-ground disturbance are several street signs and a storm drain along the parkway.

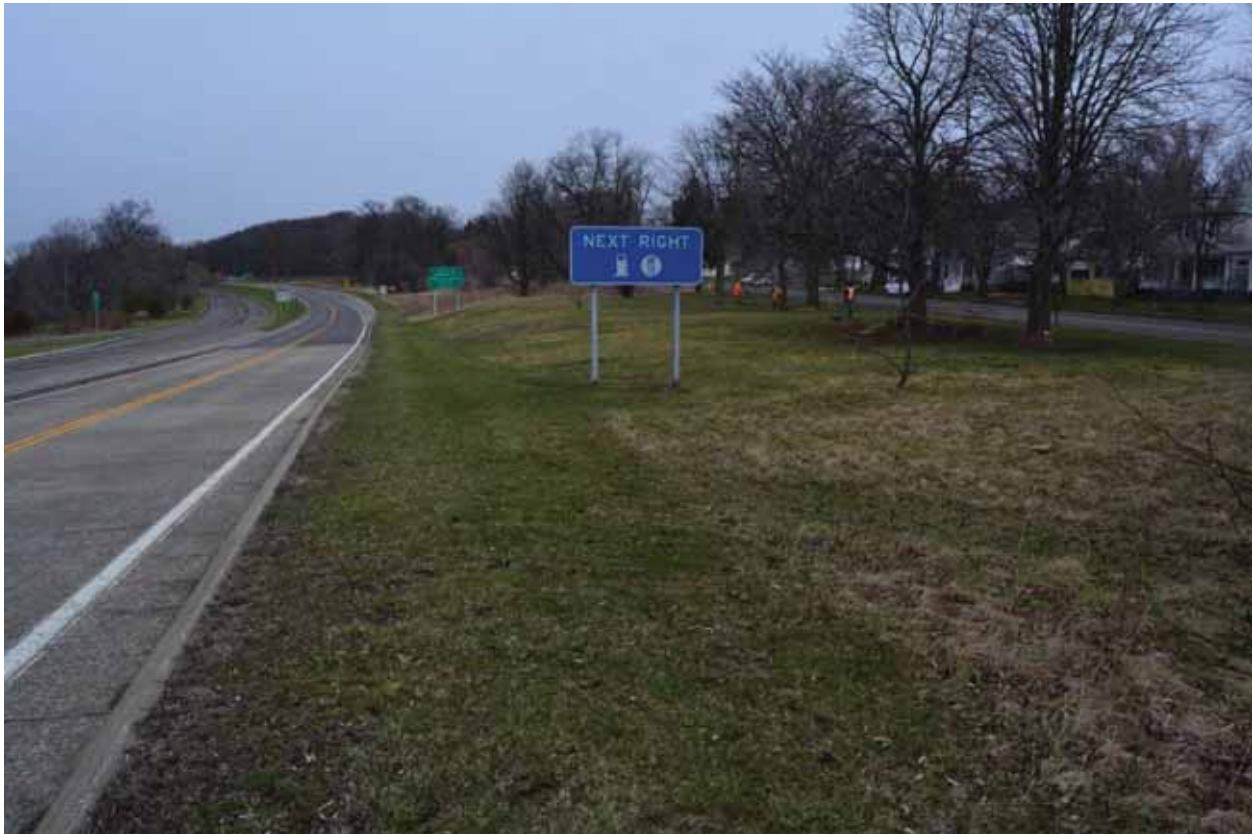
Photograph 18. Survey Area 7 from the southwest, facing northeast (Panamerican 2016).

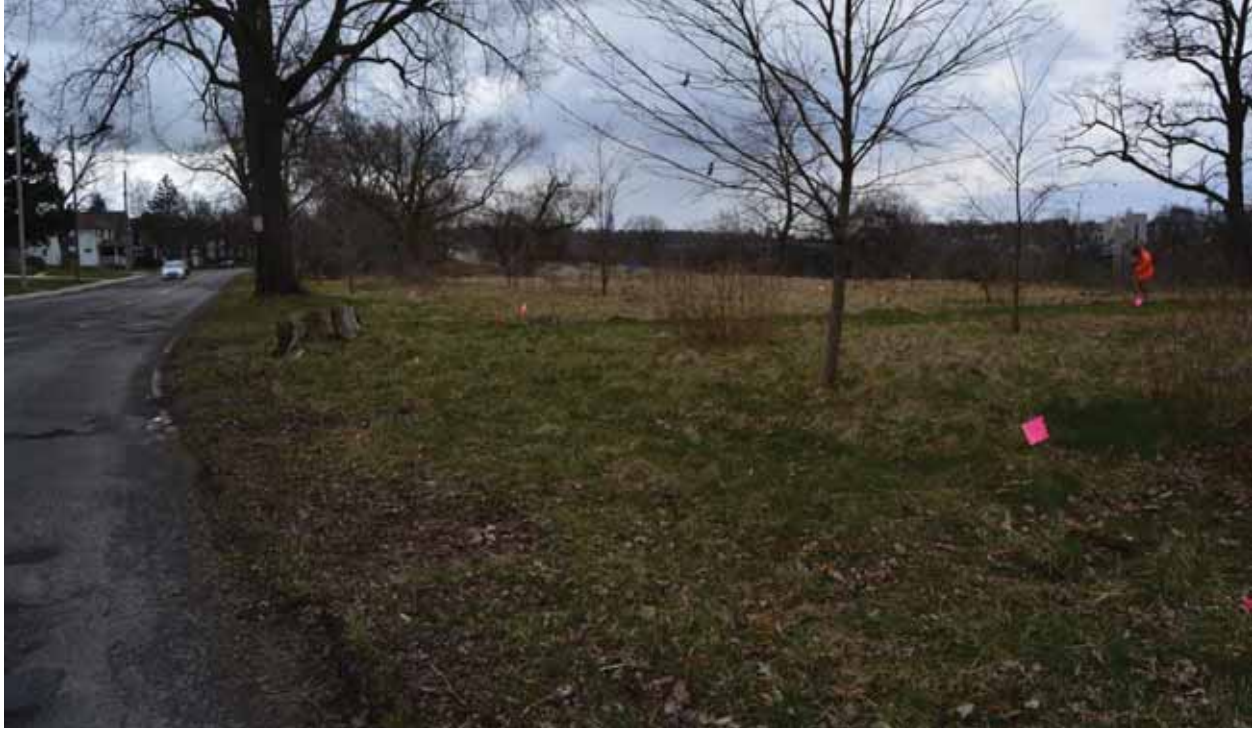
Photograph 19. Survey Area 8 from the north, facing south *(Panamerican 2016).*

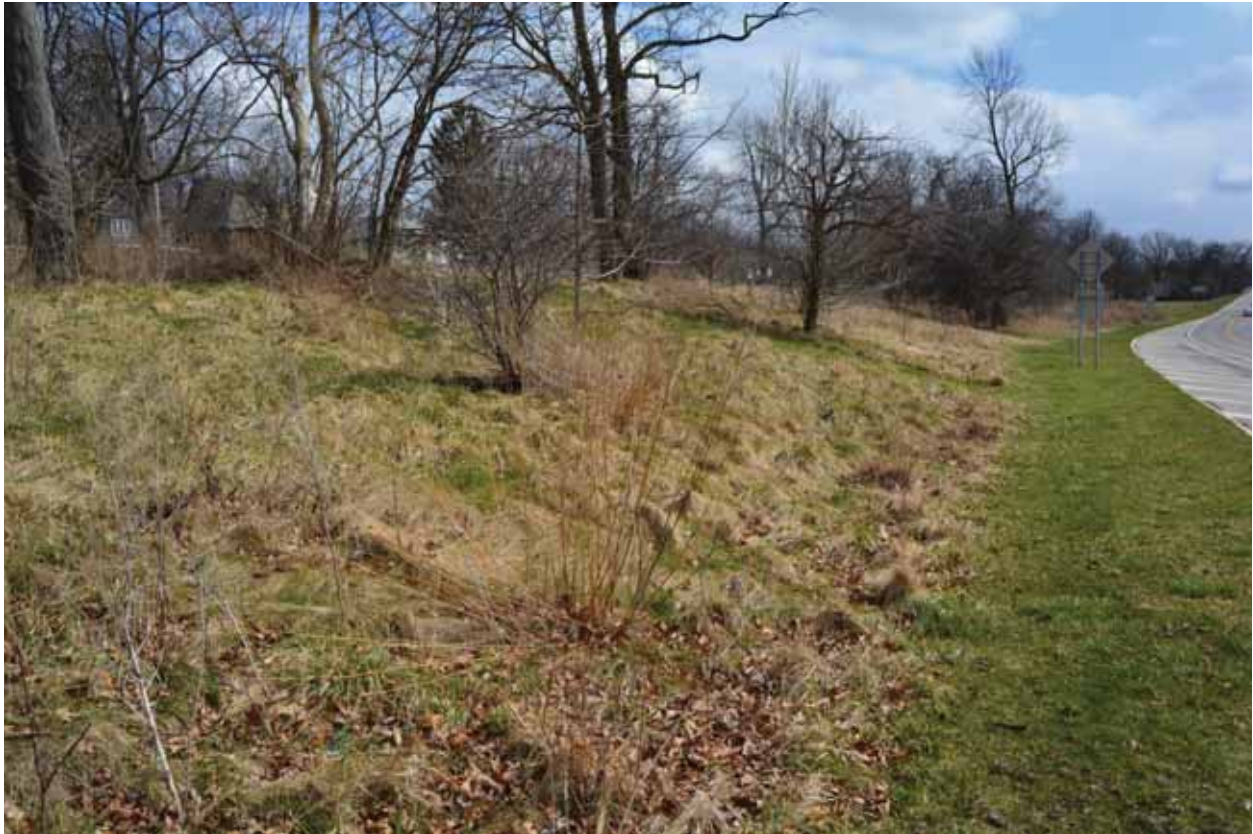
Photograph 20. Steep terrain and Robert Moses Parkway shoulder along the southwest edge of Survey Area 8, facing southeast *(Panamerican 2016).*

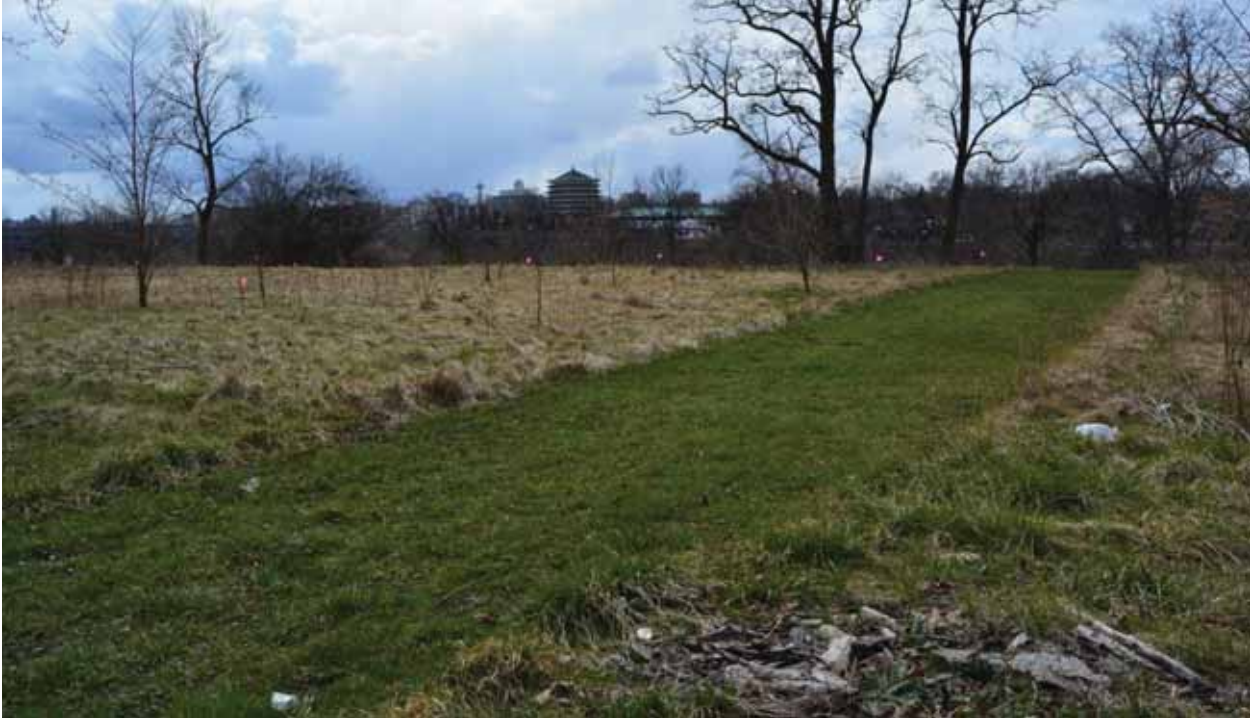
Photograph 21. Probable unimproved access road in the northern part of Survey Area 8, facing southwest (*Panamerican 2016*).
