Benthic Barriers: An Assessment of Effectiveness and Feasibility at two New York State Parks

New York State Office of Parks, Recreation and Historic Preservation, Environmental Management Bureau

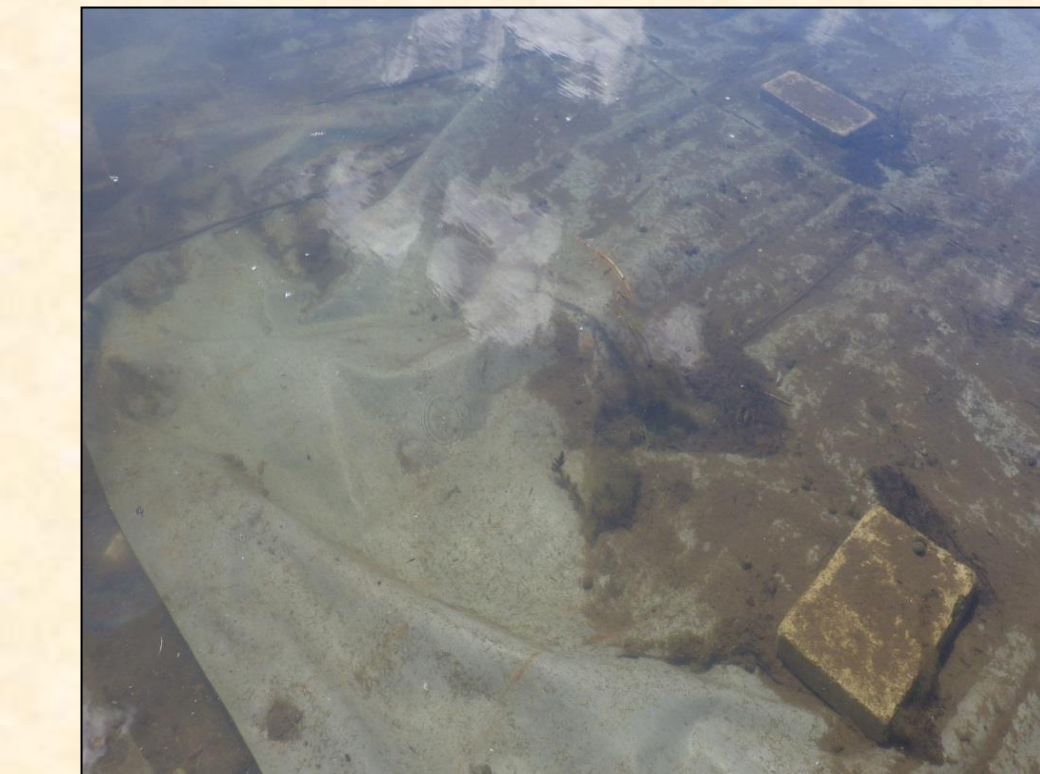
Cement Blocks

Anchoring Materials

Aquascreen	<ul style="list-style-type: none"> Does not require venting - material is a porous fine mesh. Requires rebar and cement blocks for anchoring. No built-in frame. 	<ul style="list-style-type: none"> Mats can be placed over established plant growth. Hard to grip/move by hand. Rebar and cement blocks can be lost/left behind.
Burlap	<ul style="list-style-type: none"> Does not require venting - material is a porous fine mesh. Requires rebar and cement blocks for anchoring. No built-in frame. Lowest cost 	<ul style="list-style-type: none"> Disintegrates after one season (long-term costs) Rebar and cement blocks can be lost/left behind. Unknown impacts from multiple years of installation. No maintenance needed
Lake Mats	<ul style="list-style-type: none"> Does not require venting - material is a porous fabric. Does not require rebar, has a built-in metal frame. Cement blocks can be placed to anchor if desired. 	<ul style="list-style-type: none"> Plants root into / through fabric material. Aquatic macroinvertebrates seem drawn to mat (snails, crayfish, odonate larvae). Requires significantly less anchoring material. Easiest to install and remove. After second year some material ripped / frame warped

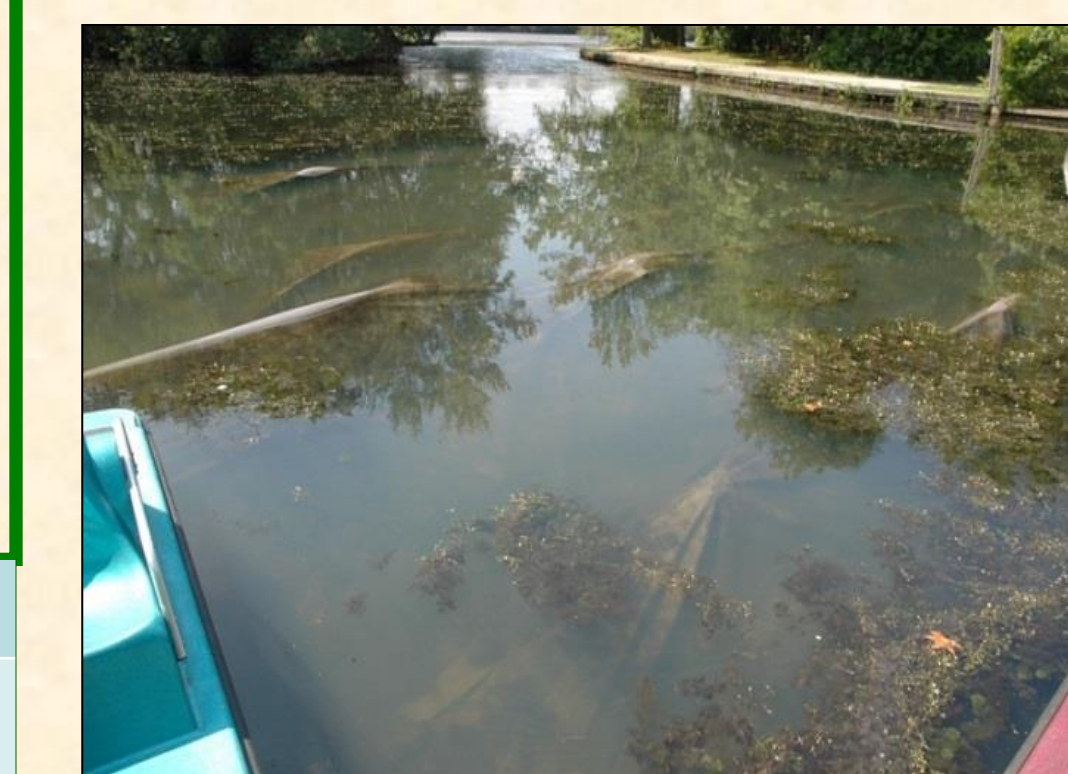
Gas Buildup Under Barrier

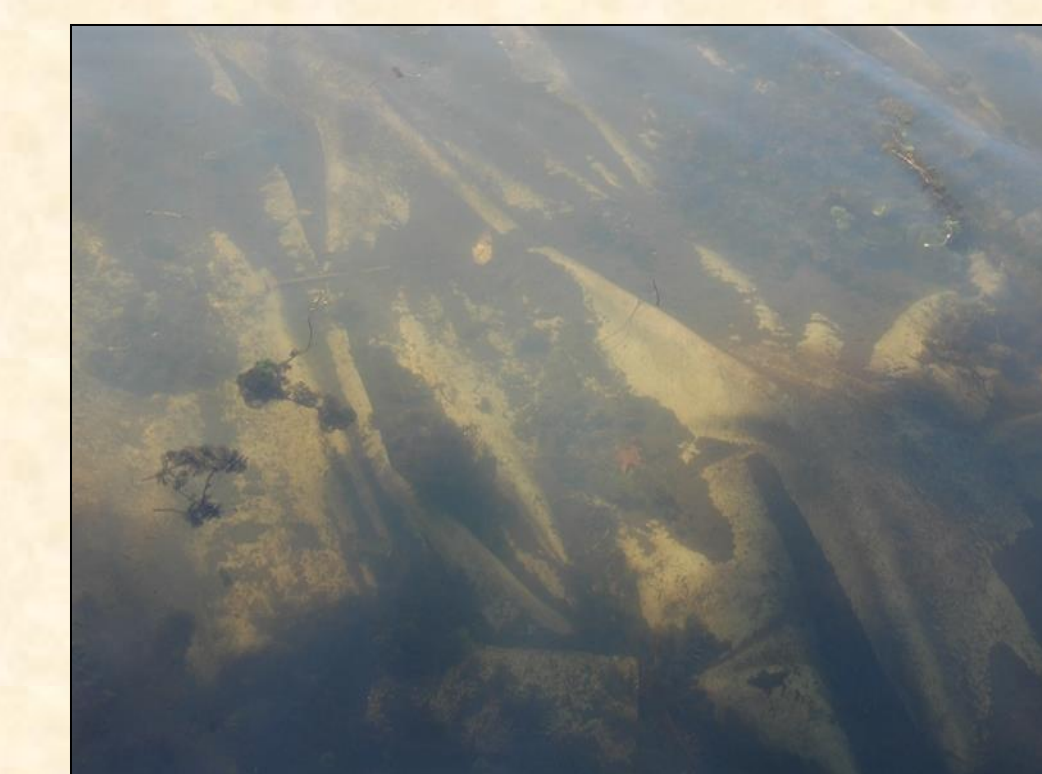
Sediment Buildup On Barrier

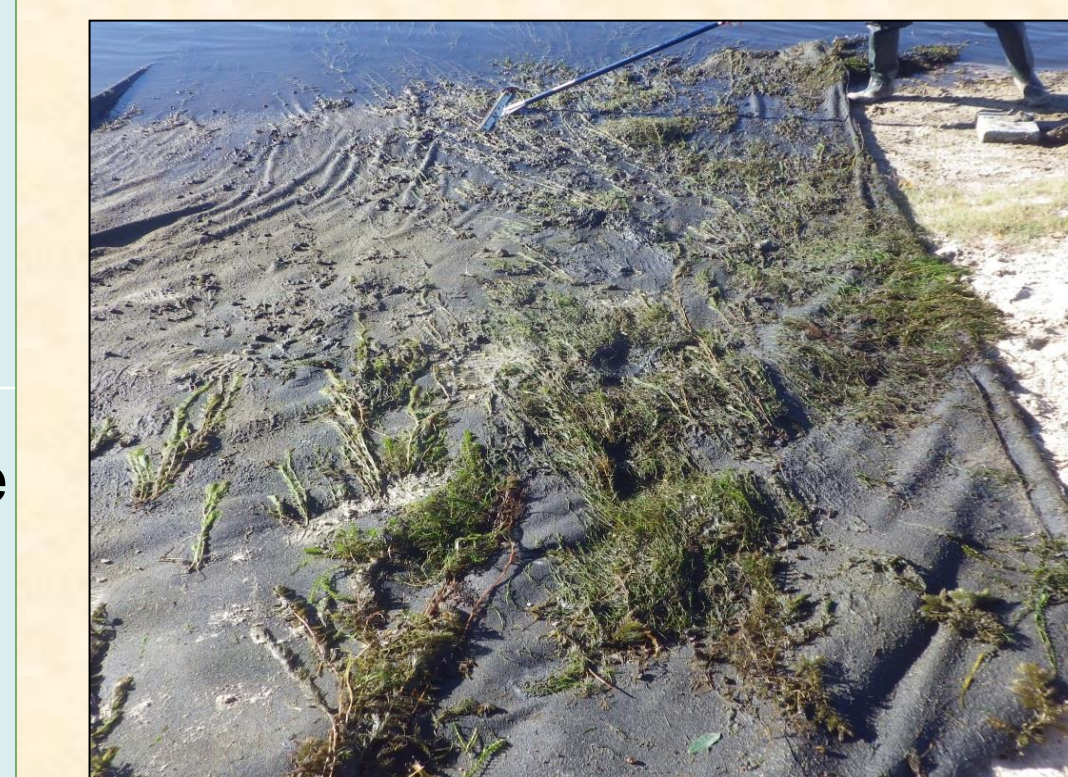
Plant Growth

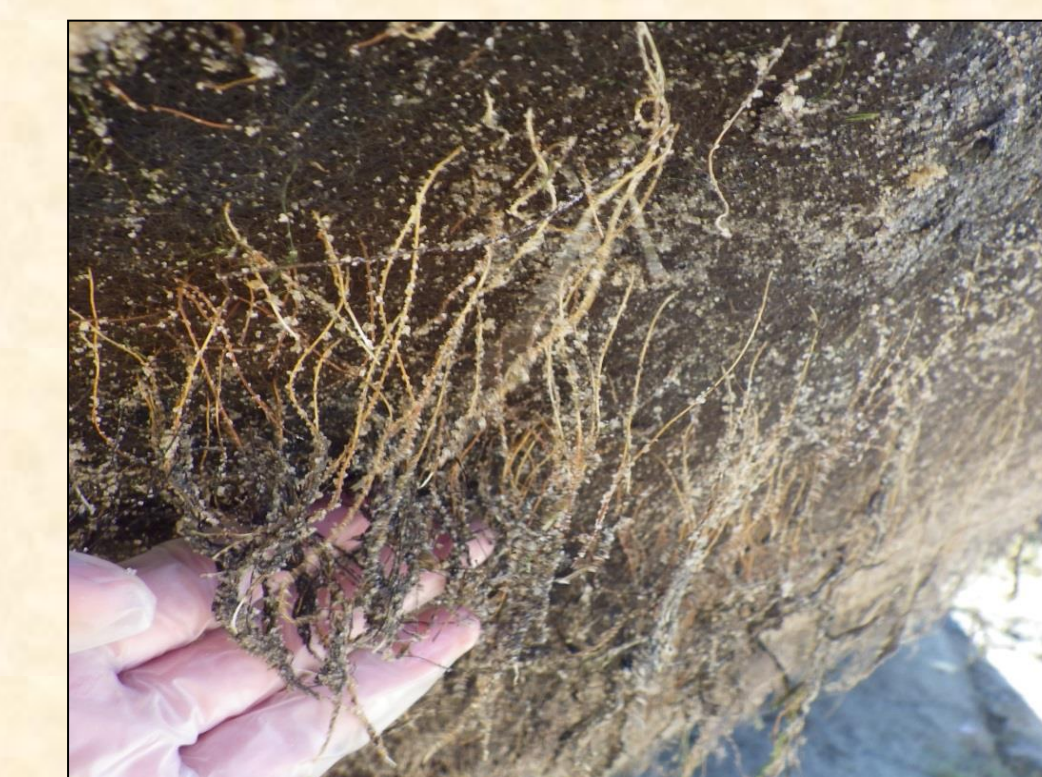
Plants Rooted Through Barrier
