Appendix A: Historic Resource Inventory Forms for Recommended Properties

HISTORIC RESOURCE INVENTORY FORM

Address or Street Location 616 Chasm AvenueCounty Niagara Town/City Niagara Falls Village/Hamlet: _____

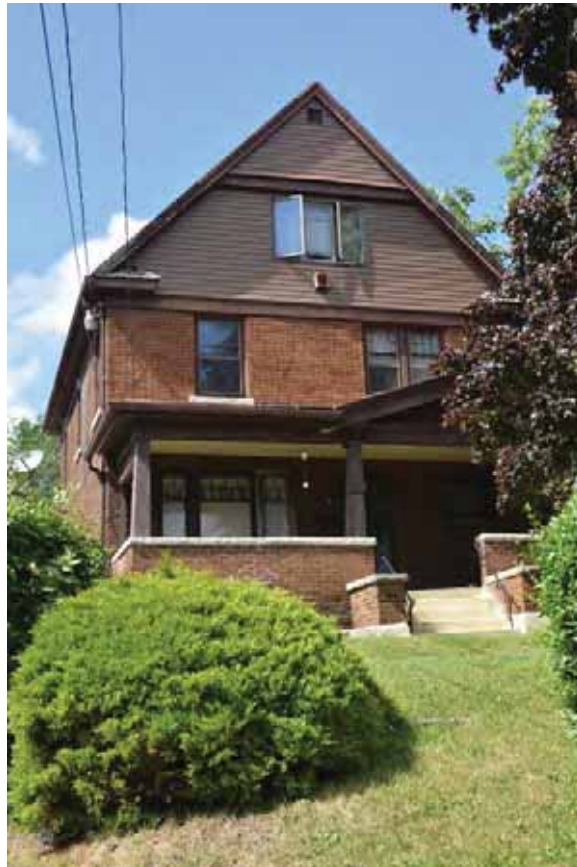
Photograph 1. Residence at 616 Chasm Ave, facing north (PCI 2014).

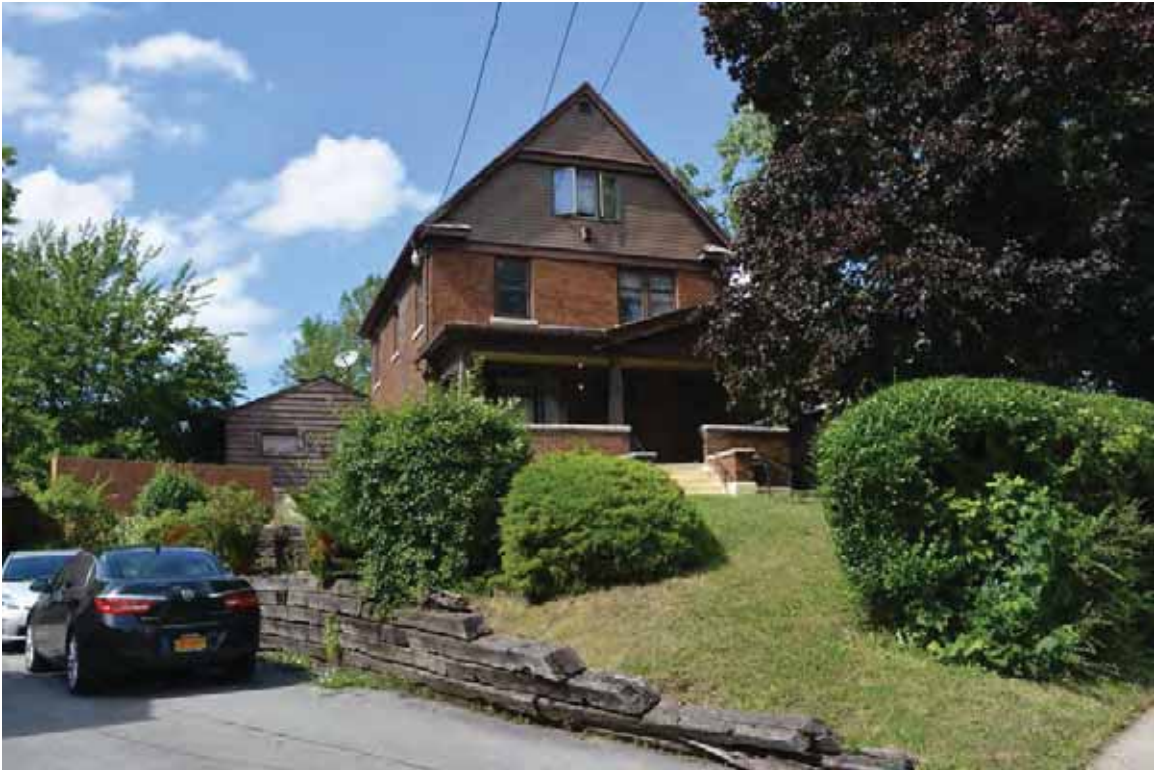
The front-gabled, 2.5 story building at 616 Chasm Avenue displays elements of the Queen Anne and Craftsman styles. It has a brick exterior on the first two floors and vinyl siding in the gable front. The south façade has an open, full-width porch with a flat roof and pediment, solid brick rail, square wooden posts, and a concrete stoop. Fenestration is single, double and triple with 8/1 double hung wood sash. Window openings feature stone sills. The front gable has cornice returns and a replacement casement window. It has an attached 1-story rear addition and a detached garage.

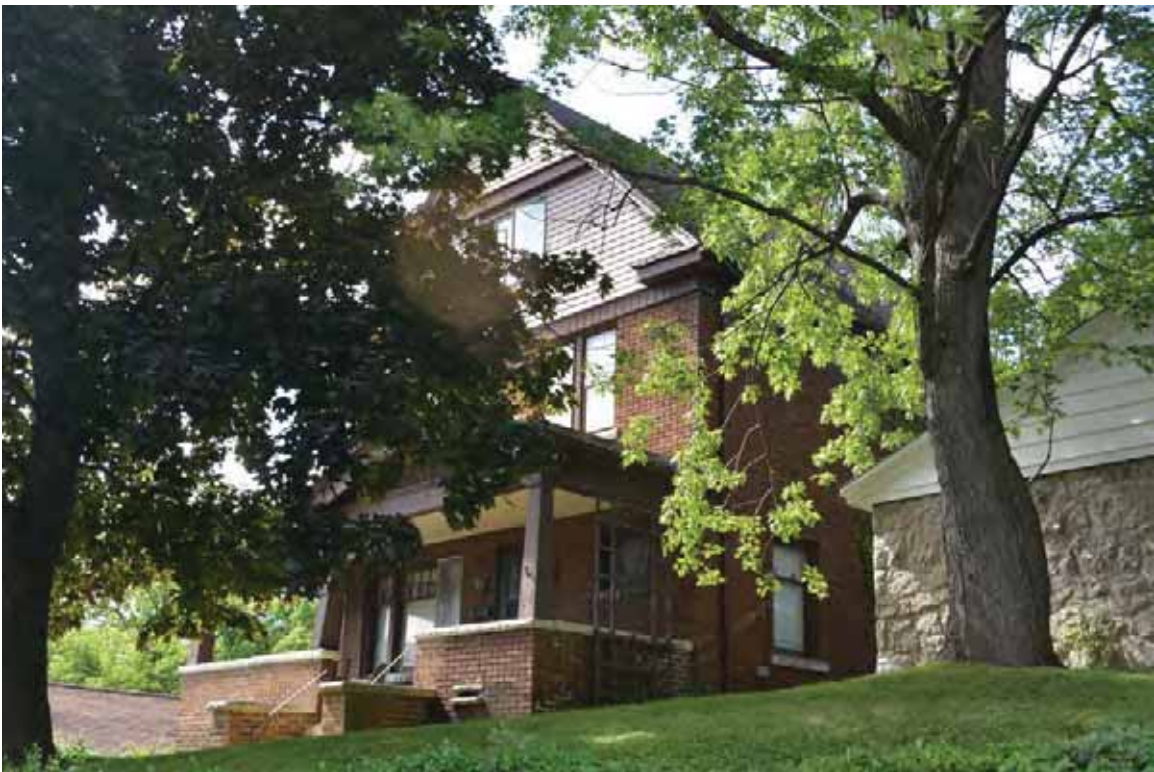
Photograph 3. Residence at 616 Chasm Ave, facing north west *(PCI 2014)*.

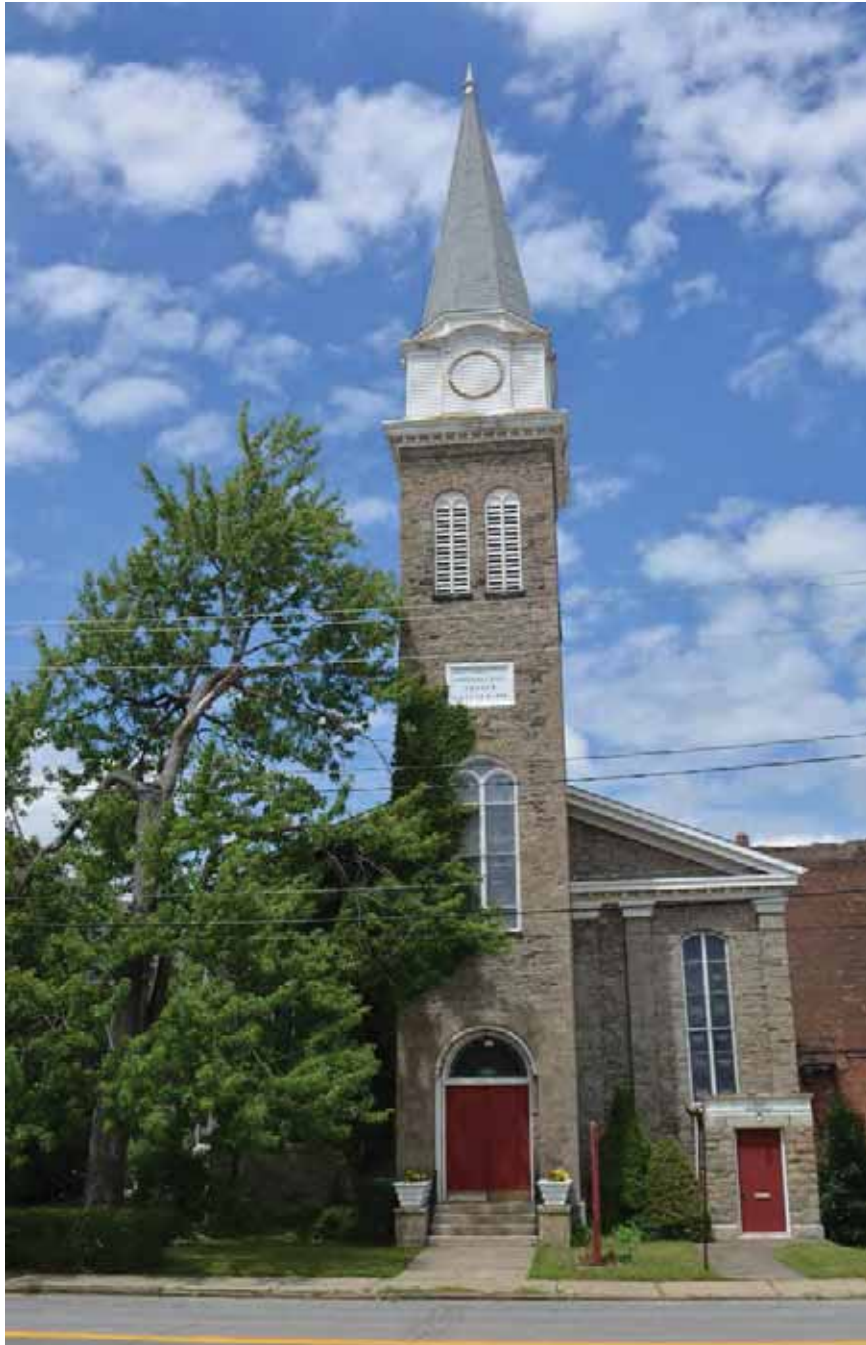
Photograph 1. First Congregational Church at 822 Cleveland Ave (left), facing north (*Panamerican 2014*).

The Italianate-inspired First Congregational Church has limestone masonry construction, a basement, and a rectangular plan consisting of a single nave and flanked by single side aisles. Greek Revival in form, it has a central, three-story stone tower topped by a spire dominates the south façade. Constructed with local Niagara limestone, stonework on the church exterior incorporates coursed and uncoursed random masonry, and ashlar masonry. The main entrance in the tower is set in a round arch and features double-leaf wood doors, decorative stained glass in the tympanum, and stone voussiors. A set of small stone steps with stone rail leads to the central entrance. A round-arch window with stained glass punctuates the second level of the tower. Other tower details include a name panel inscribed "First Congregational Church Erected 1855", a belfry with paired round-arched openings with wooden louvers, a wood cornice with modillions, and spire with square base and hexagonal roof. The three-bay-wide south façade is further articulated by a temple front with stone pilasters and a denticulated cornice. Tall, narrow segmental-arch windows are set in the end bays. An enclosed, stone entrance bay for basement access is attached west bay of the south façade. It has single wood door, ashlar water table and lintel, cornice, and flat roof. Five similar segmental arch windows punctuate the east side, while four are located on the west side. Gas lightning was installed in the church in November 1860. An organ was put in 1884 and the stained glass windows were added in 1891. A 1923 addition is attached on the northwest side. It housed Sunday School rooms, a boiler room, and a pastor's study. The church steeple once had a clock (out of service prior to 1945). A major interior reconstruction occurred in 1904.

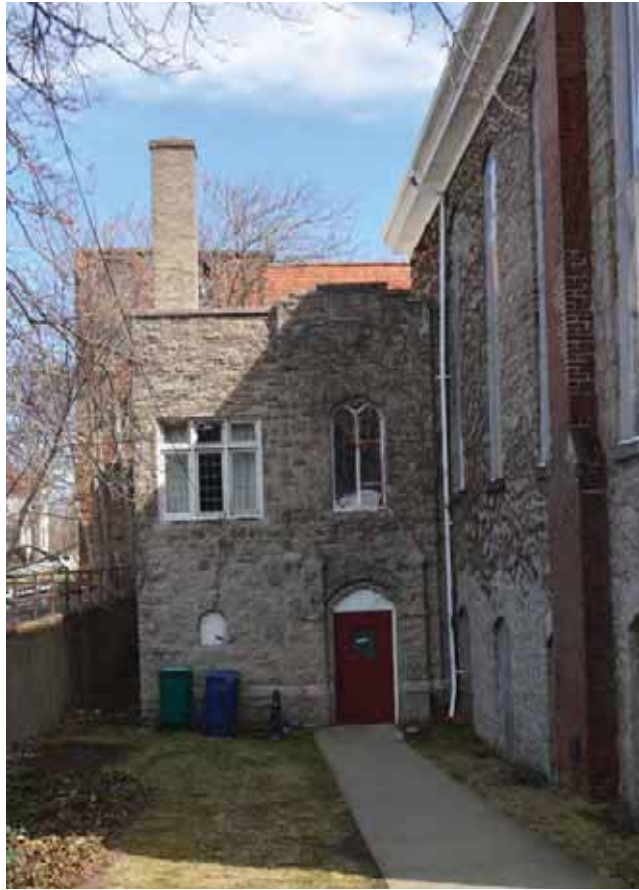
Photograph 3. First Congregational Church at 822 Cleveland Ave, facing north (*Panamerican 2014*).

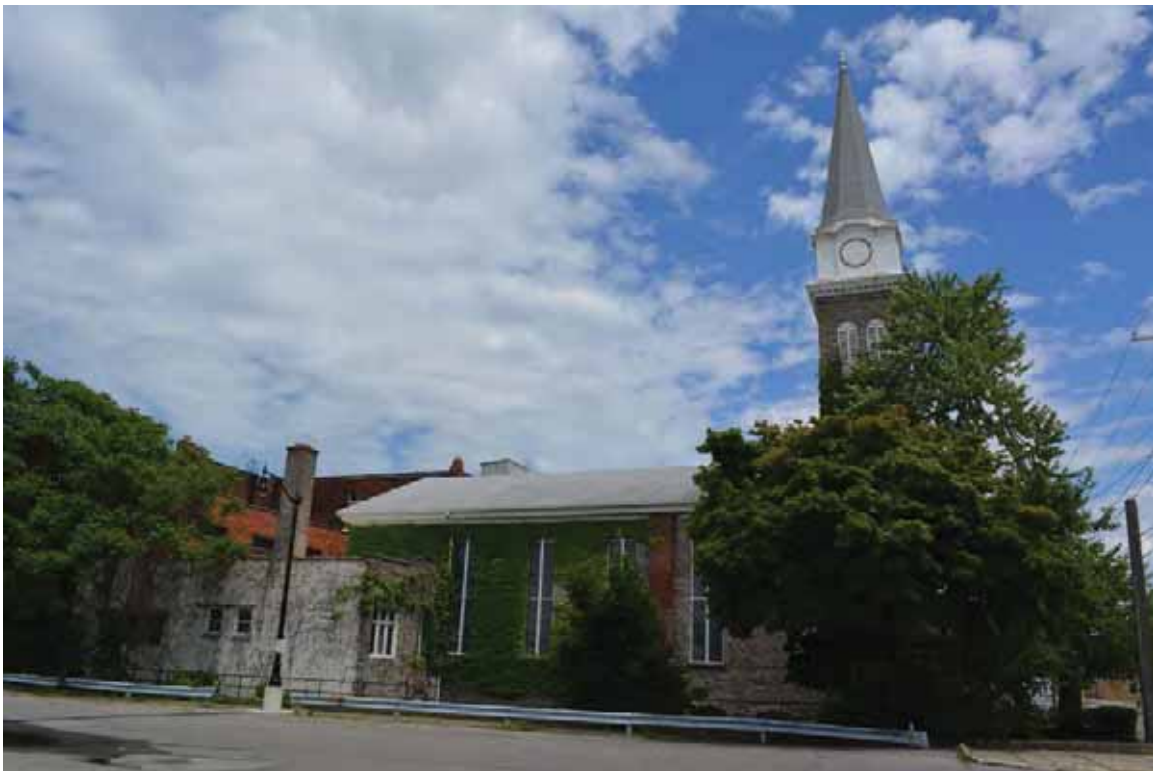
Photograph 4. First Congregational Church at 822 Cleveland Ave, facing east (*Panamerican 2014*).

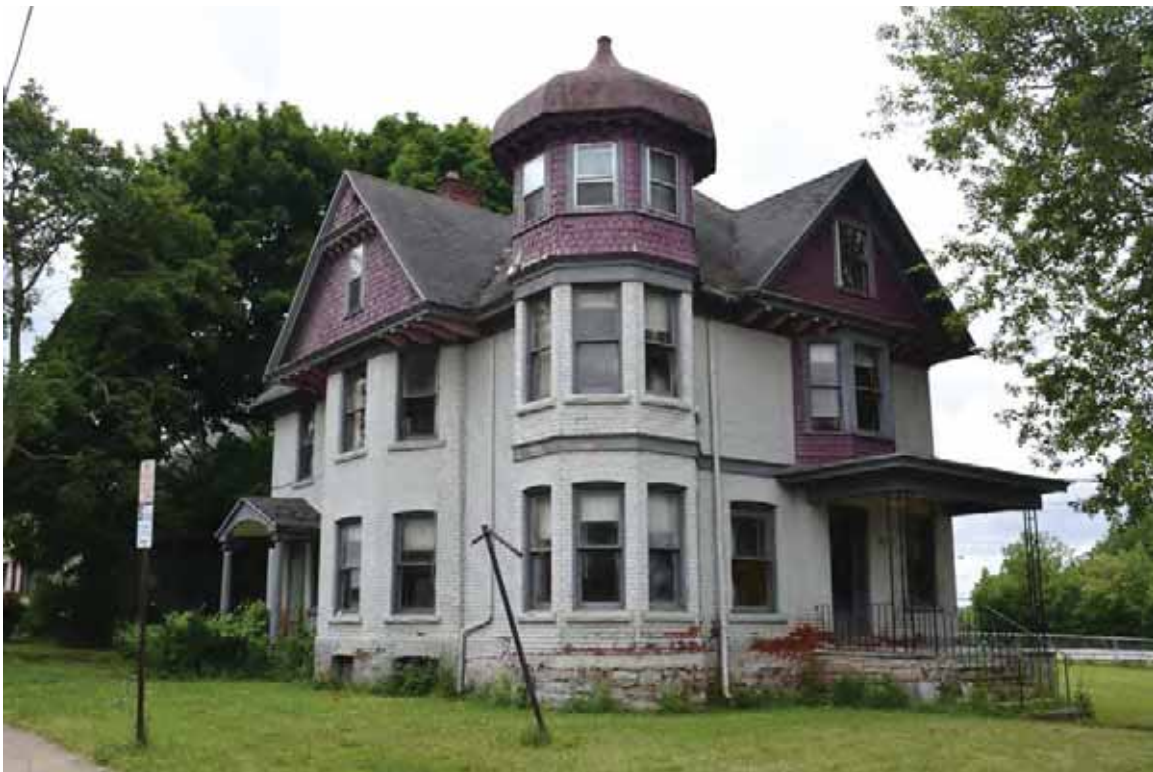
Photograph 1. Residence at 723 Division Ave, facing southwest (PCI 2014).

The building is a 2.5 story example of a Queen Anne Style residence with a brick veneer. It has a roughly rectangular plan, hipped roof, and limestone foundation. The building stands out for its corner tower with onion-type roof and multiple gables. A partial porch with flat roof, stone foundation and replacement metal rail and supports is on the main façade (north). It has an off-center entrance and a polygonal bay is above the entry porch. A projecting gable with brackets, fishscale wood shingles, and a single window opening caps the north façade. Similar style gables are located on the west, south, and east sides. Fenestration is single and triple 1/1 double-hung wood sash (and replacement). Window openings are segmental arch with stone lintels; first floor and basement windows have brick soldier courses. The east façade has a entry porch, with Doric-type columns and gabled roof, and a full-height polygonal bay capped by a projecting gable. The west side has shallow projection from the plane of the main block; it has a round arch staircase window with hood molding (presently boarded up). A rear entrance is located on the south side.

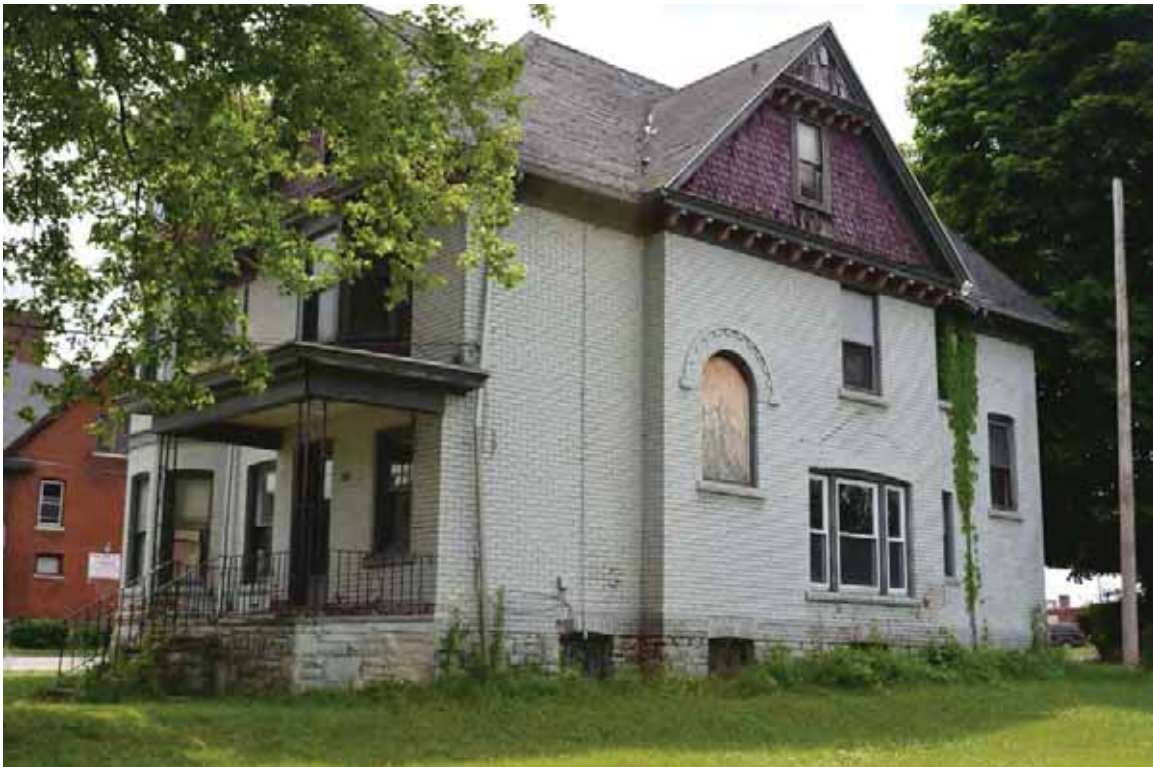
Photograph 3. Residence at 723 Division Ave, facing southeast (*Panamerican 2014*).

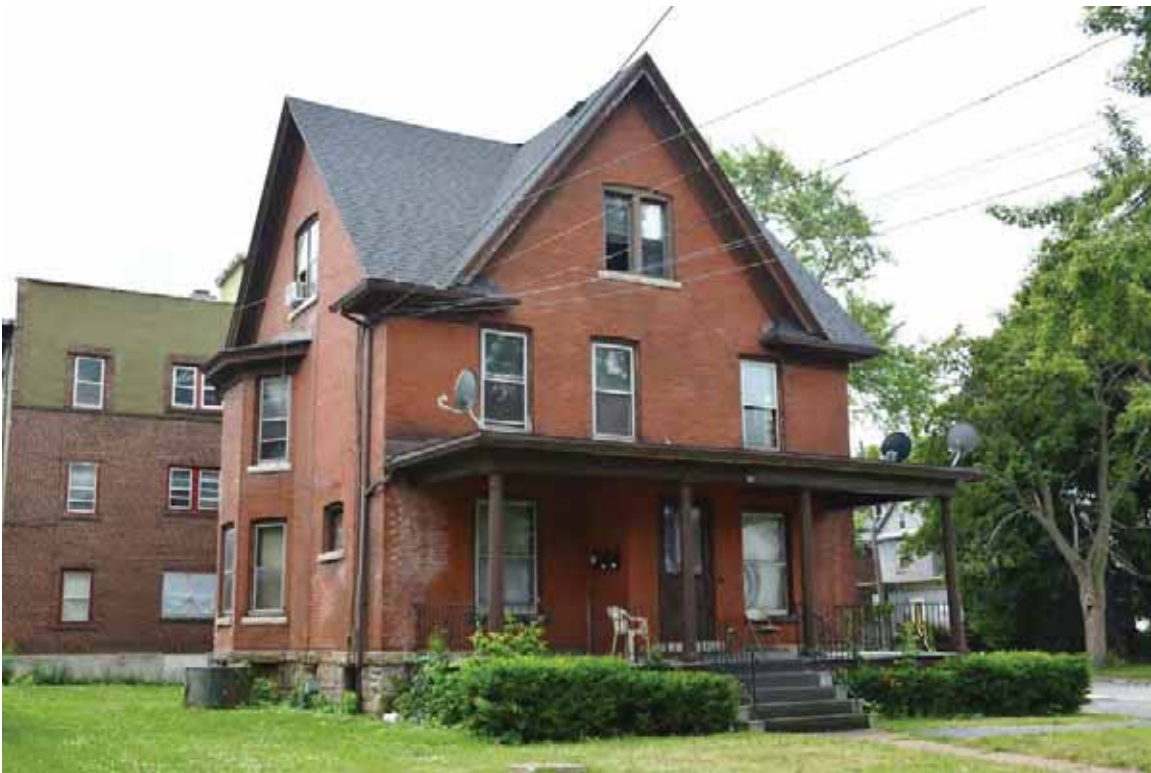
Photograph 1. Residence at 803 Division Ave, facing southwest (*Panamerican 2014*).

The building is a 2.5 story Queen Anne style residence with brick veneer. It has a rectangular plan, cross-gabled roof, limestone block foundation, and stone belt course. The principal north façade has an open, full-width porch with Tuscan Doric-type columns, replacement metal rail, and flat roof. The north façade has a central entrance vestibule. Fenestration is single on the first and second floors with one-over-one double-hung wood sash. Window openings have stone sills and soldier course lintels. Gable ends feature cornice returns and paired windows. A two-story polygonal-bay is on the east side. The west side has an entry porch.

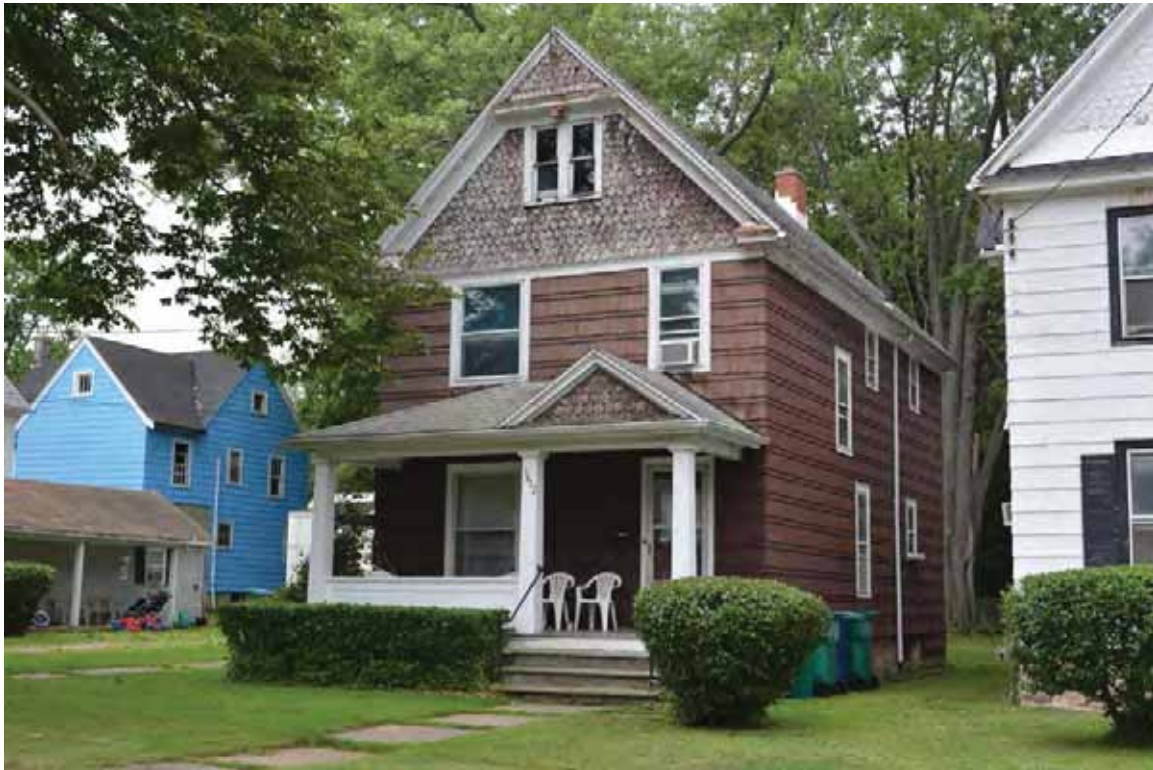
Photograph 1. 1412 Eighth Street, facing southwest (*Panamerican 2014*).

The 2.5 story, Queen Anne/Craftsman-inspired building has a rectangular plan, front-gabled roof, and a stone foundation. Its exterior is sheathed with mixed wood shingles and the gable end has fishscale wood shingles. The east facade has an open full-width porch with pediment over the entrance, square columns, and a solid rail. The entrance is in the north end bay. Fenestration is single, one-over-one double-hung sash. The gable end has cornice returns, paired windows, and a projecting peak. An interior brick chimney is located on the north slope. A one-story oriel and a gabled wall dormer are on the south side. A detached, frame two-car garage with hipped roof stands on the southwest corner of the parcel.

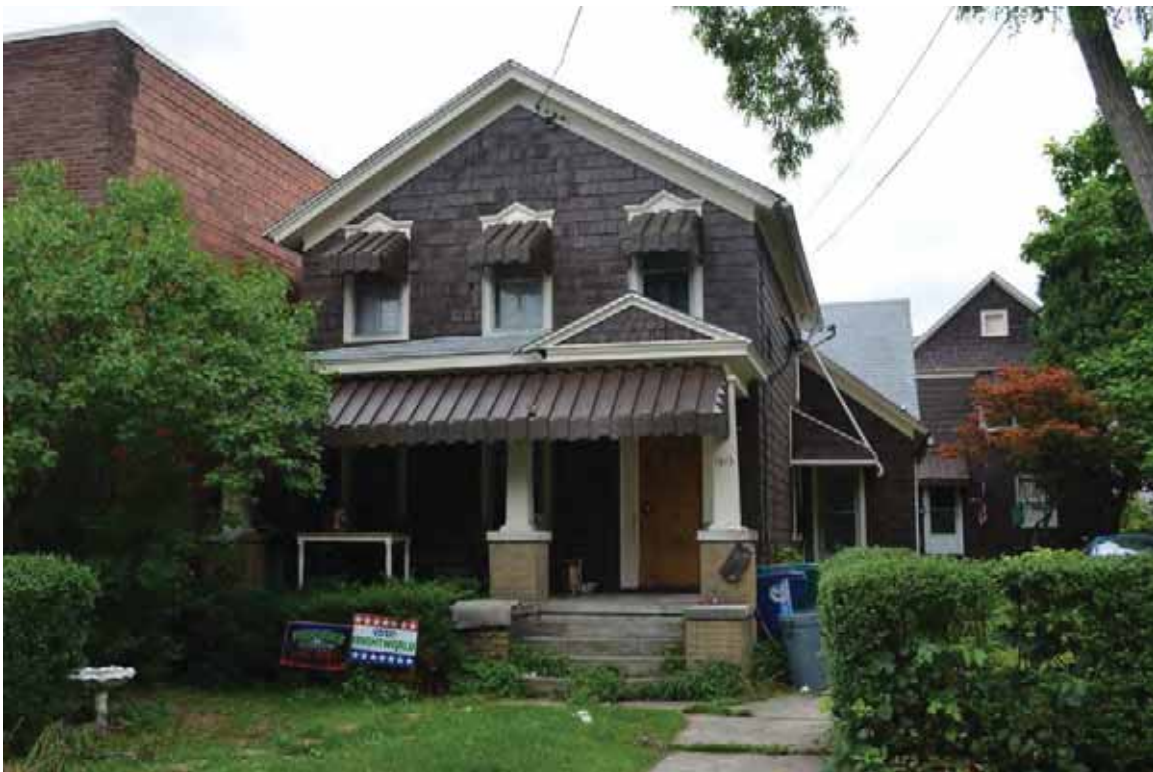
Photograph 1. Residence at 1511 Eighth Street, facing northeast (*Panamerican 2014*).

The primary residence at 1511 Eighth Street consists of a frame two-story, front-gabled main block and a frame two-story, side-gabled rear addition. It has a stone foundation and the exterior is sheathed with wood shingles. The building originally had a Queen Anne-type front porch with pediment over the entrance. It was modified with Craftsman-era porch supports with square columns set on buff-brick pedestals and stoop rail. The entrance is in the south end bay. Window surrounds openings on the south façade have molded pointed arch hoods. Fenestration is single two-over-two double hung sash. The rear addition has an entrance on its west front.

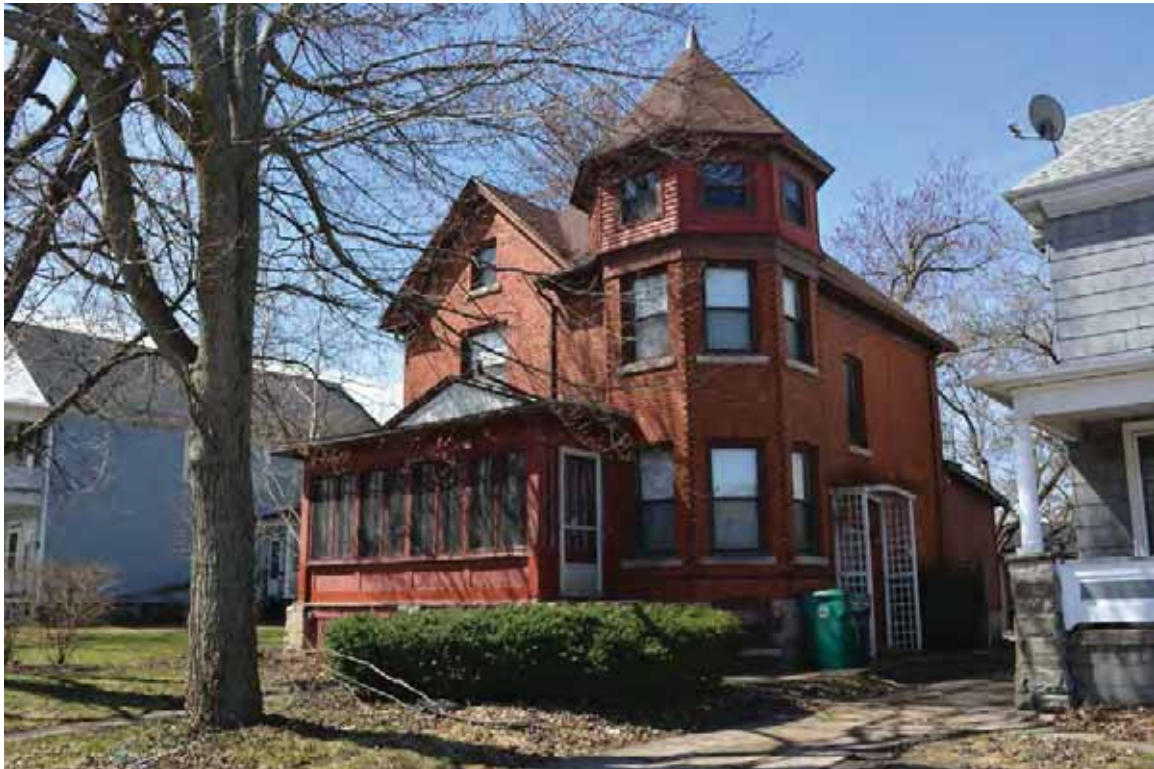
Photograph 1. Residence at 1618 Eighth Street, facing southwest (*Panamerican 2015*).

The 2.5 story, Queen Anne style building has a brick veneer, gabled roof, and a random coursed limestone foundation. The east façade is distinguished by a polygonal tower with interlocking brick corners and a conical roof. It has an enclosed full-width front porch with entrance on the north side. Window openings have stone sills, flat arch lintels, and replacement windows. The upper floor of the tower is covered in vinyl siding. A polygonal bay is on the south side. The north side has an entrance. It has a frame, 1-story, rear addition with shed roof. It has a detached wood frame garage with side-gabled roof.

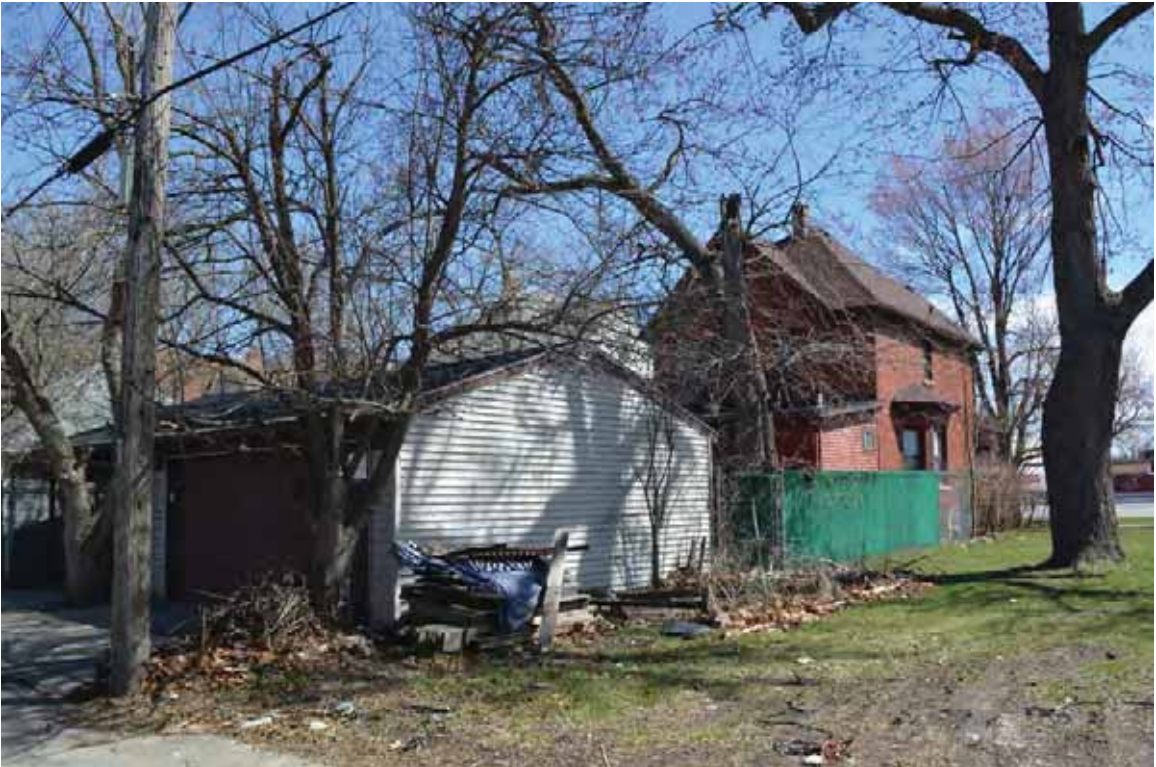
Photograph 3. Residence at 1618 Eighth Street, facing northeast (*Panamerican 2015*).

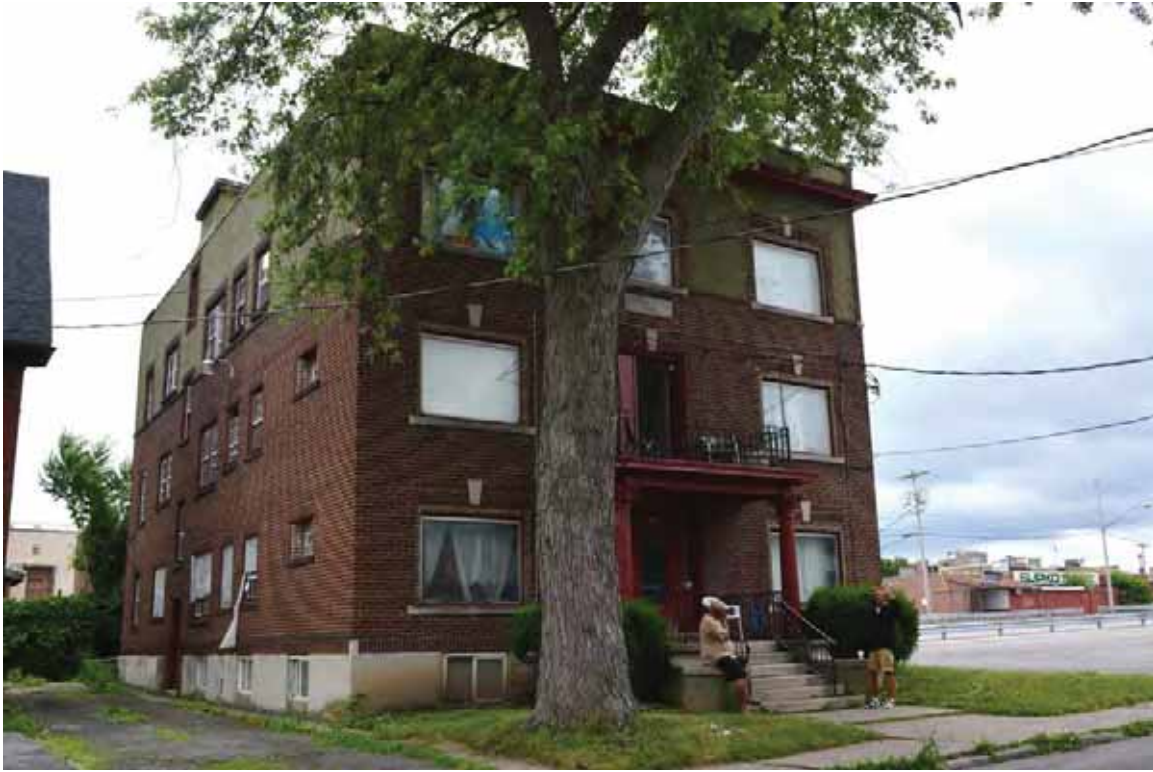
Photograph 1. LaRose Apartments at 1643 Eight St, facing northeast (Panamerican 2014).

The three-story, Neoclassical Revival-inspired multiple-unit apartment building has brick and tile masonry construction. It has a rectangular plan, flat roof with parapet, and a concrete foundation. The exterior of the first and second stories have multi-color brick veneer laid in stretcher bond, while the third floor is sheathed with stucco accented by brick corner piers with brick tabs. Original windows have been replaced, but window openings remain intact. They feature decorative brick surrounds, cast stone sills and keystones and soldiers course. The west façade is distinguished by a Neoclassical Revival central entrance porch with a concrete stoop, concrete porch foundation, and two Corinthian-type columns supporting a flat roof with dentils. It has replacement metal handrails. The front entrance has a wide, single panel and light door with partial side lights and transom. Above the second floor porch door is a stone panel carved with "LaRose Apts 1925." A cornice accents the west façade. An entrance is on north

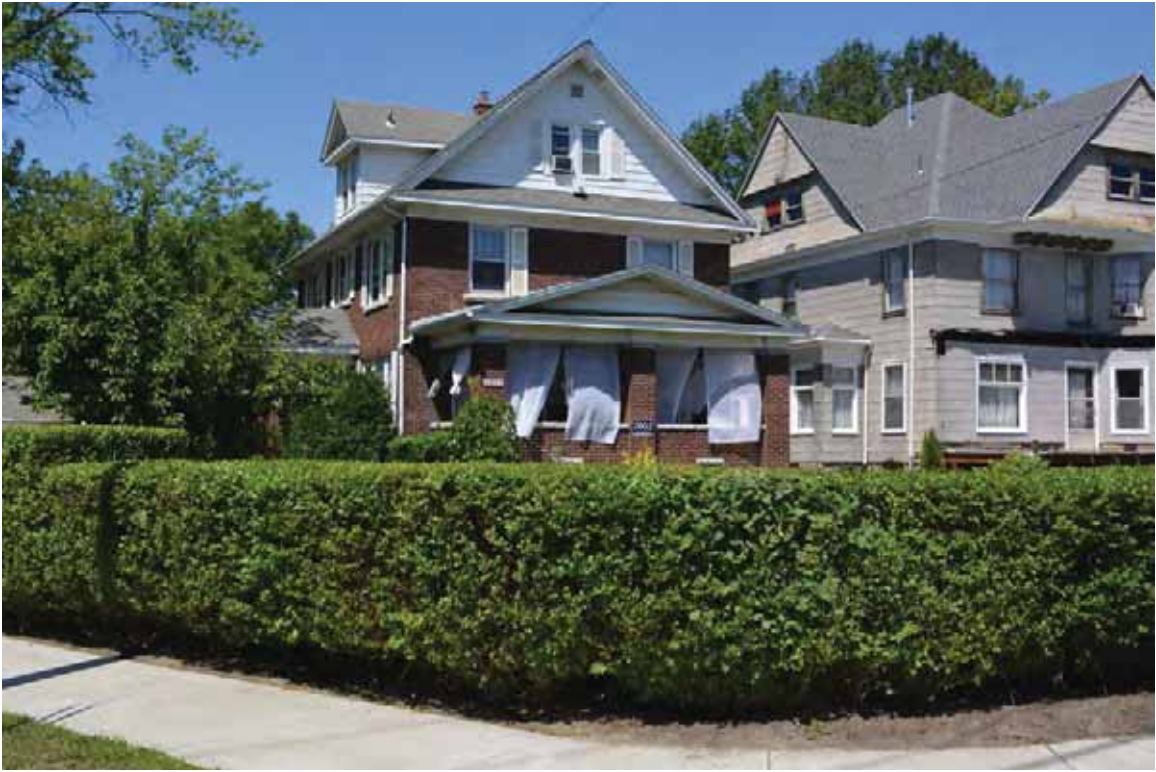
Photograph 1. Residence at 2802 Lewiston Road, facing west-southwest (*Panamerican 2014*).

The 2.5 story building is a ca. 1925 Colonial Revival single-family dwelling. It has a rectangular plan, brick veneer, side-gabled roof, and concrete foundation. The main entrance is on the south façade on Chasm Street. It has a central entry porch with brick piers, brick rail with stone coping, and a pediment. The entrance door has multi-pane sidelights. Triple window groupings with a soldier course lintel punctuate the first floor of the south façade. Windows on the second floor are paired. Windows have stone lintels and double hung wood sash (3/1, 4/1, or 1/1). An open, full-width porch with gabled roof extends across the east façade. The east side has a closed gable. A gabled dormer is on the south slope. It has a center ridge brick chimney.

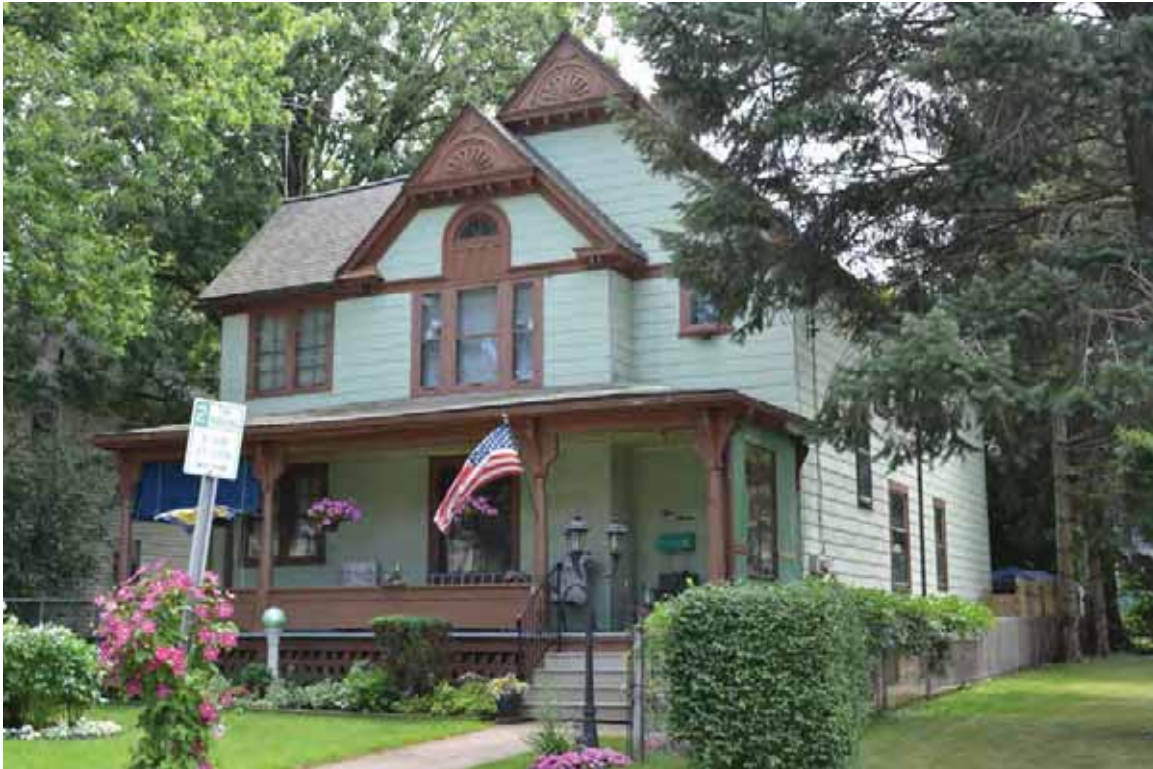
Photograph 1. Residence at 811 Lincoln Place, south (*Panamerican 2014*).

The single-family dwelling at 811 Lincoln place is frame, 2-story Queen Anne building with an open, full-width porch and two front-facing gables on the principal north façade. It has a stone foundation and asbestos shingle exterior siding. The porch has a hipped roof, turned posts, scroll cut brackets, a solid wood rail with panel, and a porch entries in the west bay and the side of the east bay. A decorative scroll cut wood screen accents the foundation level of the porch. The porch stoop and rail has been replaced. The main entrance is in the west bay of the north façade. Fenestration includes Queen Anne type windows, 1/1 double-hung sash, and casement. A round arched window opening with fanlight and wood panels in the central front facing gable rests on top of the tripartite window grouping on the second floor, and forms a Palladian-type window motif. Gables on the principal north façade feature cornice returns, dentils, and sunburst-pattern panels. The east elevation has ribbon windows on the first and second floors and cornice returns. Fenestration is irregular on the west side of the building. A detached, frame, two-car garage with front-gabled roof is located in the southeast corner of the parcel.

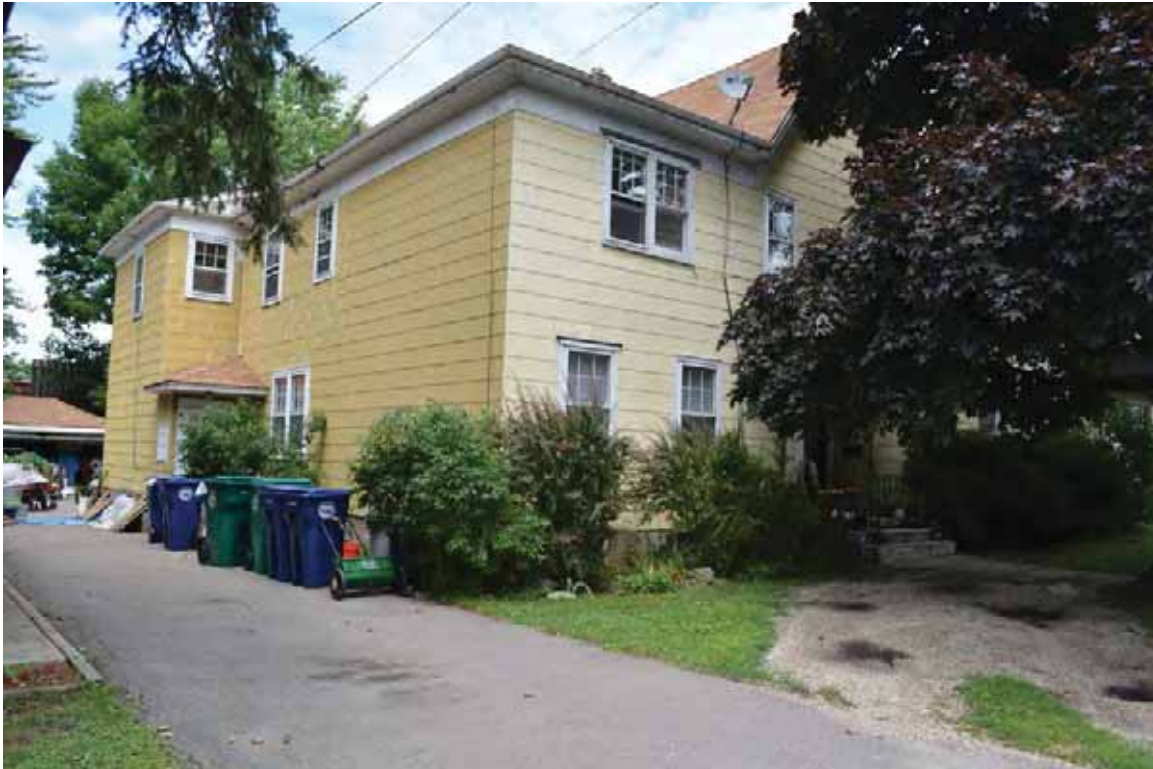
Photograph 1. 816 Lincoln Place, facing north (*Panamerican 2014*).

The building is a frame, 2-story, Colonial Revival style residence. It has a hipped roof with a central gabled wall dormer on the south façade. The exterior is sheathed with cement-asbestos shingles and the original foundation material is not visible. Fenestration is single and paired six-over-one double-hung sash. The south façade has a central entrance with a round arch canopy. A wide unadorned frieze accents the roofline. An exterior brick chimney/fireplace, entrance with metal canopy, and a small one-story addition is on the west side. It has a two story rear addition with entrance and a lesser shed roof addition on the rear. A detached frame garage with hipped roof is on the northwest corner of the parcel.

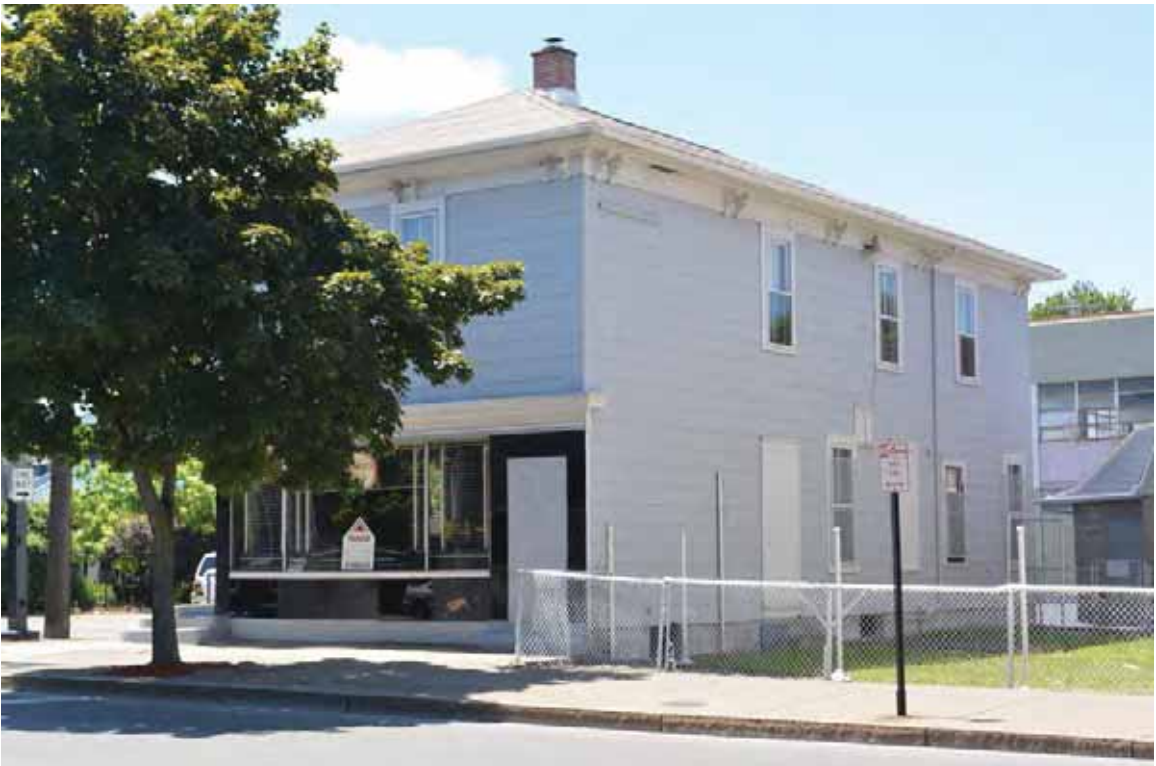
Photograph 1. 1402 Main St, facing west (*Panamerican 2014*).

Bramer's Tavern is a two-story, frame, Italianate style building with a ca. 1940s, black structural glass panel storefront. It has a rectangular plan, hipped roof, and parged stone foundation. Asbestos shingles were applied over the original clapboard. The west façade features a recessed corner entrance with concrete steps facing the intersection of Main Street and Portage Road. An entrance to the second floor is in the north bay of the storefront. The storefront has fixed display-type windows. Presently, the storefront is missing a few of its structural glass panels. a wood cornice accents the storefront. Fenestration is single with two-over-two double hung wood sash. Paired decorative scroll-cut brackets accent the roofline. Typical of a tavern of this type, the dining room entrance is on the side (south).

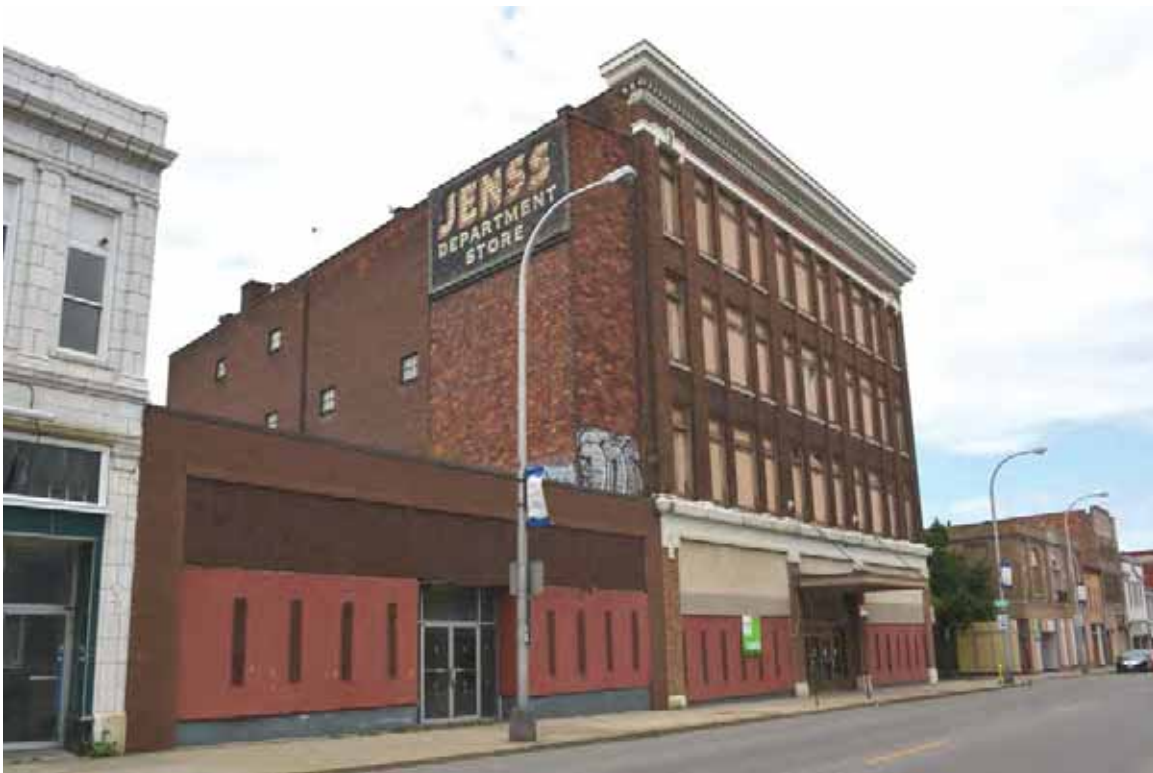
Photograph 1. 1708 Main St., facing southwest (*Panamerican 2014*).

The Jeness building is a four-story, two-part commercial block executed in the Early Twentieth Century Commercial style with restrained Neoclassical Revival details. The building has fire proof construction with steel frame, brick walls, and concrete floors. It has a flat roof and a concrete foundation. In the mid-twentieth century, the window display bays and entrance were "modernized" with a glassy storefront. The principal east façade features central entrance with marquee supported by chains with lion head and two paired double-leaf glass and metal doors. The east sides of the display cases in the vestibule flank the entrance doors. A mid-twentieth century neon sign is above the entrance doors. Brick pilasters with terracotta bases and capitals divide the display window bays. Presently, the two large display window bays on the east façade and two on the north side are boarded. One of the display windows on the north façade is partially covered and the mid-twentieth century display window is visible. It has small blue tiles on the bulkhead and large display windows with metal glazing system. It is unknown if the upper portion of the window bays is intact. A decorative white terracotta cornice accents the storefront. The upper floors are punctuated by eleven window openings with transom and stone sills divided by full-height pilasters. Each window is presently covered so the sash is only partially visible in areas where the covering has peeled off. The top of the building has a terracotta stringcourse, a brick parapet, and a heavy terracotta cornice with egg and dart molding and dentils.

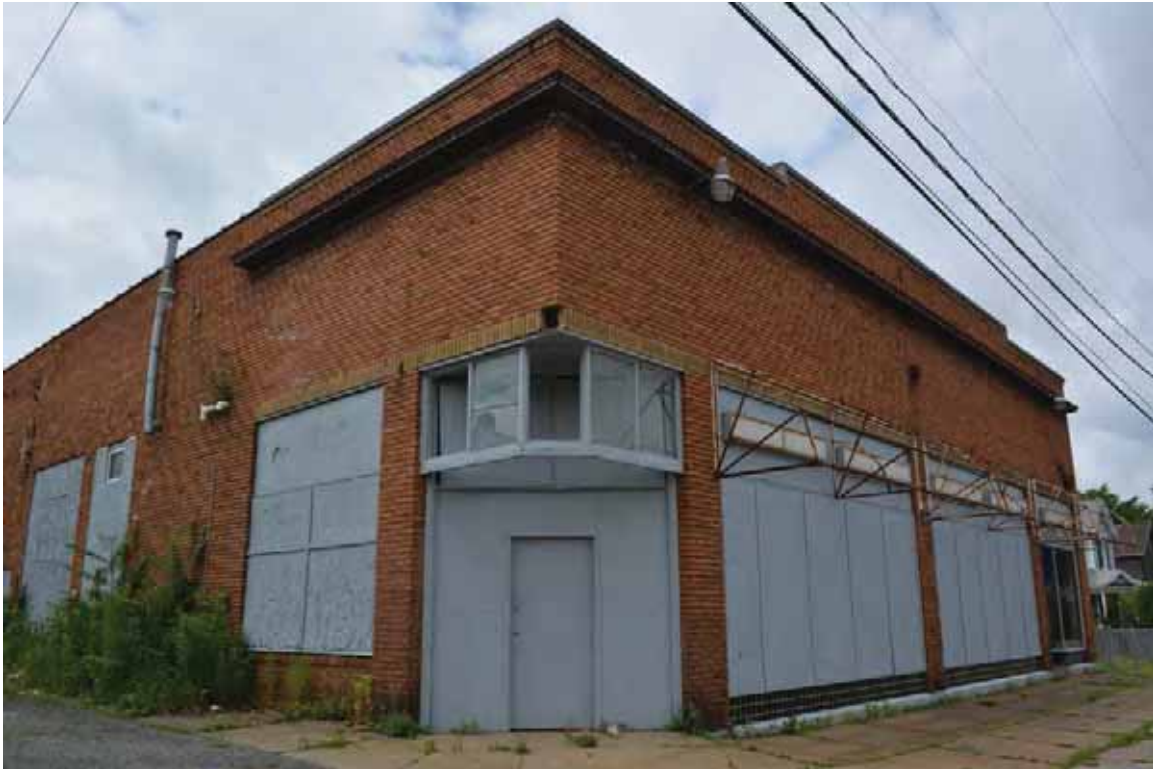
Photograph 3. 835 Willow Ave, facing southeast (*Panamerican 2015*).

The commercial building at 835 Willow Avenue is an example of the Early Twentieth Century Commercial style. It has a rectangular plan, flat roof, steel frame, structural clay tile walls, and brick veneer on principal facades. The north façade has two storefronts with an entrance on the northwest corner and a recessed entrance on the west storefront. The corner entrance has a transom with five fixed lights, a replacement door, and the side panels are boarded up. Presently, the storefront and windows on the east side are boarded (except for the west storefront). The bulkheads are faced with black ceramic tiles. A brick soldier course accents the storefront. Other details include a cornice and parapet.

The Krueger Motor Sales Company auto sales and service building at Willow Avenue is good representative example of an early Twentieth Century Commercial style commercial building in the city of Niagara Falls. It was constructed with large storefront windows to showcase automobiles on display inside of the building. Krueger also once operated a Pontiac dealership at 1316 Main Street. The auto service garage at 809 Pierce Avenue was not included in the 2005 Niagara Falls Intensive Level Historic Resources Survey. Collectively, these two buildings are recommended as potentially eligible for the NRHP under Criterion C. Further research and assessment of the building is also recommended.

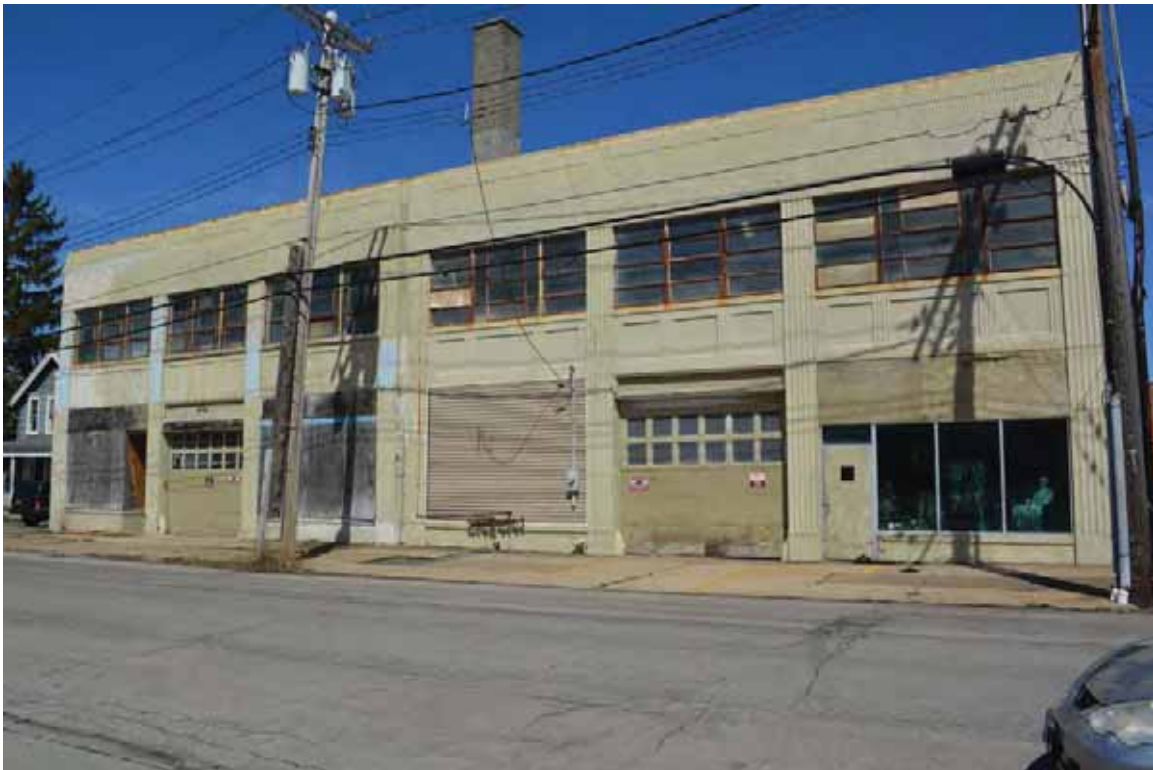
Photograph 4. 832 Pierce Avenue, facing northwest (*Panamerican 2015*).

The commercial building at 835 Willow Avenue originally served as the Krueger Motor Sales Company auto sales and service building while the attached building at 809 Pierce Avenue (Photograph 4) functioned as the auto service garage. The five-bay-wide garage is distinguished by finished Neoclassical style façade with full-height fluted pilasters and spandrels with panels. Its industrial sash windows are intact on the east and west sides are intact. It has two garage bays and three storefronts. The east side has a brick exterior and the west side is concrete block.
