CASE STUDY: COXSACKIE BOAT LAUNCH

OVERVIEW

Improve eroding shoreline consisting predominately of historical dredge fill in order to protect the nearby parking lot. Demonstrate the functionality of restored natural shoreline features at providing erosion protection and improved habitat, as well as human access.

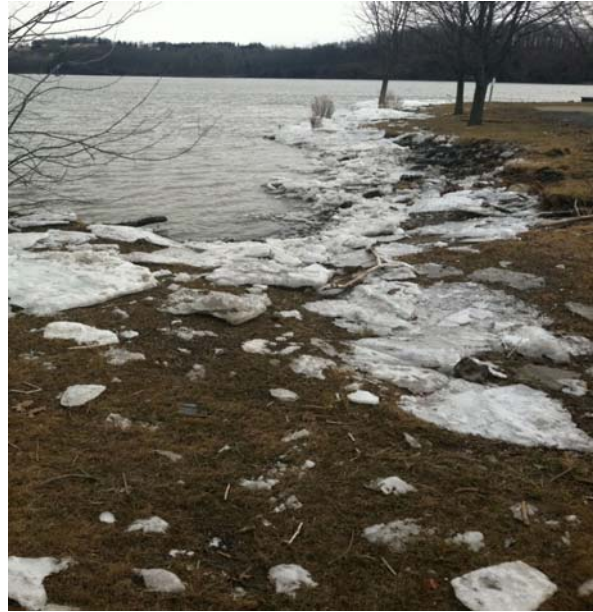
Erosion occurring along the natural shoreline near the sunken historical boat began encroaching on the parking lot. Village officials and OPRHP sought simple solutions to mitigating erosion and damage to the boat launch site, while maintaining human access to the shore.

Figure 1: Preconstruction view looking east during winter with ice in shore zone, note erosion on right.

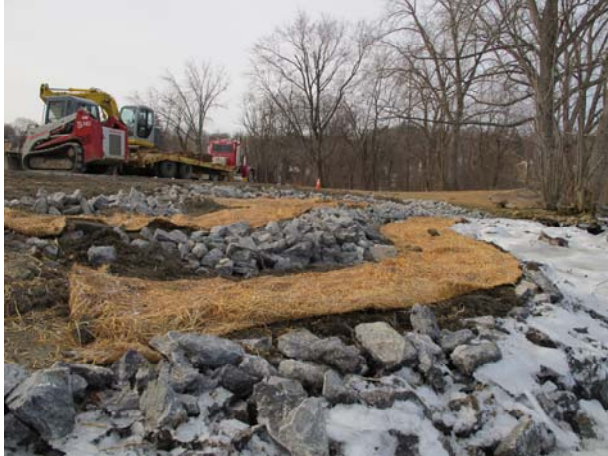
Figure 2: The site following construction in February 2012.

The shoreline restoration activities began on February 6 and 7, 2012 with the re-grading of the site with clean fill. Working at low tide and using a floating silt curtain, and careful machine work, the contractor placed rock fill in the intertidal and upland areas. Three terraces using medium sized were created. Medium sized stone was also used to stabilize the area around a nearby outfall pipe. Large boulders were placed in the intertidal to create a partial sill to increase erosion protection. The terraces were planted with two species of bulrush, pickerelweed, dogwood and buttonbush. Sycamore trees were planted in the upland adjacent to the parking lot.

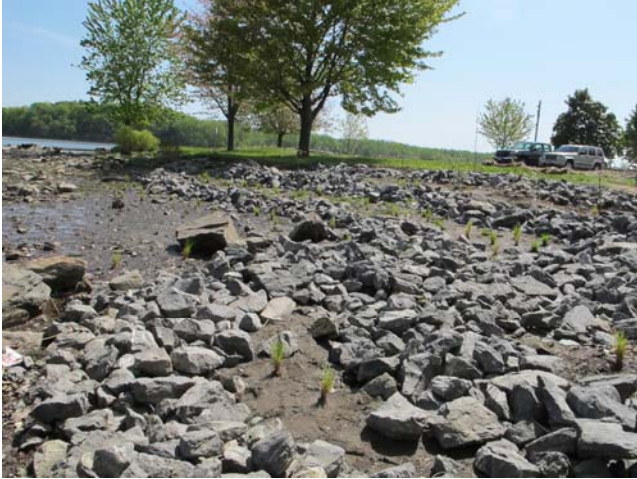
Figure 3: The site immediately after planting, note the small plants between rock terraces.

The native planting took place in early May during spring growing season to maximize potential for stability and growth. Students from Cocksackie-Athens High School helped plant approximately 200 plugs and saplings on May 7, they also participated in various other educational activities.

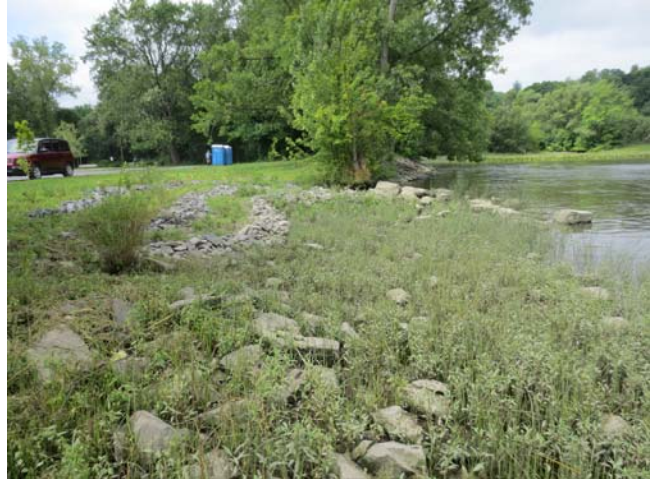
Figure 4: The site after approximately three months of growth.

As of July 2012, monitoring of the shoreline restoration indicated that the gradual slope, rock and plant stabilization improved the erosion issues threatening the parking lot. Very few plantings experienced die-off in the immediate months following the restoration project. The pickerelweed and bulrush showed significant growth as seen in Figure 4. Retaining and enhancing the natural appeal of this shoreline reach has provided diversity in shoreline within this park, and has allowed continued human access with the shore zone.
