To: Wehle Core Team Members
From: Casey Holzworth
Re: Trail Assessment Site Visit – Wehle State Park

Based on the recommendation of the Core Team, Dan Heneka, John Shultz, Bob Smolka and I conducted a field evaluation of the park's trail system on April 20, 2010 for the purpose of assessing the need to re-route or close trails due to their location or condition. During this visit we walked sections of trails that were under evaluation by the Core Team for closure or relocation. Also, sections of trails that were either identified as being located in NWI wetlands or as "wet areas" on the Albany GIS Unit's preliminary map were checked.

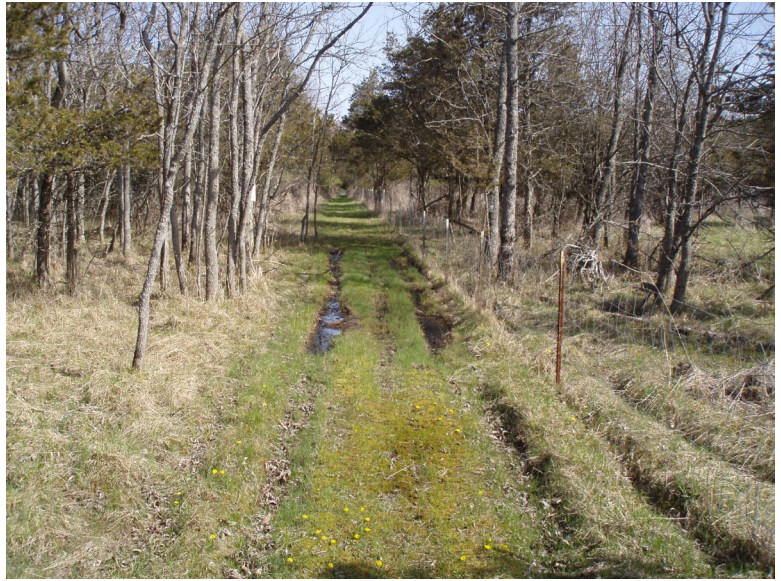
1. Dancing Dog – The area near the fence line was not indicated to be wet, however, inspection found a roughly 50' wetland crossing with areas of the trail completely submerged. This trail was recommended for closure due to trail planning considerations (two trails, same name and destination) and the presence of this wetland crossing supports that decision.

Regulated by: Army Corps

Recommended action: Trail removal

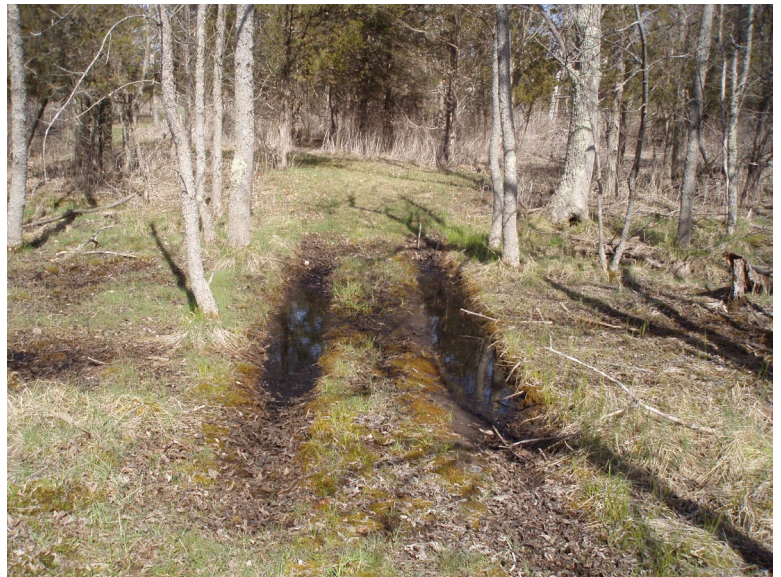
6. Knickerbocker – This site was confirmed as a wetland crossing. The crossing is narrow (15-20') and there did not appear to be an easy re-route around the wetland. Trail was still passable in the middle.

Regulated by: Army Corps

Recommended action: Boardwalk

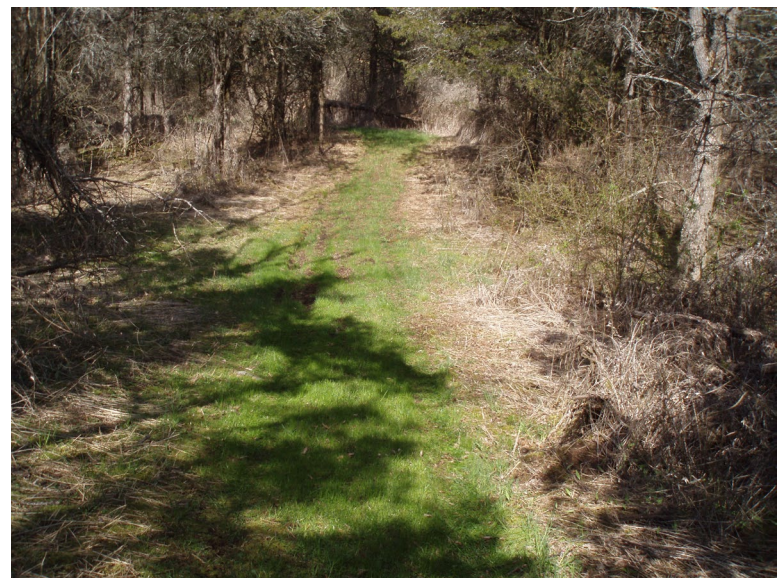
7. Dancing Dog – The area marked as wet at the northern limits of the trail was not very wet upon inspection. Clay-based soils may eventually become wetland but plant community did not show full wetland characteristics. Area was soft but no surface water was present.

Regulated by: None

Recommended action: None

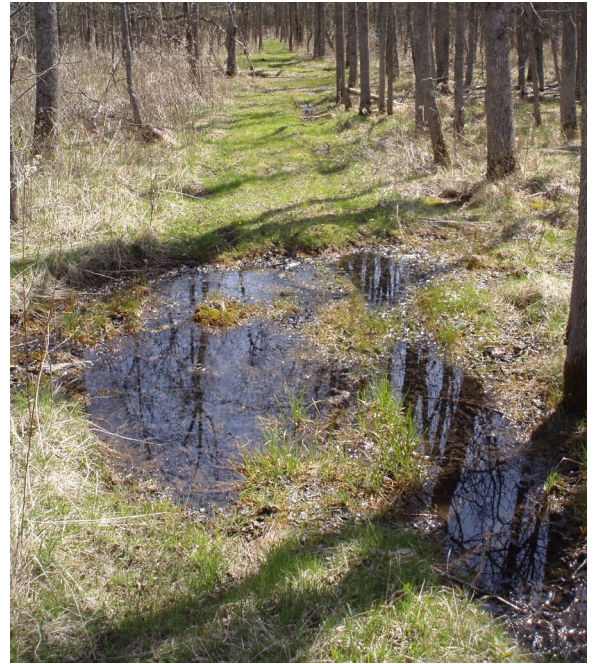
8. Marksman – Wet spot location indicates area of compaction and rutting that has caused relatively deep pools of standing water (approx. 40' long), however, the trail in this area passes through approx. 150' of wetlands that are currently passable.

Regulated by: Army Corps

Recommended action: Multiple Boardwalks or re-route

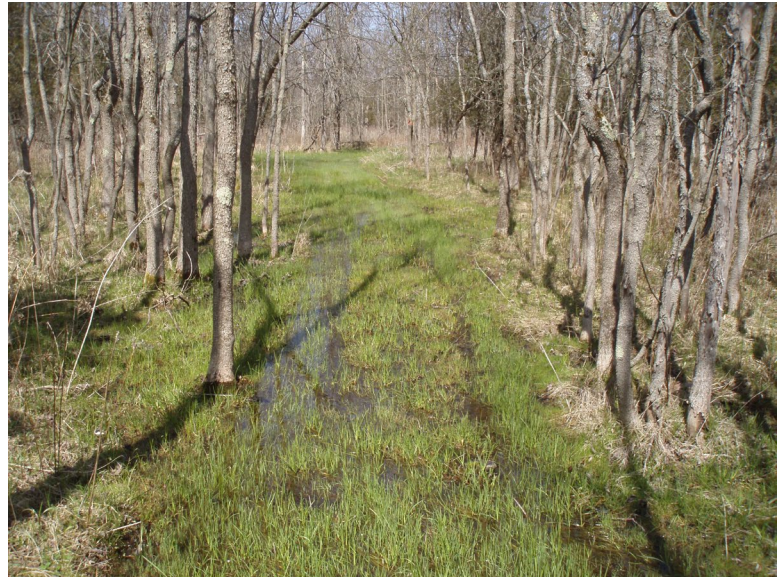
9. Jungle Cut-off – A culvert to the right of this picture, under the north-south portion of the Jungle Trail, connects this wetland area to the large wetland complex extending across military road and beyond the park boundary. According to John, this wet area, measuring approximately 60', is only passable in the driest of times.

Regulated by: Army Corps and DEC

Recommended action: Trail removal

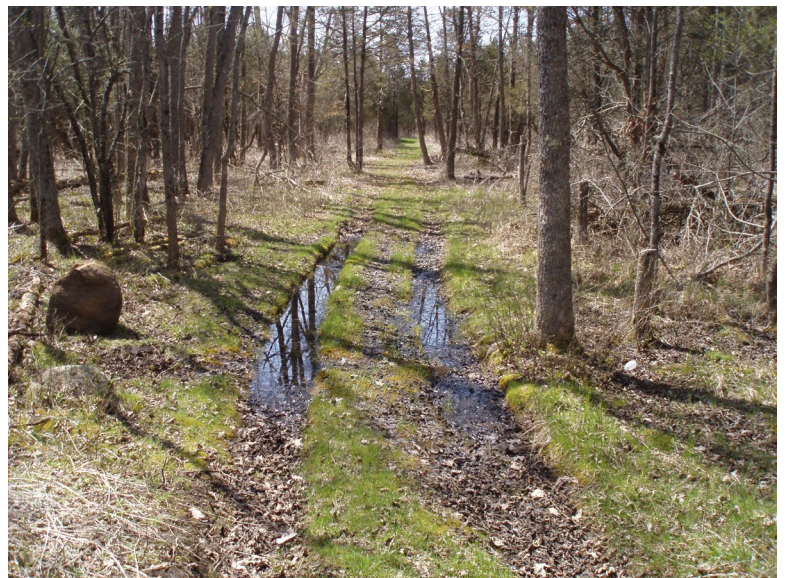
10. Snakefoot – 1000' south of the intersection with Marksman/Park Road. Approx. 30' impounded wet area through larger wetland crossing.

Regulated by: Army Corps

Recommended action: Boardwalk or Trail re-route

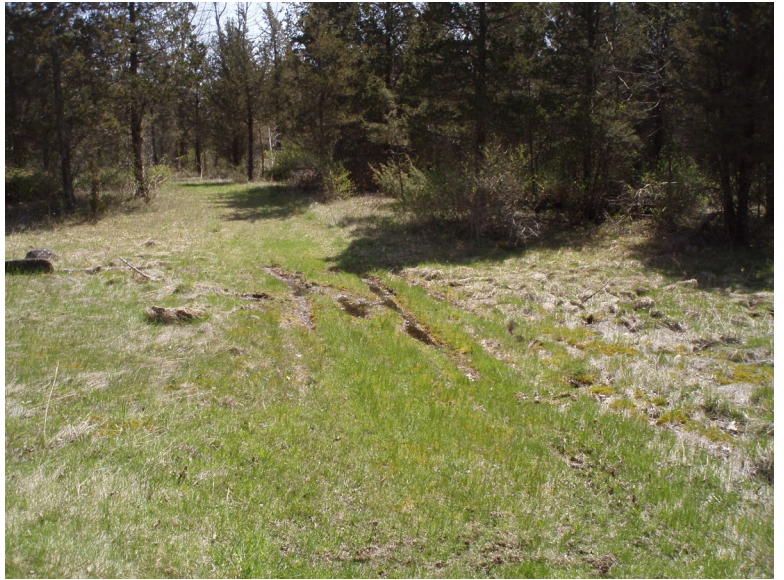
11. Bobolink – Approx. 40' wetland crossing with an approx. 20' surface water crossing. Wetland does not extend far to the north = possible re-route.

Regulated by: Army Corps

Recommended action: Boardwalk or Trail re-route

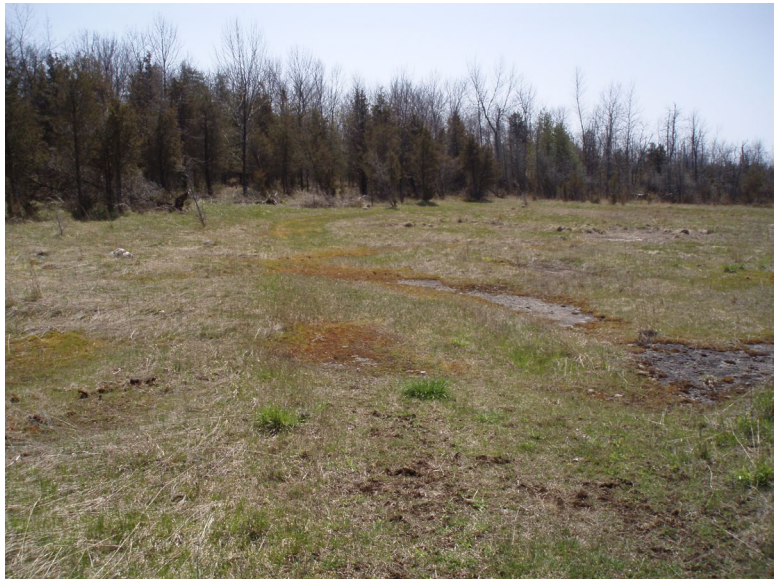
12. Bobolink – Portion of trail through sensitive alvar area. Alvar does not extend far to the north (left) (25') but does extend far to the south (right) (450'+). This trail appears to be on the edge of the alvar area. Moving the trail any further out of the area would not provide the educational opportunity that this crossing provides. The current location does a reasonably good job of limiting travel to the outskirts of the area.

Recommendation: no re-route

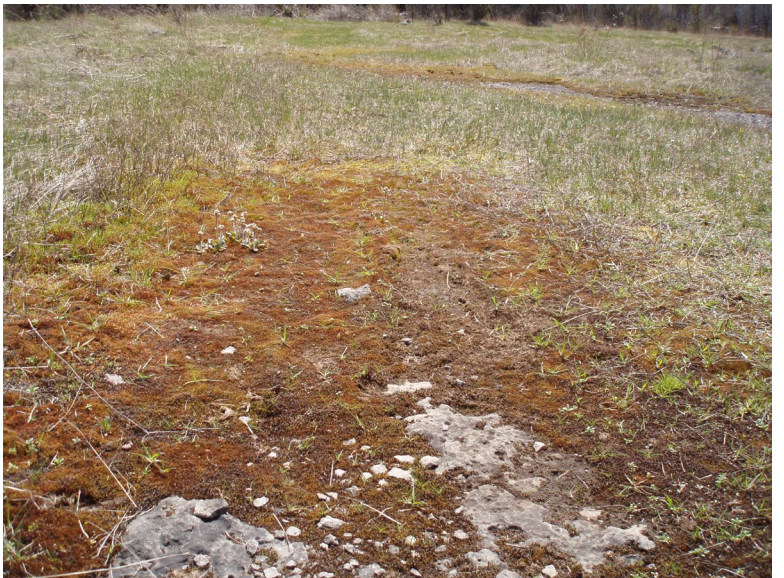
12. Bobolink – Close-up of trail through sensitive alvar area. Additionally, although there is certainly some damage to the alvar within the path of the trail, the trail is not devoid of alvar vegetation and has not been severely eroded.

Recommendation: The placement of large stones as a border to provide for a more clearly defined trail and keep visitors and equipment from unnecessarily leaving the trail.

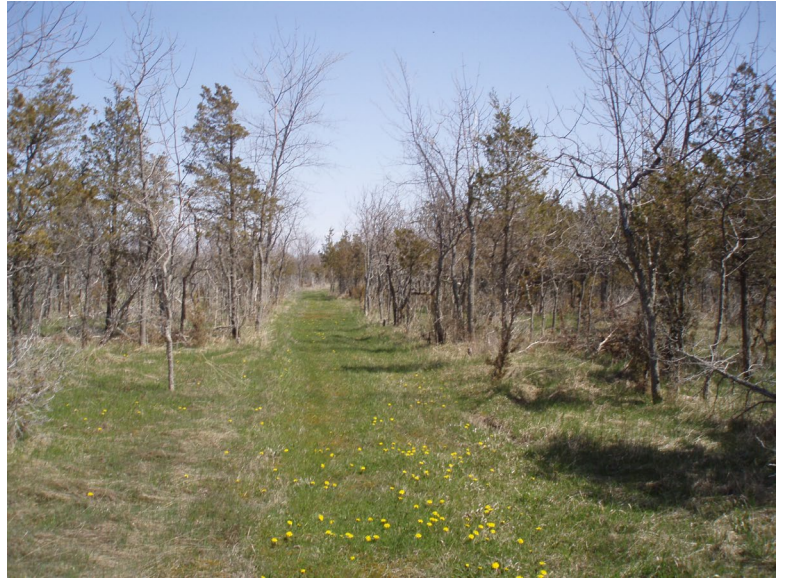
13. Huckleberry – Area of trail through pavement barrens just east of intersection with un-named trail headed south. Un-named trail to the south (14) was planned to become the new alignment of Huckleberry and this portion of Huckleberry was to be closed. The un-named trail(14) appeared to travel along a relatively clear edge of the pavement barrens, which extended to the north of the trail while Huckleberry appeared to traverse directly through the barrens, each providing a different experience of the barrens.

Recommendation: further evaluation

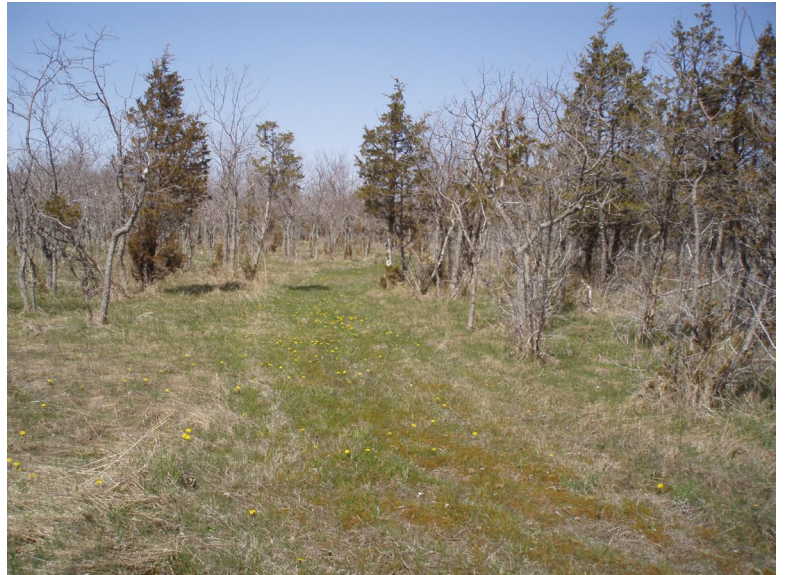
15. Un-named trail headed north from Huckleberry Trail – this trail, too, goes through the middle of pavement barrens. The trail also crosses a wetland just south of the intersection with the other un-named trail that connects to the utility access road. No wetlands were identified on the second un-named trail (4) or the nearby Midge trail suggesting that the wetland may be small in nature and that a re-route may be possible to avoid wetlands.

Regulated by: Army Corps

Recommended action: Boardwalk or Trail re-route
