National Register of Historic Places **DRAFT** Registration Form

historic name Miller, Hall & Hartwell Shirt Collar Factory

street & number 547 and 558 River Street not for publication
city or town Troy vicinity
state New York code NY county Rensselaer code 083 zip code 12180

The Miller, Hall & Hartwell Collar Factory is a manufacturing facility located at 547 and 558 River Street in the City of Troy, Rensselaer County, New York. The property is composed of two brick buildings on either side of River Street that were constructed between 1880 and ca.1915 for Miller, Hall & Hartwell, a local textile manufacturing company. The buildings that make up the facility were the main cuff and collar factory (547 River Street), located on the west side of the street, and a box-making factory (558 River Street) located directly across River Street on the east side. Both are contributing buildings (Figure 1). The five-story brick cuff and collar factory was built in two major campaigns. The southern half was constructed in 1880 and the northern half was added in 1891. The two-story brick box factory was built ca. 1915.

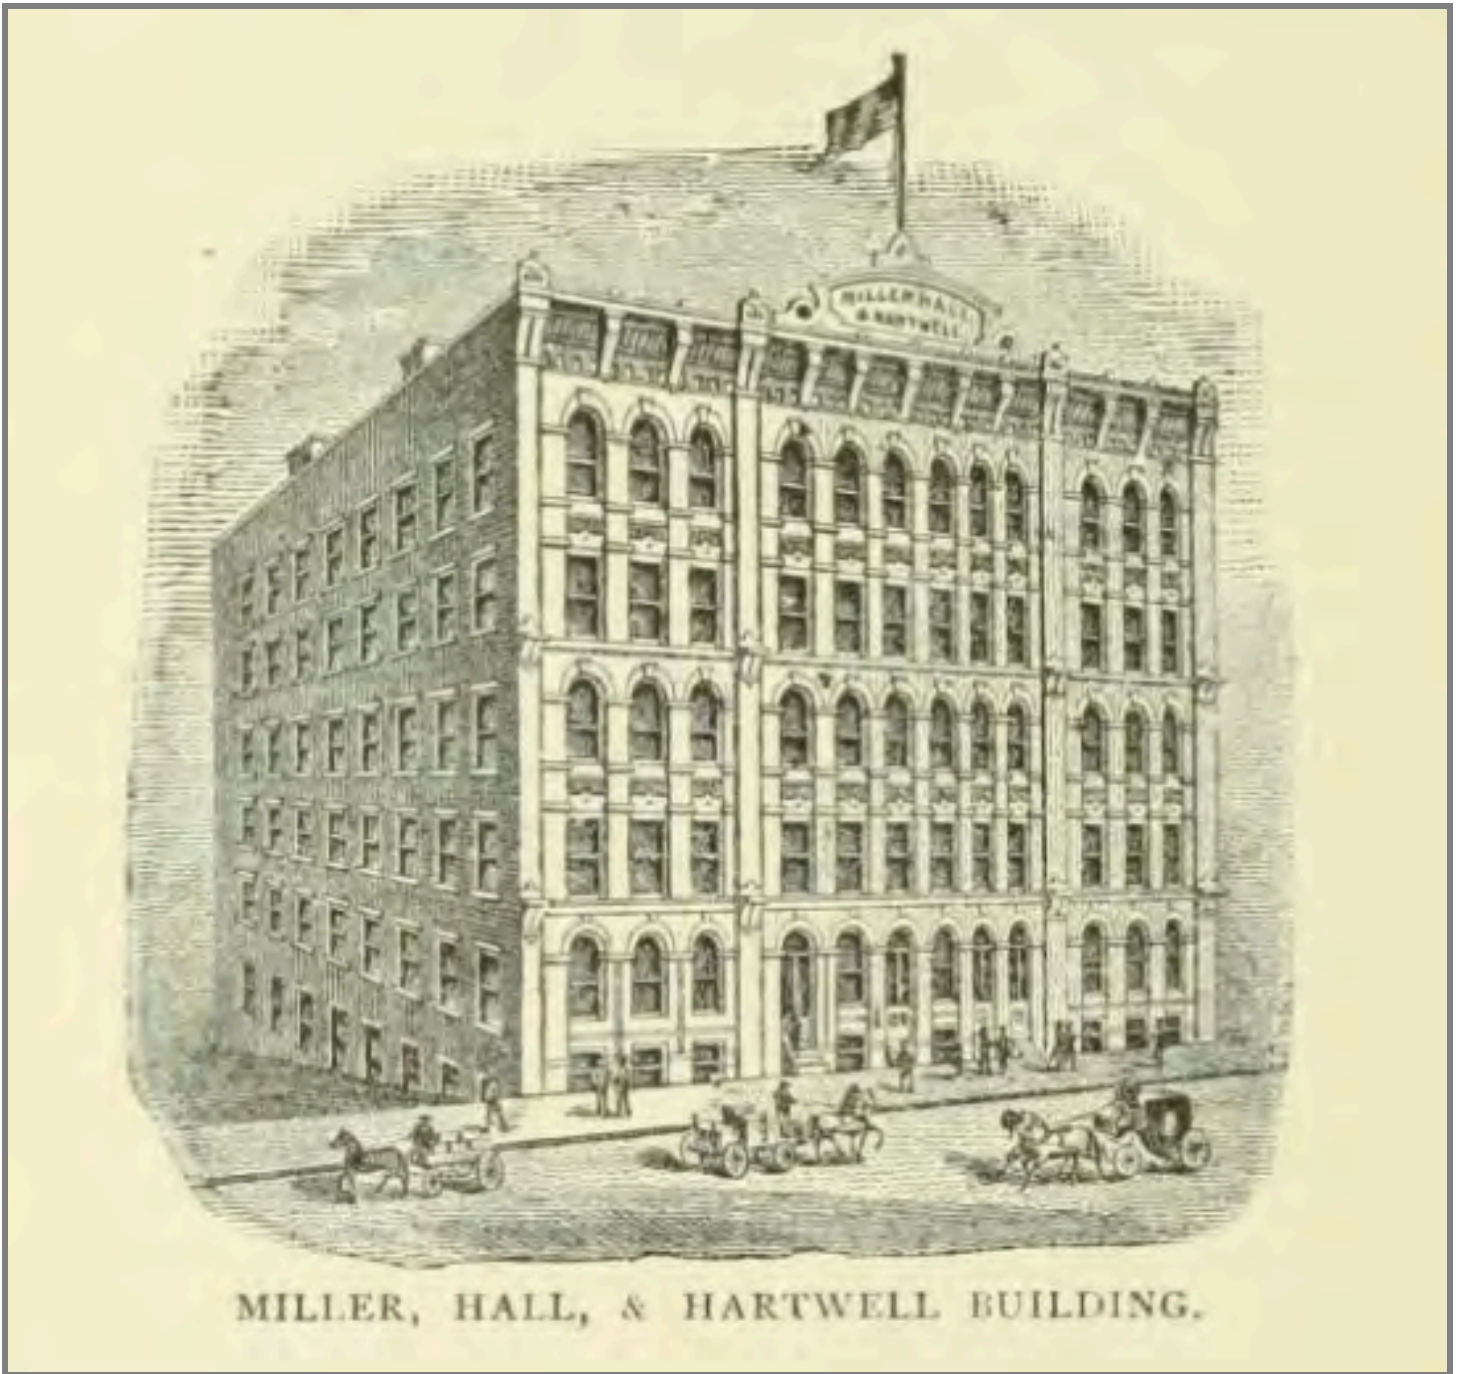
Figure 4: The collar factory ca. 1886 prior to the construction of the addition in 1891 (source: Arthur James Weise, *The City of Troy and Its Vicinity* [Troy: E. Green, 1886] 274).

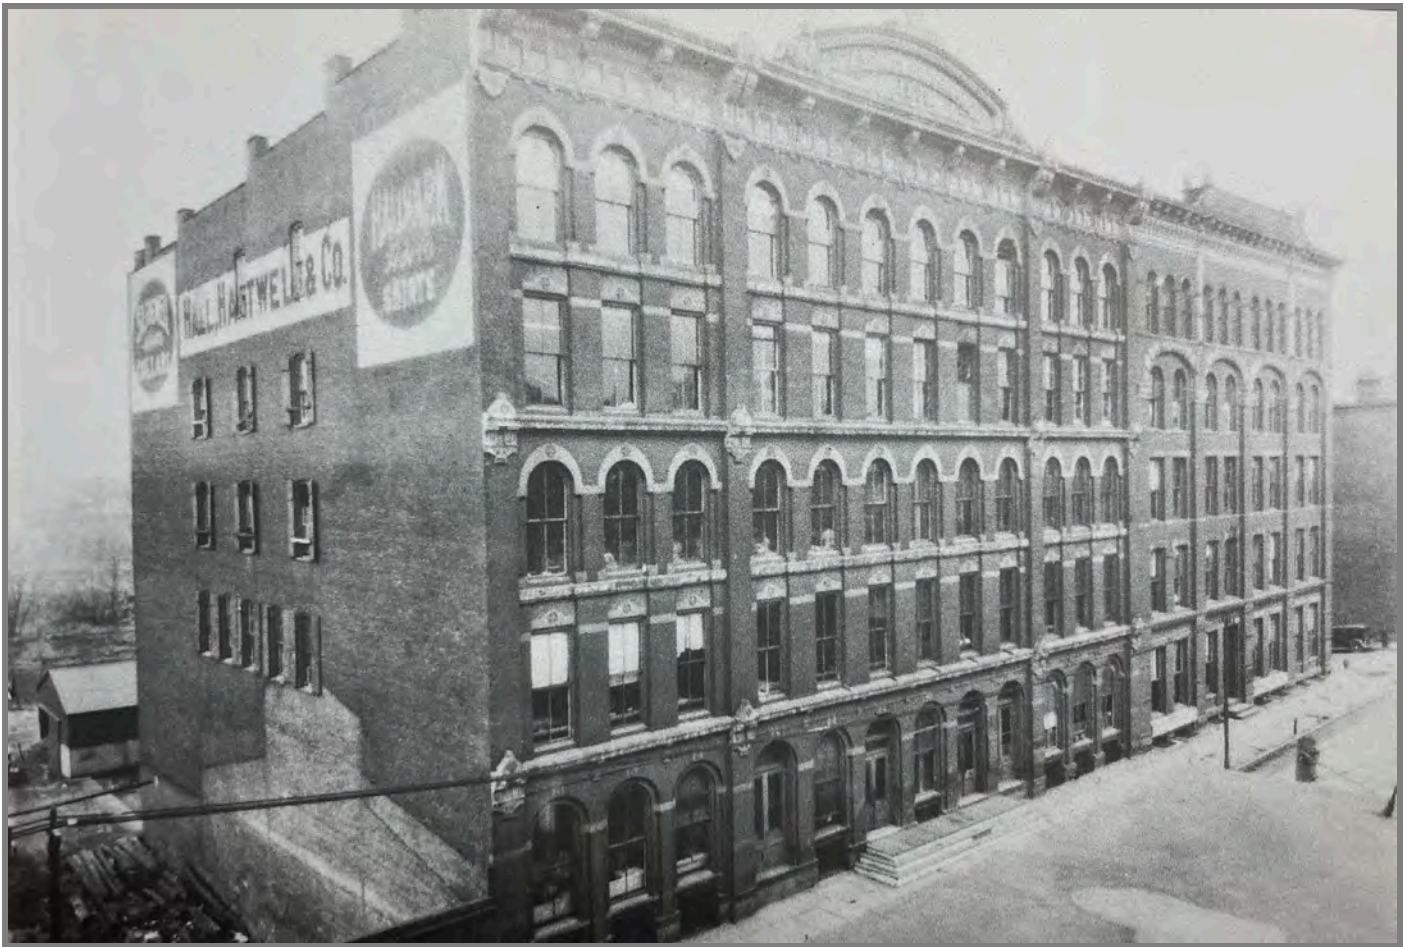
Figure 6: Undated photo of the factory, likely taken in the mid-1920s to 1930s (source: Don Rittner, *Images of America: Troy* [Charleston: Arcadia Publishing, 1998], 54).
