## Appendices

## ***Appendix A—New York State Bird Conservation Area Program Management Guidance Summary***

**Site Name:** Caumsett State Historic Park Preserve BCA

***Appendix D – Existing Building Inventory: Caumsett State  
Historic Park Preserve***

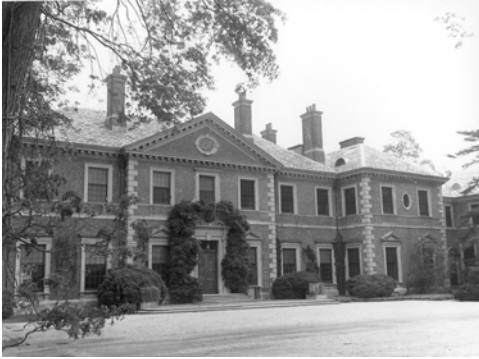
## Main House

The house includes a green terrace that overlooks Fresh Pond. The remains of a formal garden and terrace lie at the west end of the house. This garden, designed by the Olmsted Brothers, included a circular box garden that stepped down to a rectangular flower garden. The flower garden terminated in a small staircase with a terrace that provided a scenic view of the Sound over open parkland.

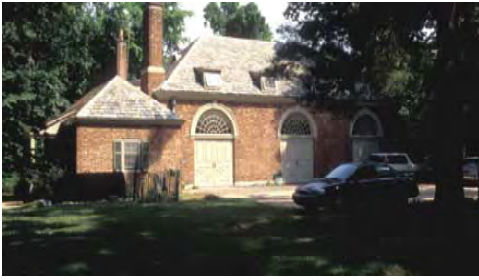
## Garage and Chauffeur's Cottage

The garage and chauffeur's cottage was built concurrent with the main house. The exterior of building has changed very little from its original design and use. This building, along with the main house and the butler's (Dinham's) cottage, was leased to Queen's College Center for Environmental Teaching and Research from about 1980 until about 2002. In 2008, the garage bays on the main floor level were sub-divided internally to create public restrooms. The small apartment within the northern wing is used to house interns and still retains its original floor plan along with most of its original finishes and features. The ground floor continues to be used for storage of materials and equipment.

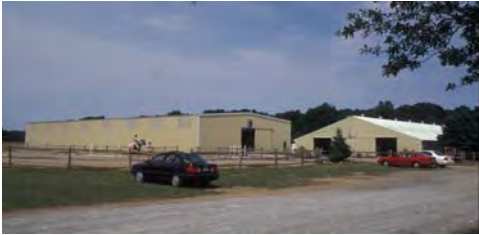
## Indoor Riding Rink

The indoor riding rink is a long, low metal-clad pole barn. The barn has a low-pitch metal roof; the exterior walls are clad in vertical metal panels. The interior has a clear open space and earthen floor.

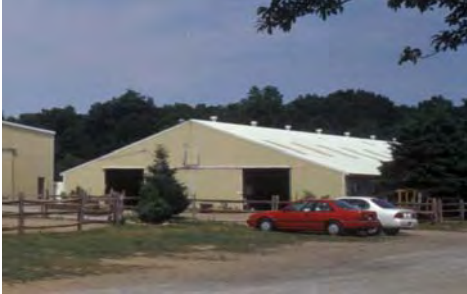
## Boarding Stable

The boarding stable is a large, metal-clad pole barn. It has a low-pitch gable roof with two entrances on the gable end. The building contains stalls for horses along with space for storing feed and equipment.

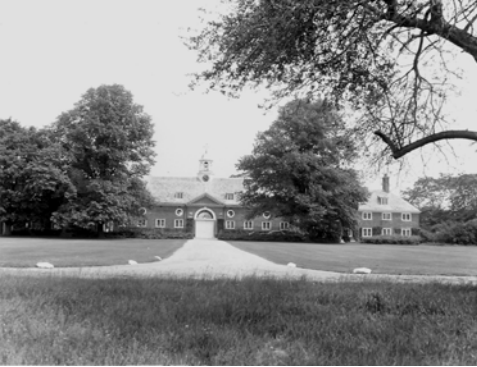
## Polo Stable

The exterior of the building remains largely intact. The gates at the entrance to the main courtyard are missing and several bedrooms on the second floor have been damaged by water infiltration. The Polo Stable has been leased to a concessionaire that operates an equestrian boarding and training program since about 1980.

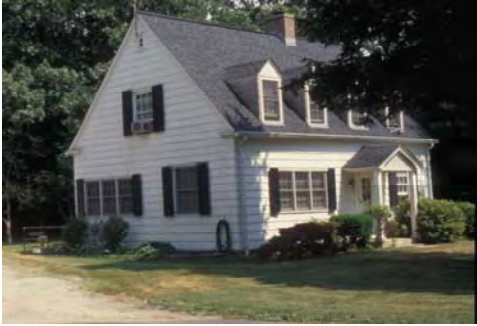
## Groom's Cottage

The Groom's Cottage is a typical example of the Colonial Revival style framed residences that were built to house the staff who managed the Field estate. Typical Colonial Revival features include molded wooden cornices, a central doorway with Federal style surround, and six-over-six double-hung sash with exterior shutters. The house has a steeply pitched gable roof pierced with several narrow gable dormers and a central brick chimney. The roof is covered with asphalt shingles and the exterior walls are clad in wood shingles.

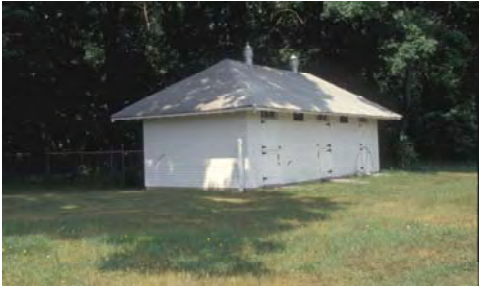
## Stallion Stable

The stallion stable is a small wood-frame building with a hip roof that contains three stalls. The roof features a wide overhang supported on decorative, exposed rafter tails and two tall sheet metal vents. The exterior walls are clad in horizontal, novelty wood siding with flat trim boards. The stall doors are planks with cross bucks divided horizontally and supported on wrought-iron strap hinges. Above each door is a three-light transom window.

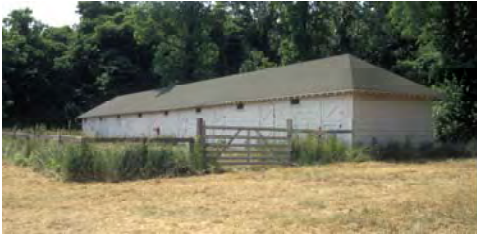
## Pony Stable (Lower Stable)

The pony stable is functionally related to the polo stable and the estate's horse breeding program. A purpose-built structure, it has remained in use as a horse stable. The pony stable is currently part of the equestrian operation's licensed premises.

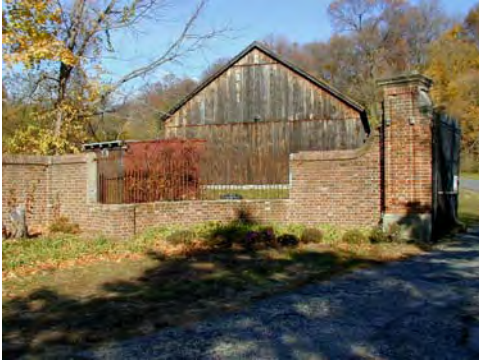
## Weir Barn

The Weir barn is a rectangular, gable roof barn of post and beam construction. The roof is covered with wood shingles and the exterior is sheathed in vertical boards.

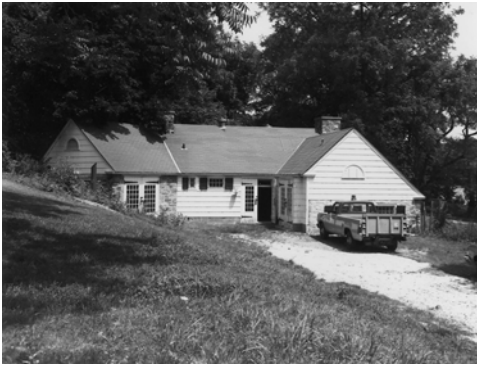
## Power House and Pump House No. 2

The power and pump house were built to provide electrical and water service throughout the Field estate. The building and the mechanical equipment is remarkably intact. None of the equipment is currently in use, and the building is used primarily for storage.

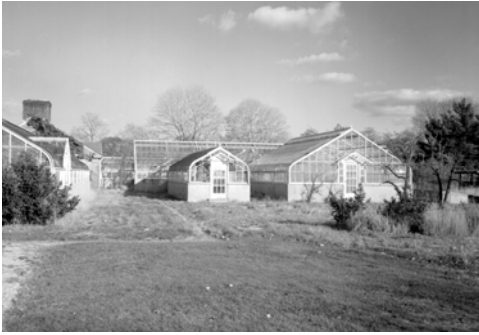
## Greenhouse Complex

The glass houses are largely pre-fabricated and modular structures designed by the Lord and Burnham Company, a leading manufacturer of glass houses from the late 19th century and continuing into the mid 20th century. The foundations and lower walls are concrete, cast-in place. Above this level is a steel framework that is sheathed with rectangular glass panes set on a grid of cypress mullion. Stylistic detailing is minimal and is limited to the doorways, which featured small glazed porches supported on wooden brackets with fanlight transoms and sidelights.

The greenhouses were built to supply the Field estate with a variety of fresh fruits, vegetables and cut flowers. The estate gardener was responsible for the greenhouse operation, and lived in a cottage nearby (now demolished). The greenhouses remained in use until 1965, when they were closed down and abandoned. The glass houses are largely intact but have suffered extensive damage due to lack of maintenance.

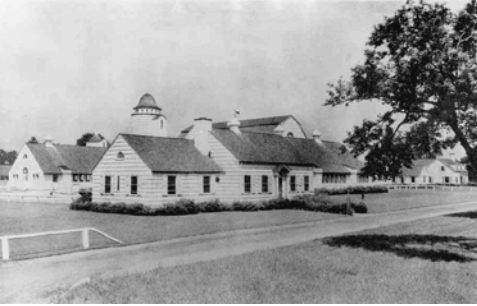
## Farm Group

Several of the farm buildings have been adapted for modern purposes while others remain largely vacant. The Volunteers for Wildlife occupy the former calf barn. The estate office functions as offices for park management while vehicle and equipment maintenance is performed in the old garage. The farmer's cottage has been adapted for public restrooms and a workroom for park employees. The Caumsett Foundation has nearly completed a multi-year campaign to repair and restore the building exteriors.

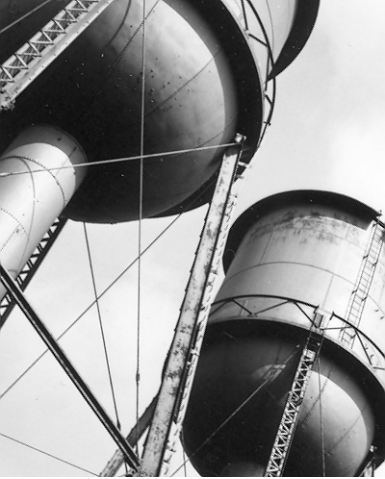
## Water Tanks

Communications equipment was attached to the side of the water tanks in 1998. These were subsequently replaced with a monopole tower. A pre-cast radio transmission structure was also located at the base of the towers.

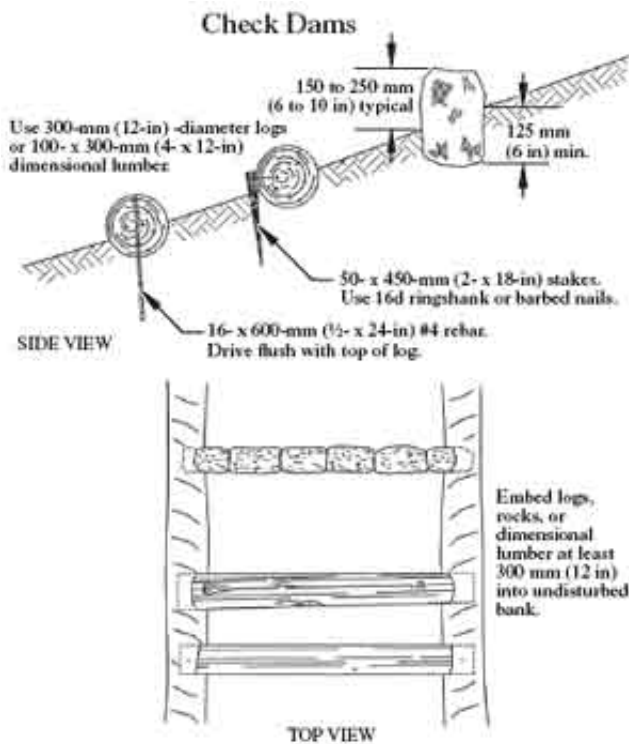
Drawing of the side view and top view of a check dam. The drawing includes the text:

- Use 300-mm (12 in)-diameter logs or 100- x 300-mm (4- x 12-in) dimensional lumber.
- 150 to 250 mm (6 to 10 in) typical.
- 125 mm (6 in) min.
- 50- X 450-mm (2- x 18-in) stakes. Use 16d ringshank or barbed nails.
- 16- X 600-mm (1/2-x 24-in) #4 rebar. Drive flush with top of log.

Embed logs, rocks, or dimensional lumber at least 300 mm (12 in) into undisturbed bank.

covered with tamped fill. These trenches take a long time to fill up. Most never do. If they do, add fill below the dam to finish the process.

Spacing between dams depends on the steepness of the old grade and the degree of restoration desired. If the check dams are intended only to slow down erosion on a 25-percent grade, relatively wide spacing is sufficient, every 20 meters (65 feet). If the intent is to fill in half of the old trench, the bottom of each dam should be level with the top of the next lower dam. On steeper grades, the dams need to be closer together. If the intent is to approach complete recontouring of the trench, the dams should be closer still, especially on grades steeper than 25 percent. A point of diminishing returns is reached on grades steeper than 40 percent. Check dams would have to be built right on top of each other to retain soil at the full depth of the trench.
