Jones Beach State Park

Jones Beach State Park
Wantagh, New York
11793

Historic Structures &
Cultural Landscape
Report

Prepared By:
Erin Moroney
Building & Landscape
Conservation Unit

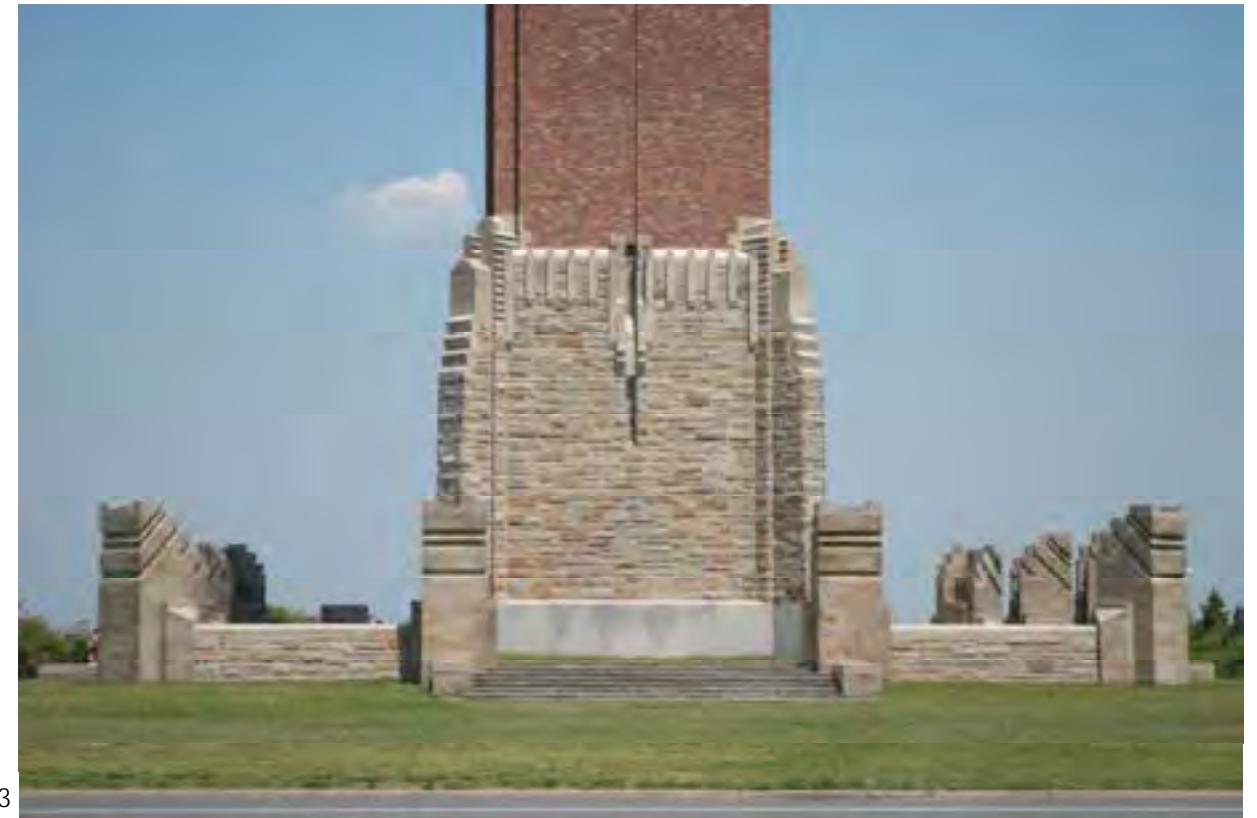
The landscape of the Water Tower plazas, however, is in very poor condition. All of the plantings relating to the formal landscape plan have been lost. The two reflecting pools have also been lost. The erosion of the original Moses designed formal landscape reduces the integrity of the Water Tower and Jones Beach as a whole.

Water Tower Plaza—2013

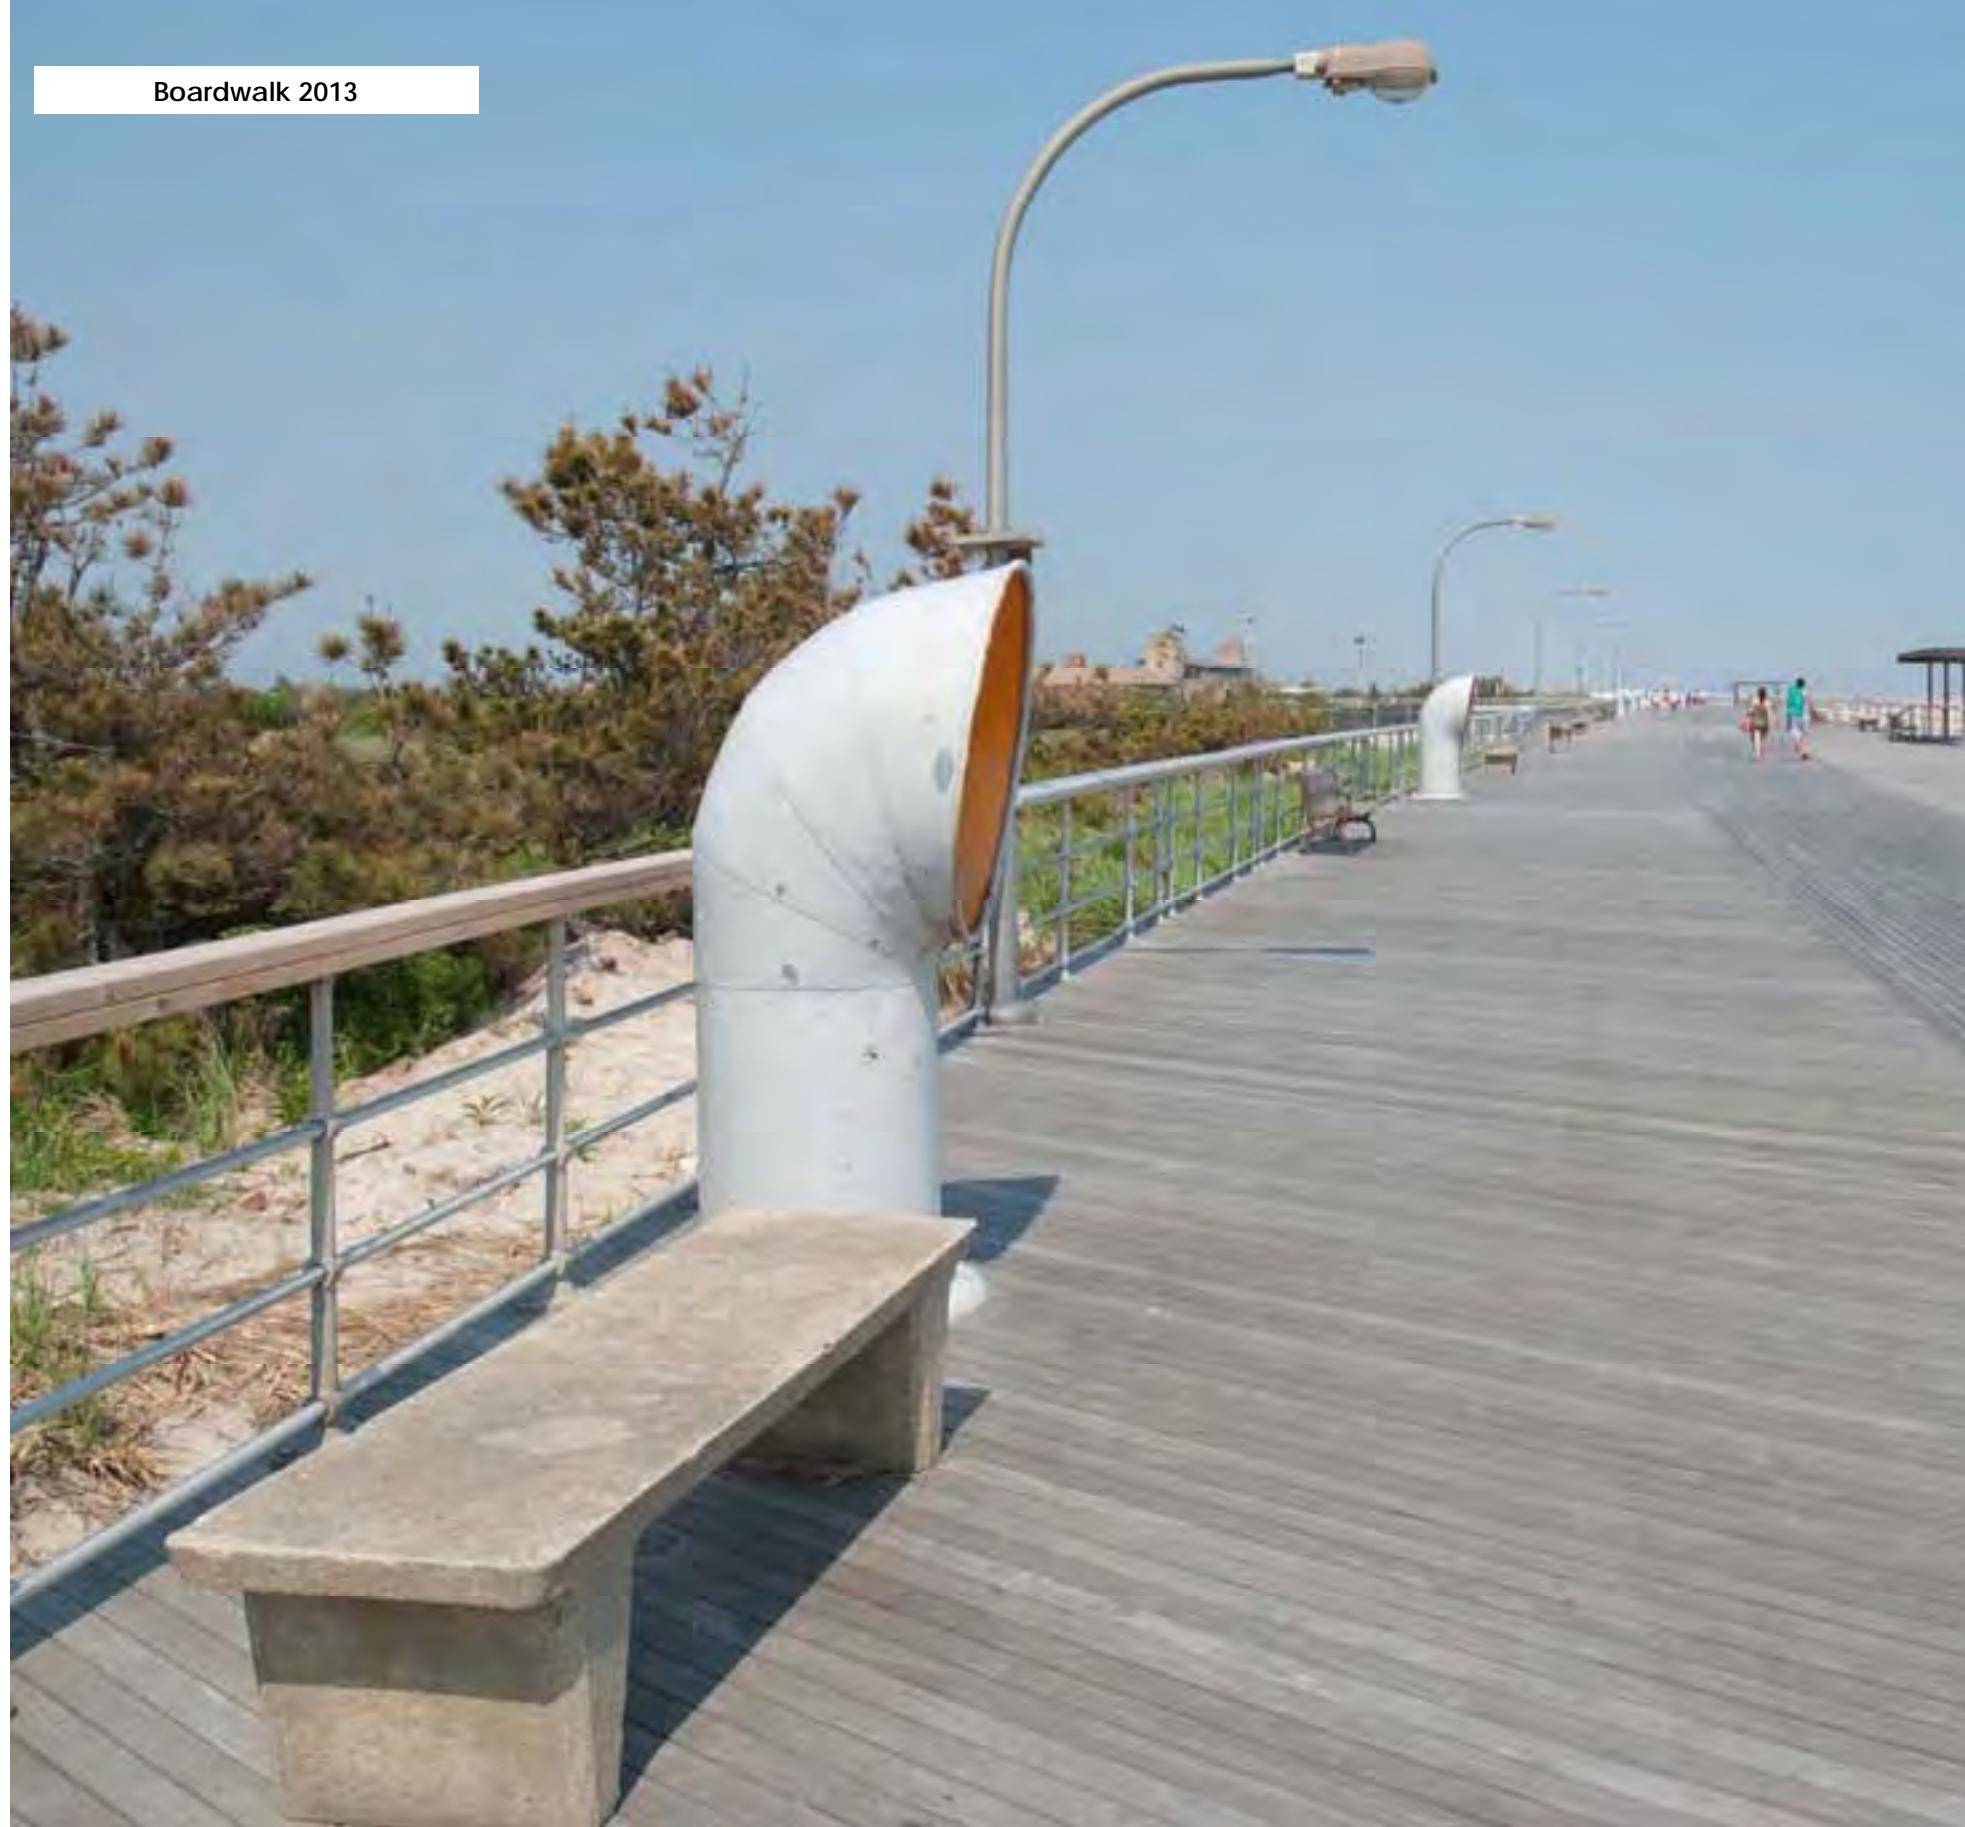
Boardwalk 2013

- As the major pedestrian walkway at Jones Beach the Boardwalk itself (plank walkway) is kept in very good condition. The Boardwalk was heavily damaged by Super Storm Sandy in 2012 but was repaired and ready for the 2013 beach season.

- The character of Boardwalk, however, has been dramatically impacted over time by the loss and replacement of historic features.
- Important features that have been lost include the wood hand rail on the railings, the historic light features, the nautically inspired water fountains and the canvas awnings on the boardwalk shelters. The loss of these features reduced the overall character and unity of the boardwalk and the Park as a whole.

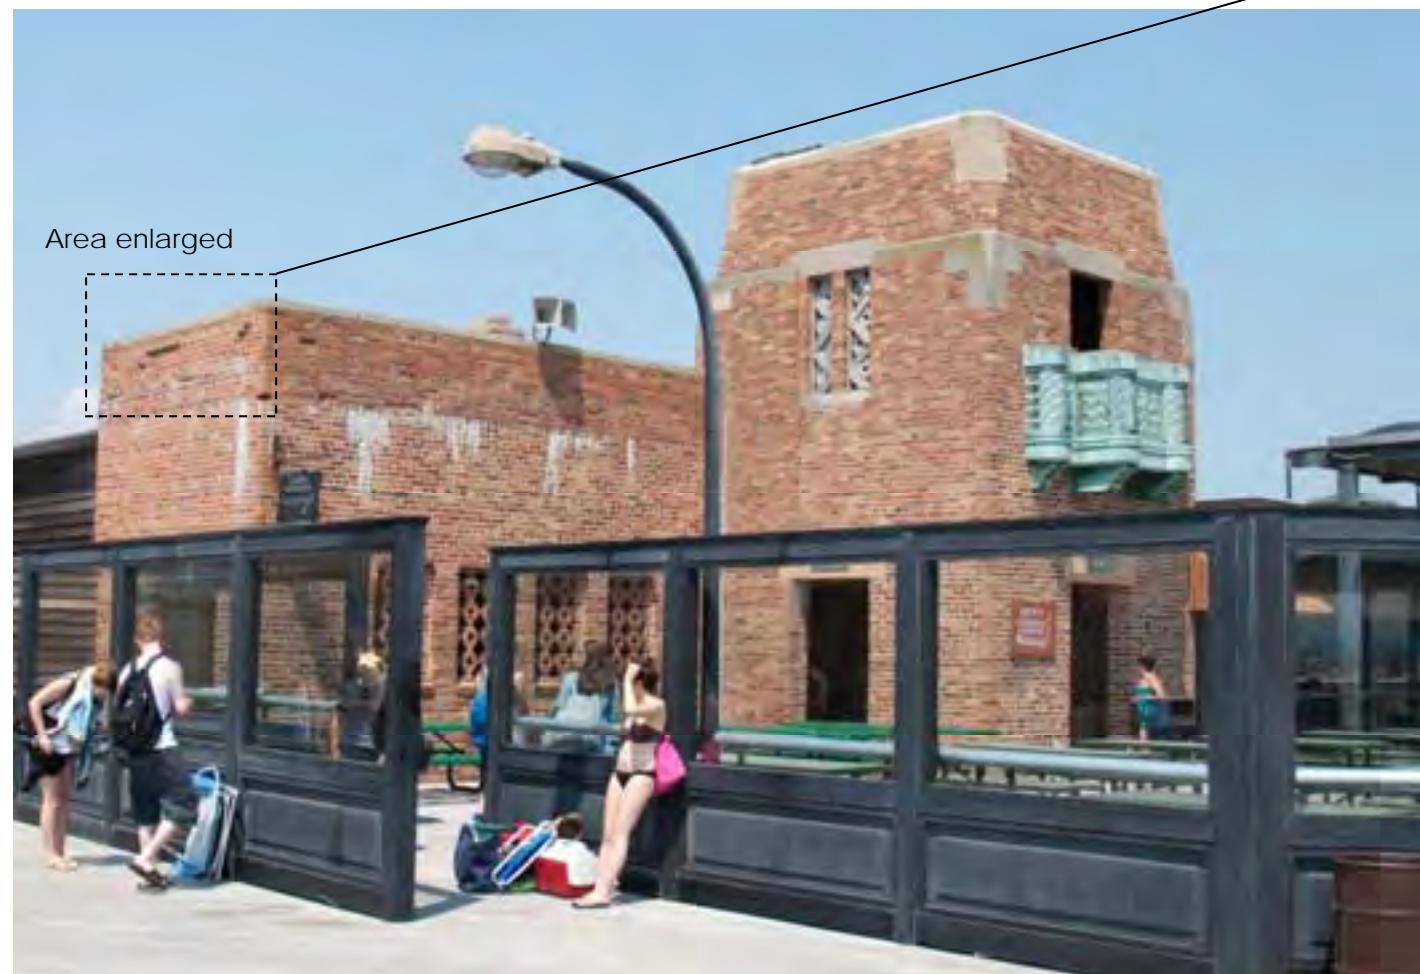
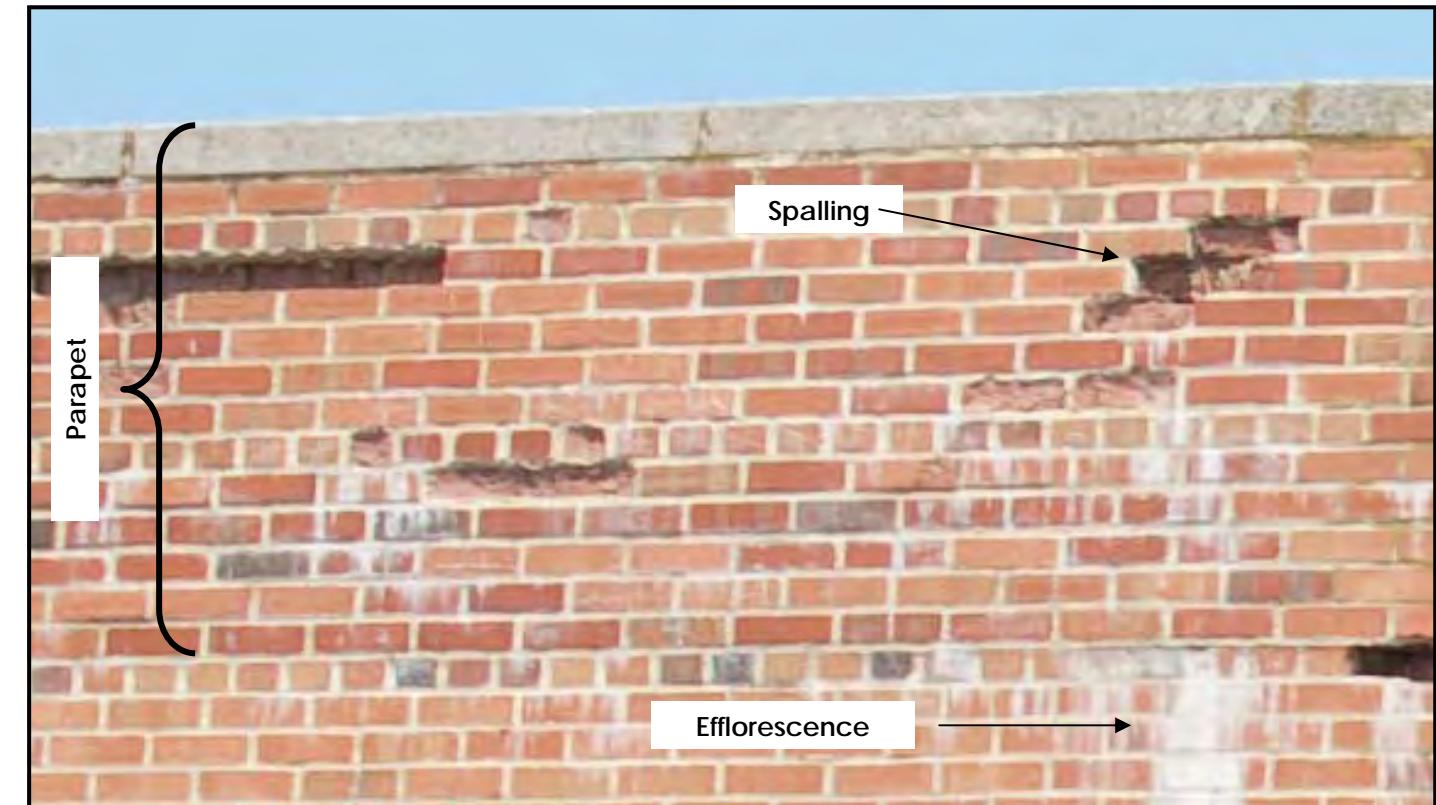
Overall the West Mall Building is in fair to good condition. Deterioration, however, is apparent in multiple locations especially at the roof level.

- **Water Infiltration.** The brick at the parapet displays evidence of prolonged water infiltration. Poor or insufficient flashing has allowed water to enter the wall cavity resulting in efflorescence (white staining) and brick deterioration. The water appears to be entering the wall cavity through the back of the parapet wall and at the junction of the roof and parapet.
- **Brick Deterioration.** Moisture traveling through the wall and emerging on the face of the brick has resulted in extensive brick spalling at the parapet level. Many bricks have already been completely lost and others are failing.
- **Sandstone Cracking.** A number of the sandstone cap stones on the tower are cracked.

Detail of brick deterioration at parapet of West Mall Building.

1. Many important features are threatened by deterioration including the sandstone, Barbizon brick & copper trim features. When necessary deteriorated fabric should be replaced in kind. While replacing in kind is an option the integrity of the building is tied to its original fabric so the primary goal should be the preservation of historic fabric.

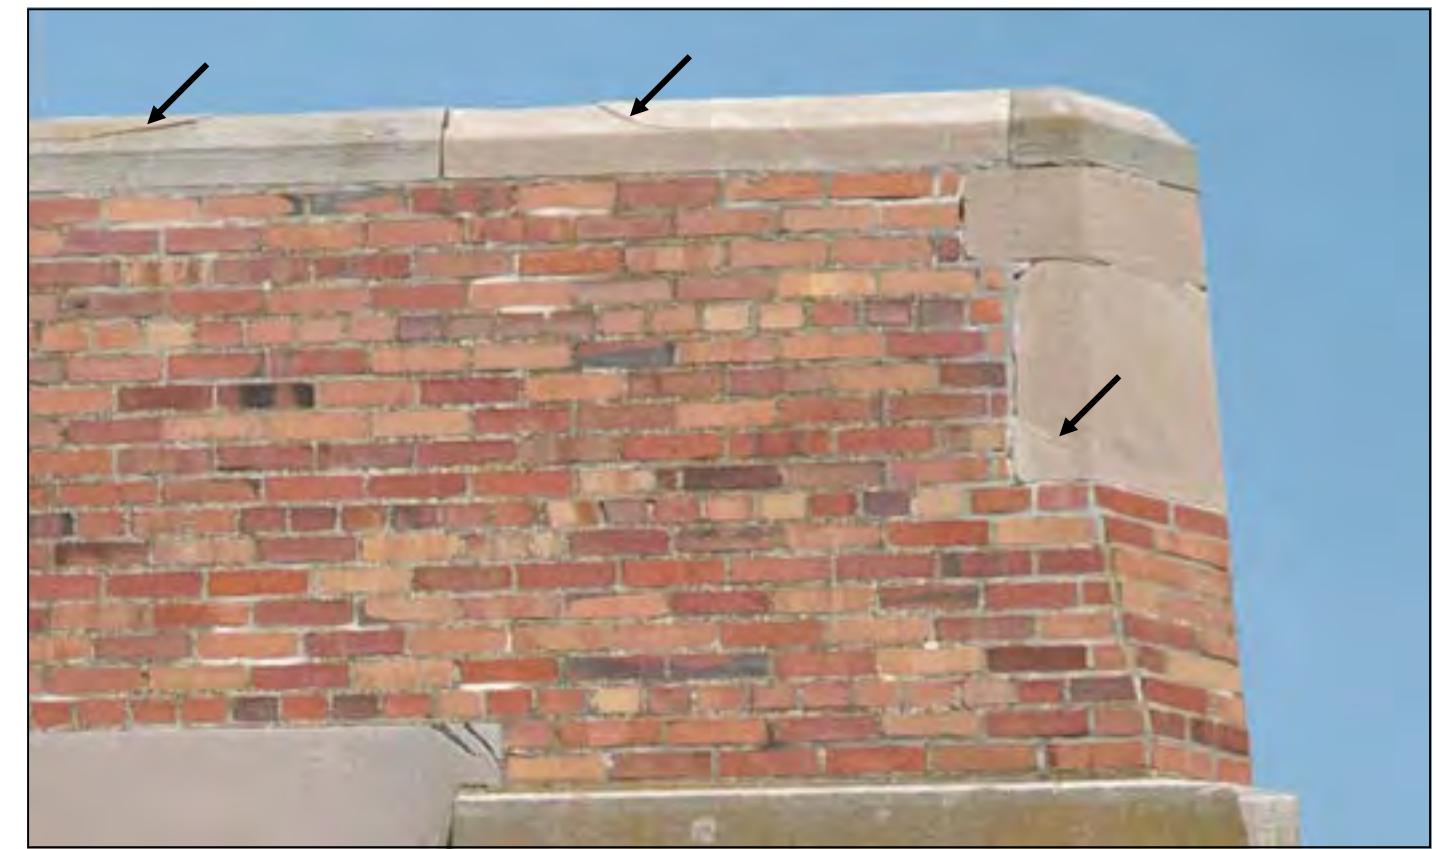
Detail of sandstone deterioration at West Mall Building.

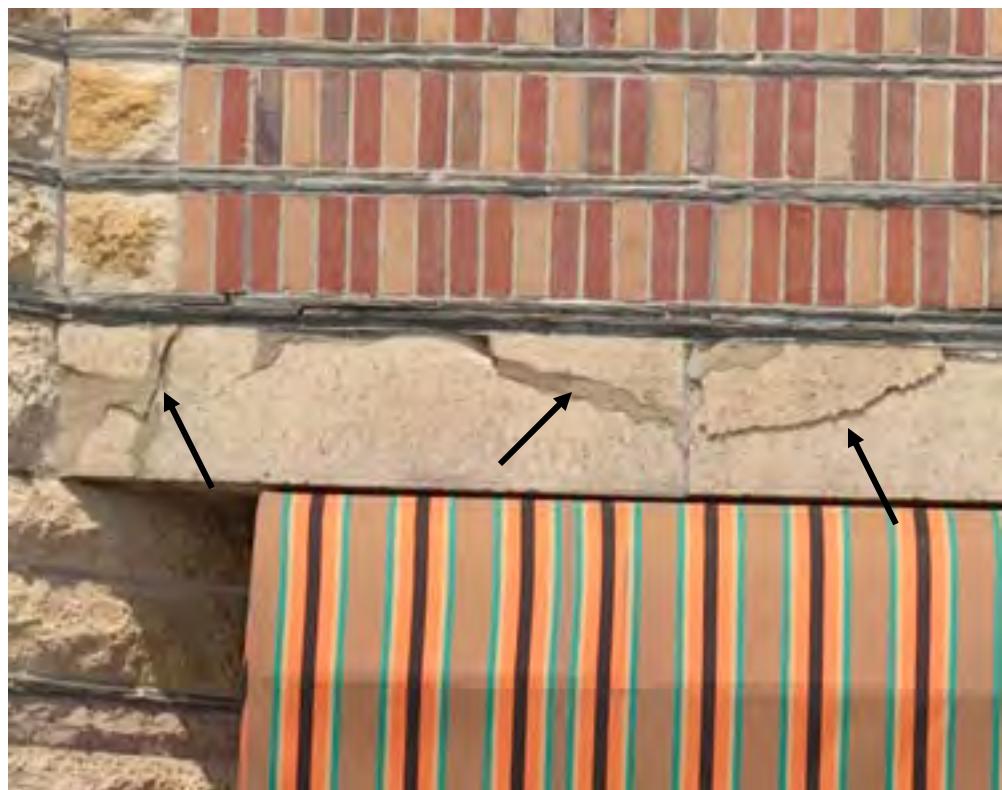
- **Stress Cracks.** The sandstone lintels on the primary facades exhibit multiple stress fractures. Some of the lintels have been patched while other areas appear ready to fall. These areas should be inspected more thoroughly. 30% of the lintels on the boardwalk facades are cracked.

South Façade: Cracking in sandstone lintels.

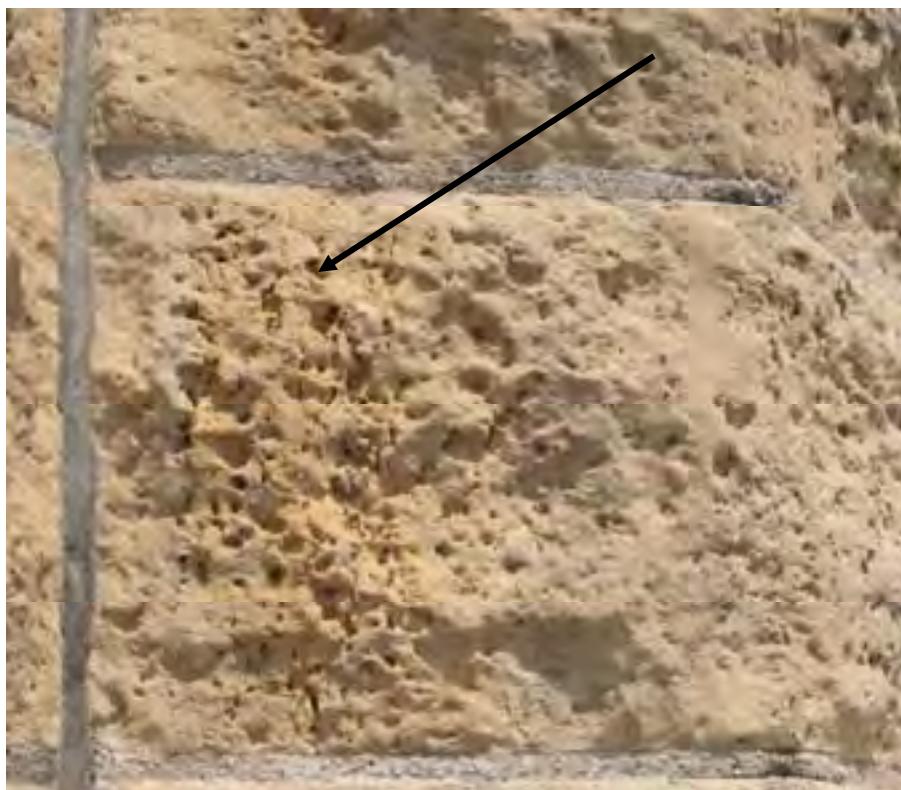
- **Sandblasting.** Erosion of the sandstone by 'sandblasting' from the beach sand. Unfortunately the strong winds off the ocean often blow sand at the buildings lining the beach. The velocity wind and the coarseness of the sand results in a sandblasting effect on the masonry. Over time the masonry becomes pitted and eroded. This is evident on many of the stone units on the south façade. While the units are pitted they are still in stable condition. Eventually severely eroded sandstone units will require replacement. 10% of the sandstone block are severely eroded.

South Façade: Sandstone pitting—typical condition.

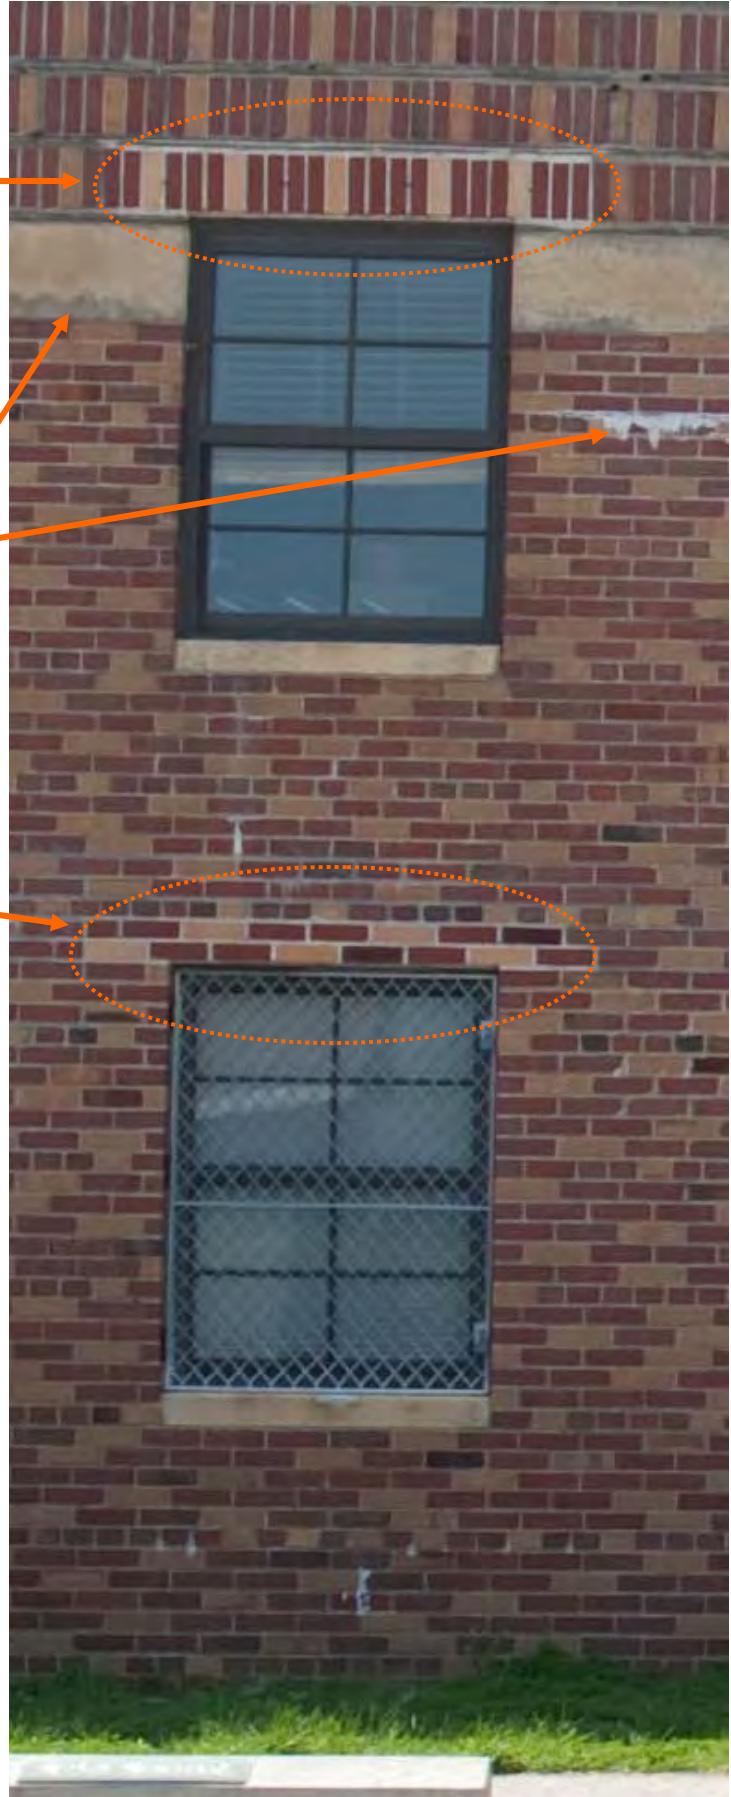
- **Rust Jacking.** Expansion of the steel as it corrodes has also resulted the loss of original material (brick lintels) on the secondary facades. The replacement brick is not a great match to the historic Barbizon brick. 100% of the brick lintels have been replaced.

Replacement Brick
Due to rusting of the
lintels

Staining &
Efflorescence from
water infiltration.

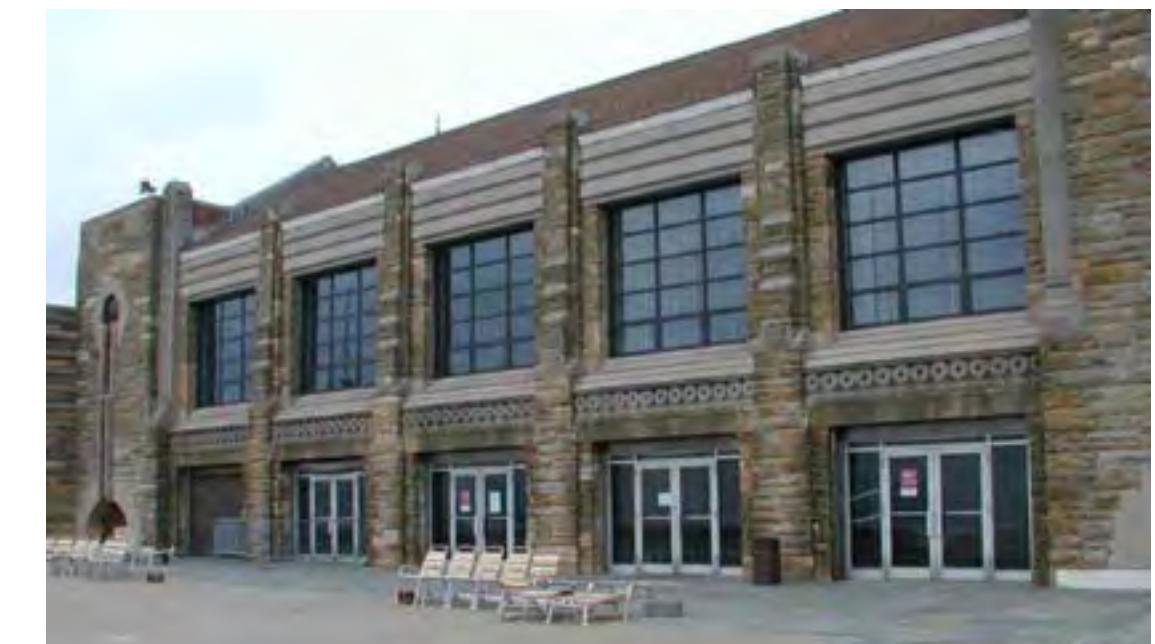
West Bathhouse, South Elevation 2009.
Note: collapse of lintels over doors.

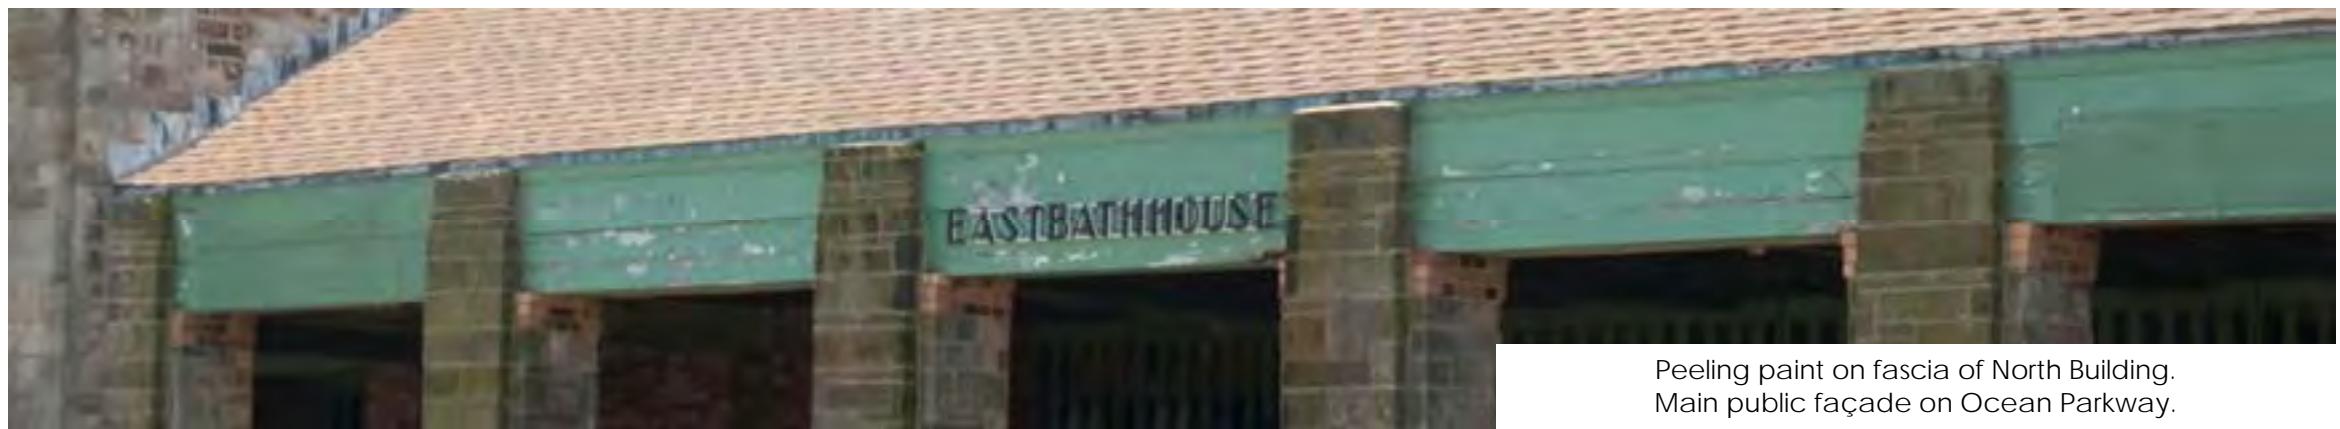
- The wood fascia boards and screening on the north building features extensive paint failure.

Peeling paint on fascia of North Building.
Main public façade on Ocean Parkway.

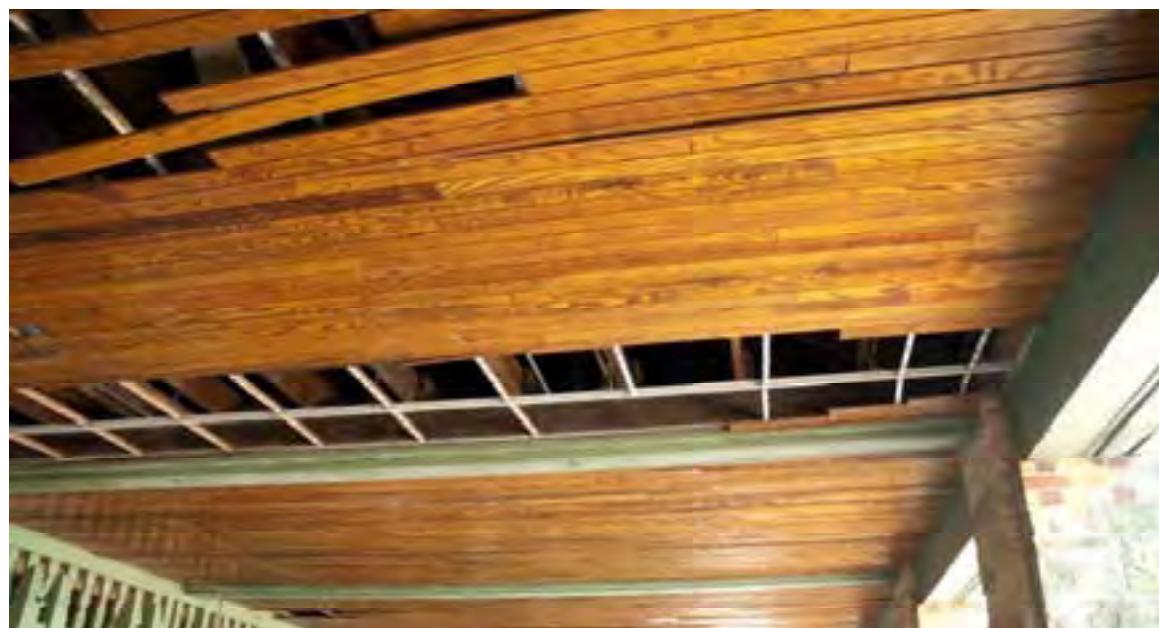
North building ceiling deterioration (2013)

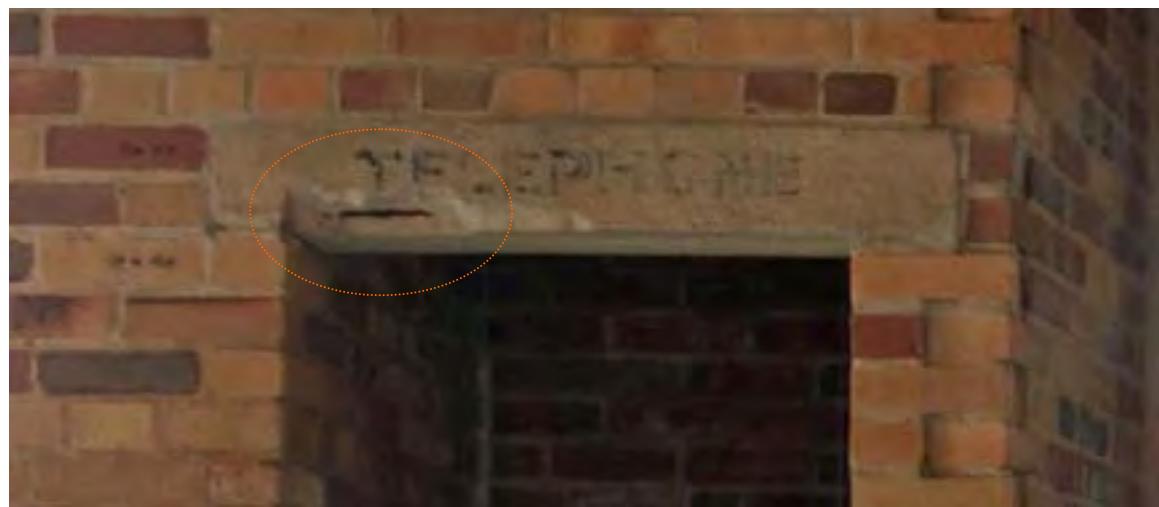
North building concrete deterioration (2013)

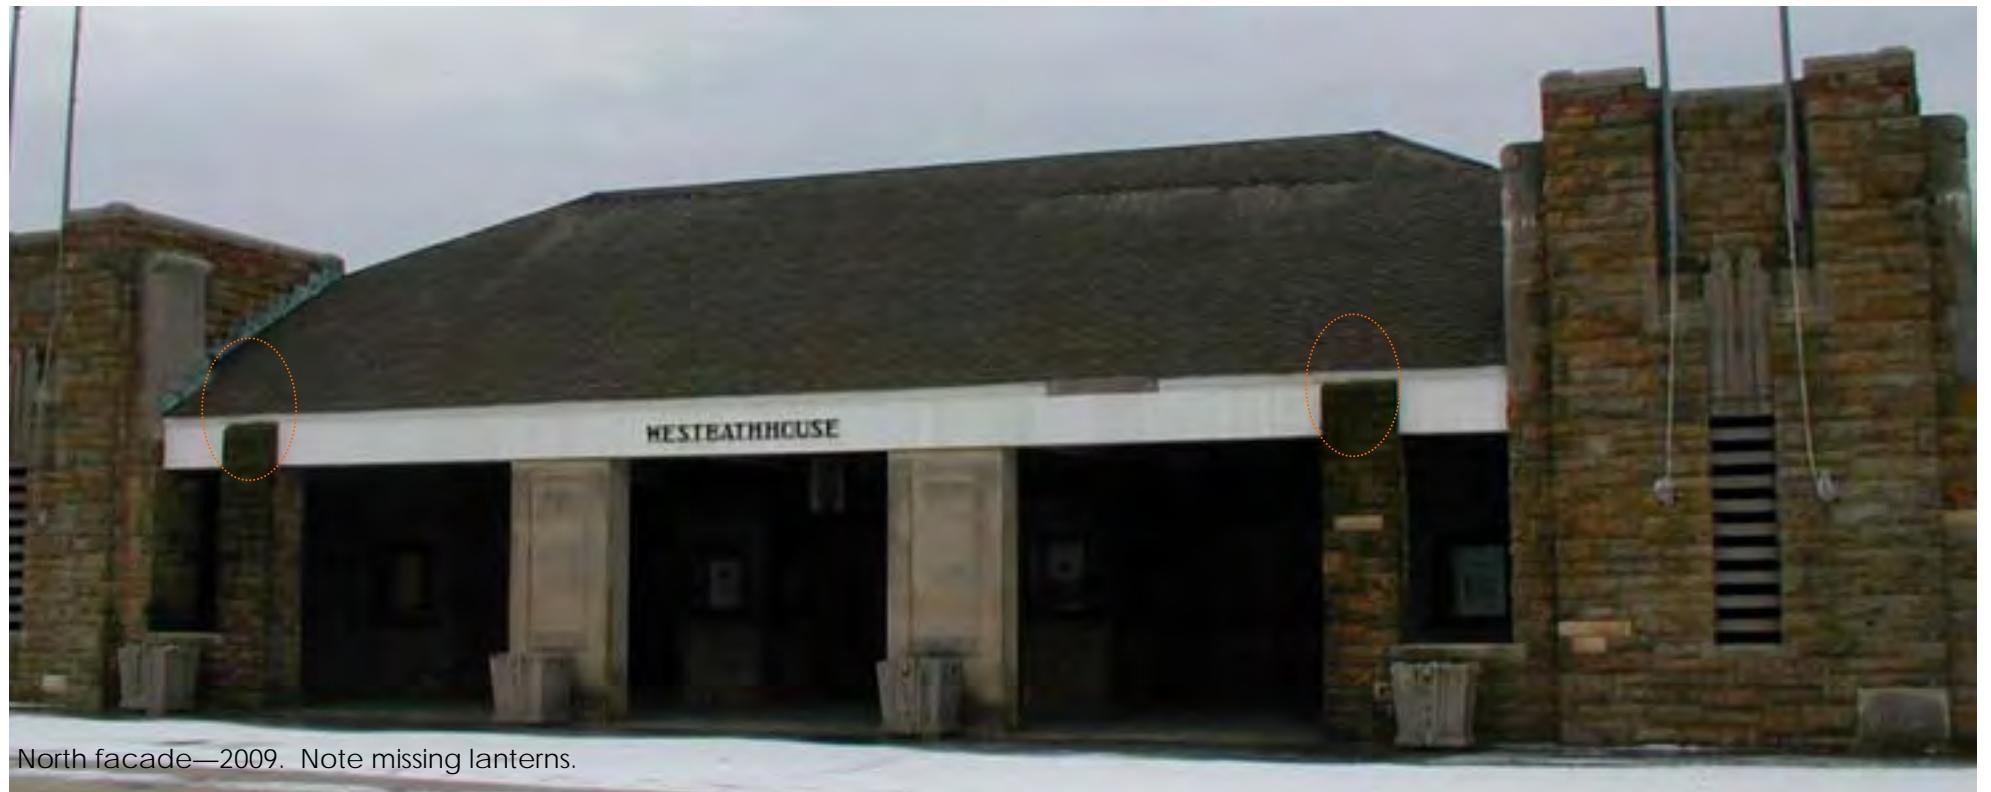
- Fortunately, the North building and north lobby are primarily intact. Alterations are primarily the result of deterioration or inappropriate repairs.
- The ceiling of the North lobby was painted, altering the appearance of the sand finished concrete and covering up the oak woodwork. The historic shallow Art Deco ceiling fixtures were also replaced with hanging fixtures with large shades. Some of the woodwork has also deteriorated resulting in losses.
- In the loggia, all but one of the historic Art Deco chandeliers have lost.
- On the main façade the wood fascia board was enclosed or replaced with an inappropriate vertical board fascia. The two cast stone lanterns have also been lost.

North facade—2009. Note missing lanterns.

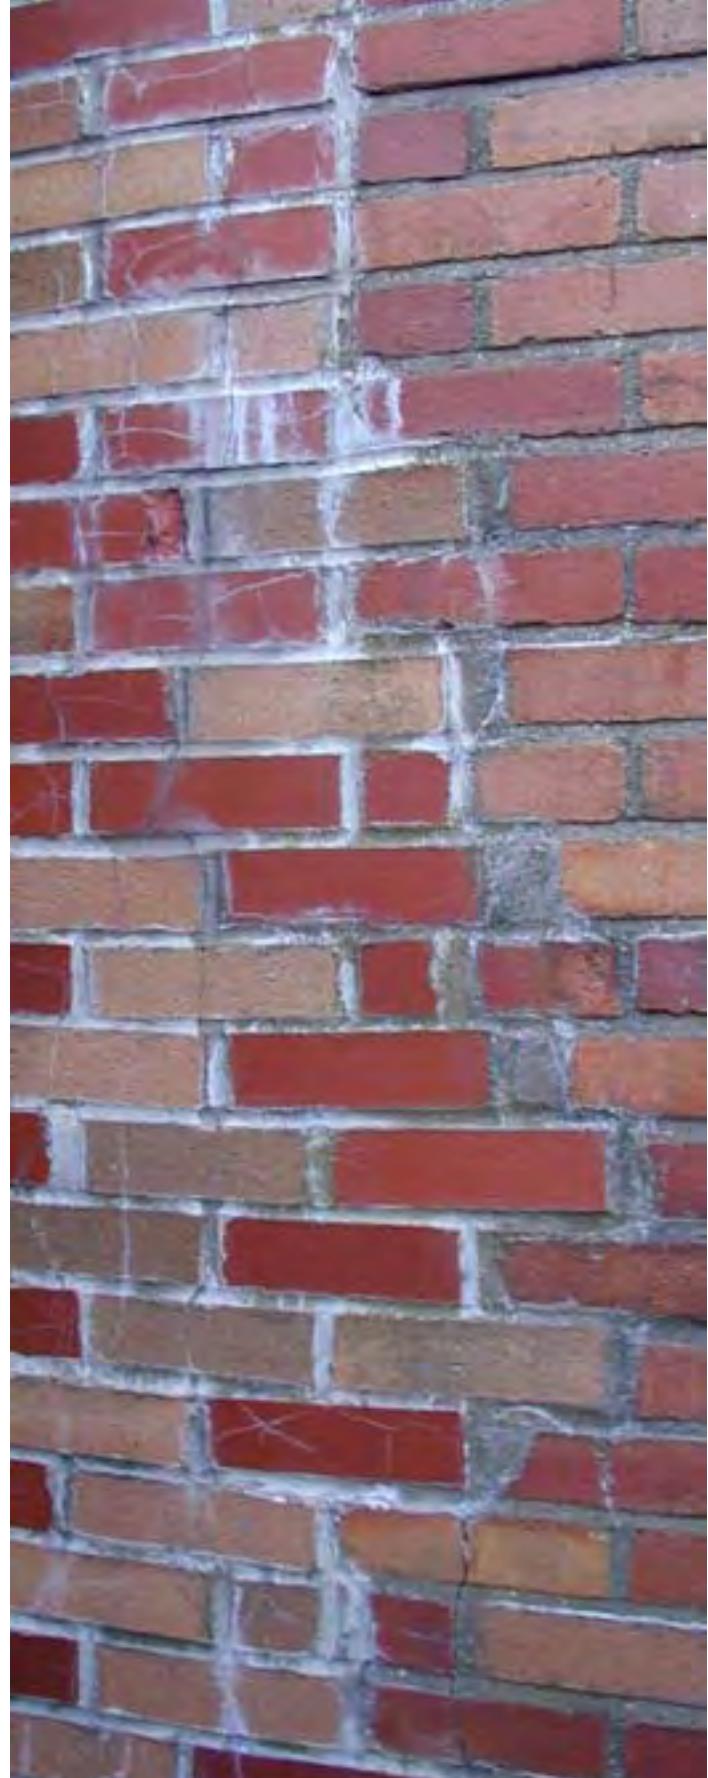
Brick deterioration (Perimeter Wall 2009)

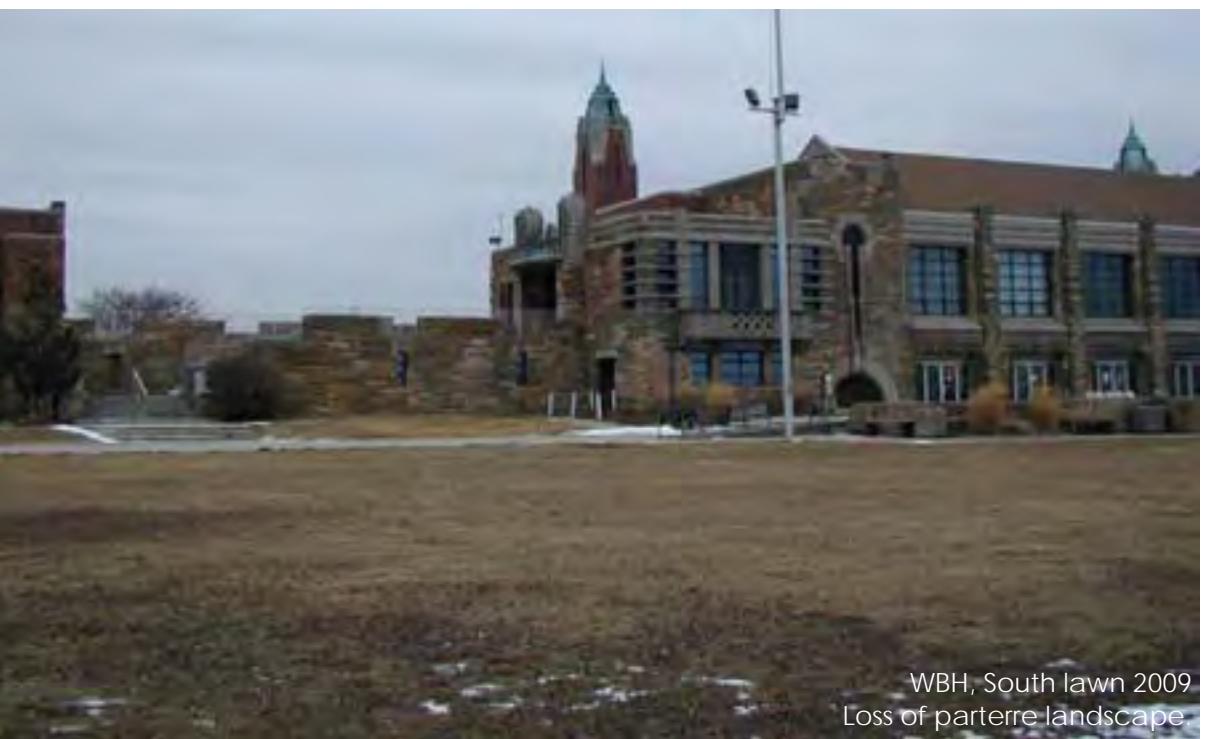
- The clean, geometric lines of the carefully trimmed hedges and shrubs around the building have been lost. Trees and shrubs are now set in mulched planting beds and shaped into rounded and irregular forms. The overgrown planting that are too close to the building also trap moisture on the masonry accelerating deterioration.
- The original Art Deco planters still exist but no longer appear to be used.
- The slightly wilder sections of the landscape were also effected by time and storm damage. Many of the larger shrubs have survived but the varieties of beach grass along the perimeter are threatened. The beach grass helps keep the sand and soil in place preventing erosion and blowing sand.

WBH, South lawn 2009
Loss of parterre landscape.

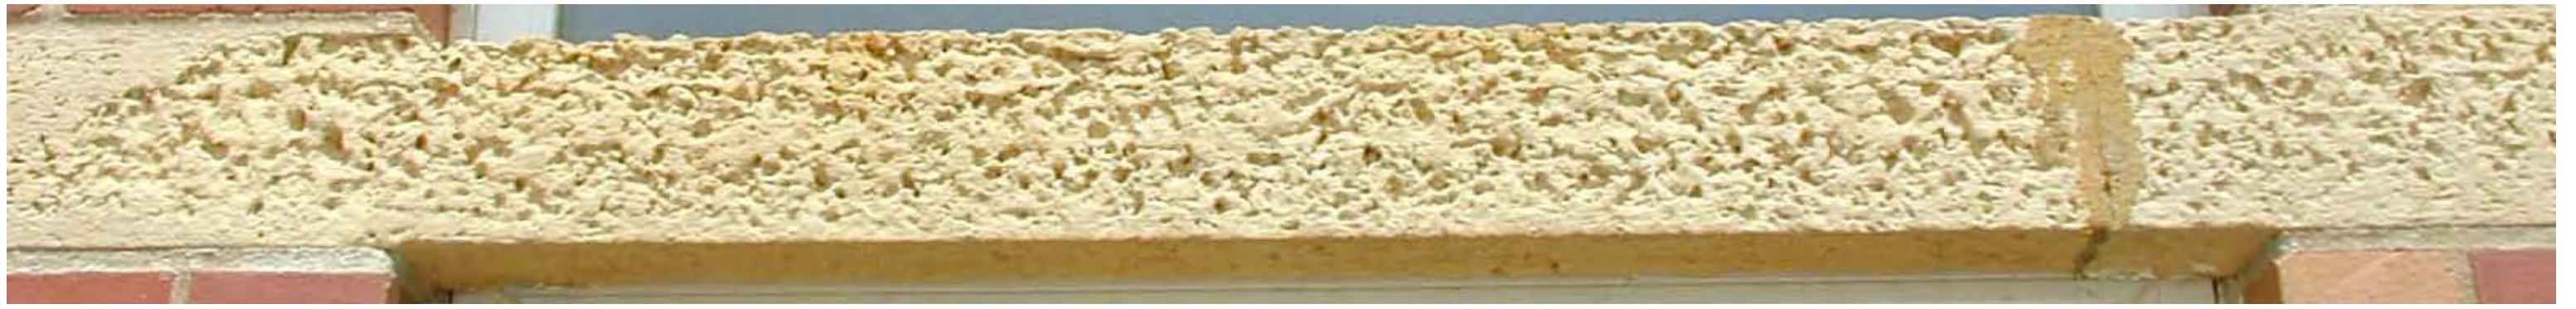
Detail of severe sandstone pitting (south elevation). The surface should be smooth. 2009

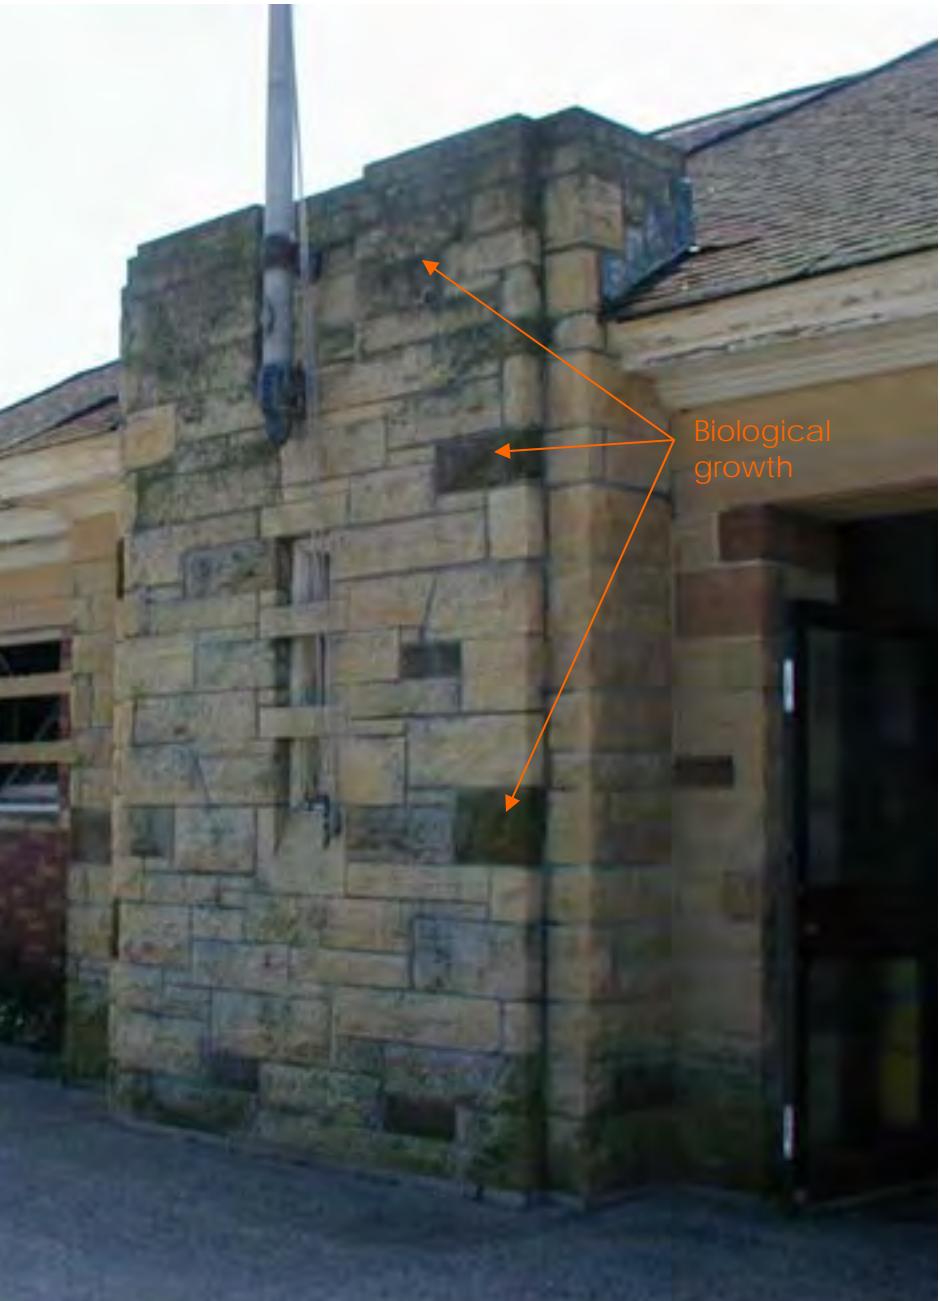
Biological growth—sandstone towers (north elevation). 2009

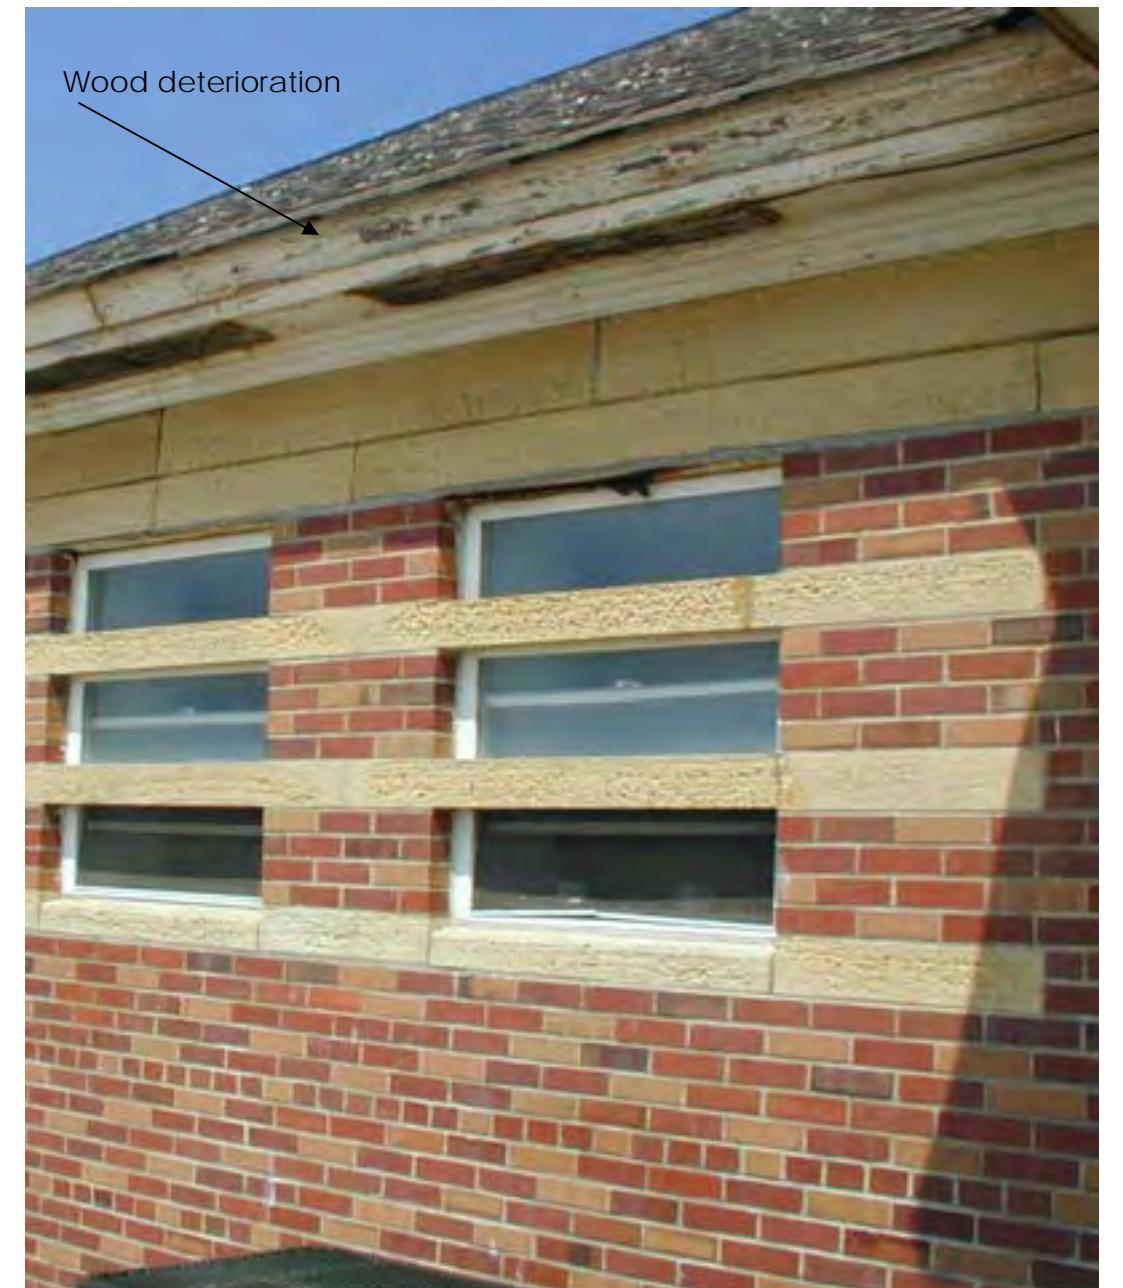
- Extreme weathering and poor maintenance has led to the deterioration of wood trim elements including the cornice and fascia.

Sandstone & Wood deterioration (south elevation). 2009
