Jones Beach State Park

Jones Beach State Park
Wantagh, New York
11793

Historic Structures &
Cultural Landscape
Report

Prepared By:
Erin Moroney
Building & Landscape
Conservation Unit

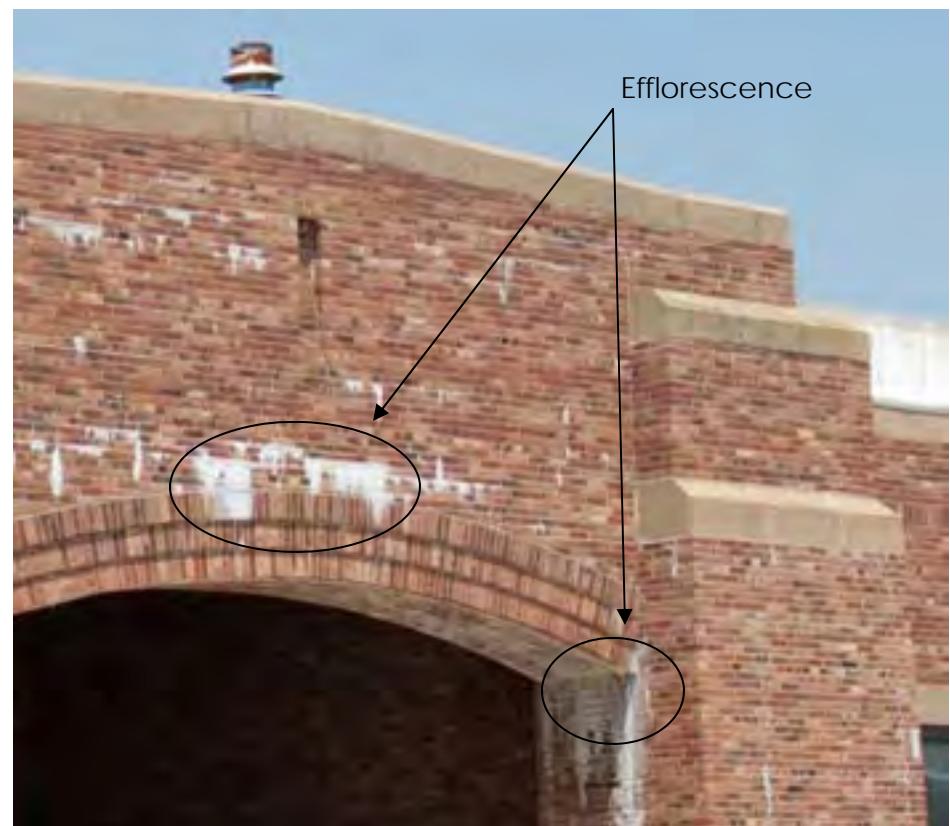
- Overall the Storehouse is in fair condition.
- The flashing is in poor condition. In many locations the flashing has curled up or become detached.
- The masonry is in fair condition with the exception of efflorescence resulting from water infiltration. Water infiltration appears to be a major problem at the parapet level.
- The roof was not surveyed as part of this project.
- Masonry staining is also a common problem resulting from ferrous attachments.

Central Section
Storehouse, 2013

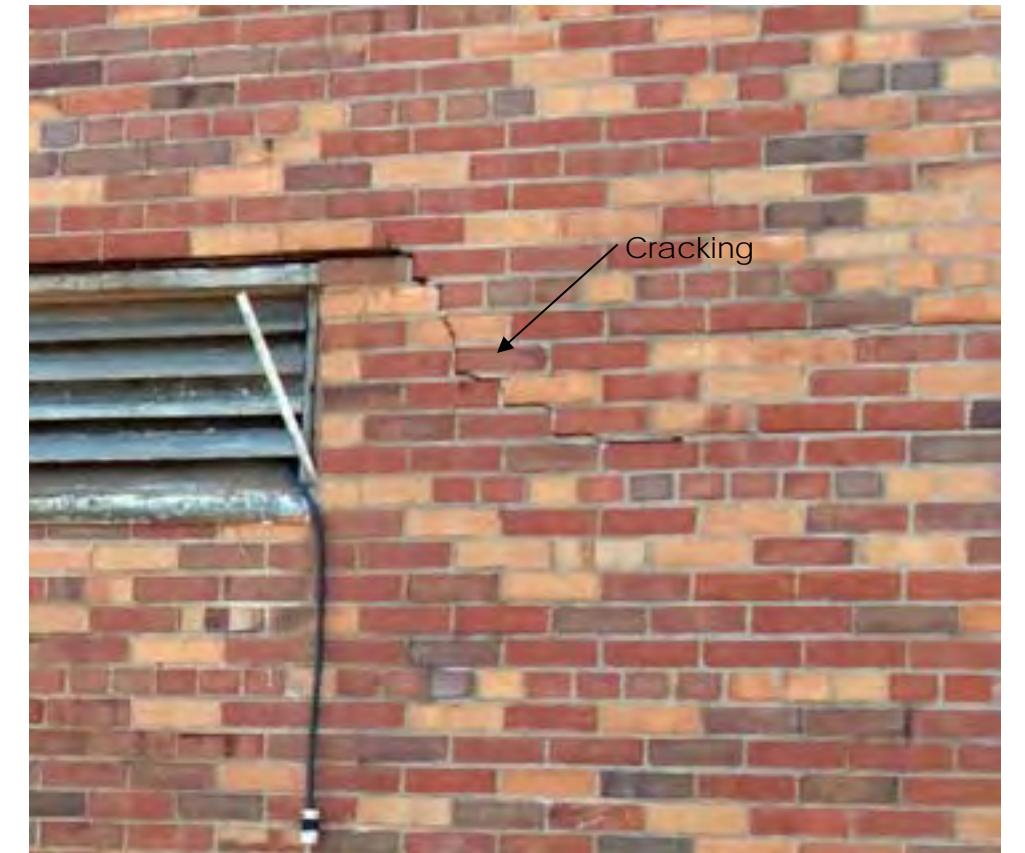
- Overall the Commissary is in poor condition.
- The masonry is in especially poor condition:
 - Cracks resulting from differential settlement are visible in many locations.
 - Spalling brick and cracked brick.

Detail of brick deterioration. 2013

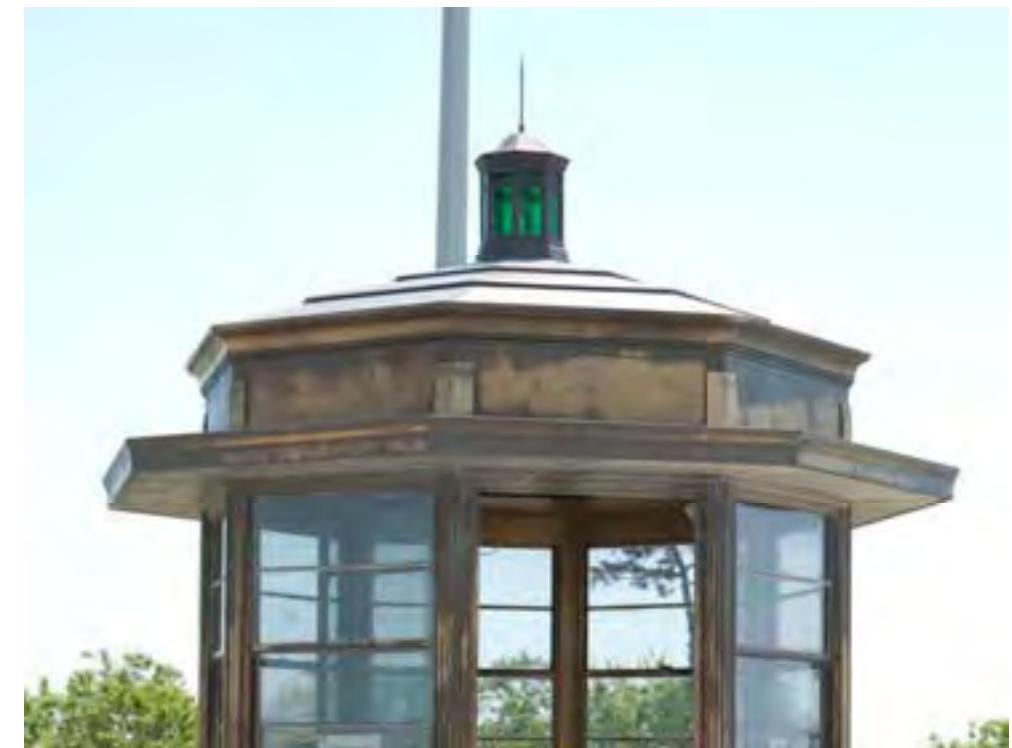
- The structure appears to be in fair condition.
- Corrosion is apparent on the bronze.

Watchman's Booth, 2013
