**A LANDSCAPE MANAGEMENT PLAN
for
"THE POINT"**

*A historic designed landscape associated with the Hoyt House,
a property located within Mills-Norrie State Park*

**NEW YORK STATE OFFICE OF PARKS, RECREATION AND
HISTORIC PRESERVATION -- TACONIC REGION**

**DOELL & DOELL
Garden Historians and Landscape Preservation Planners
Syracuse, New York**

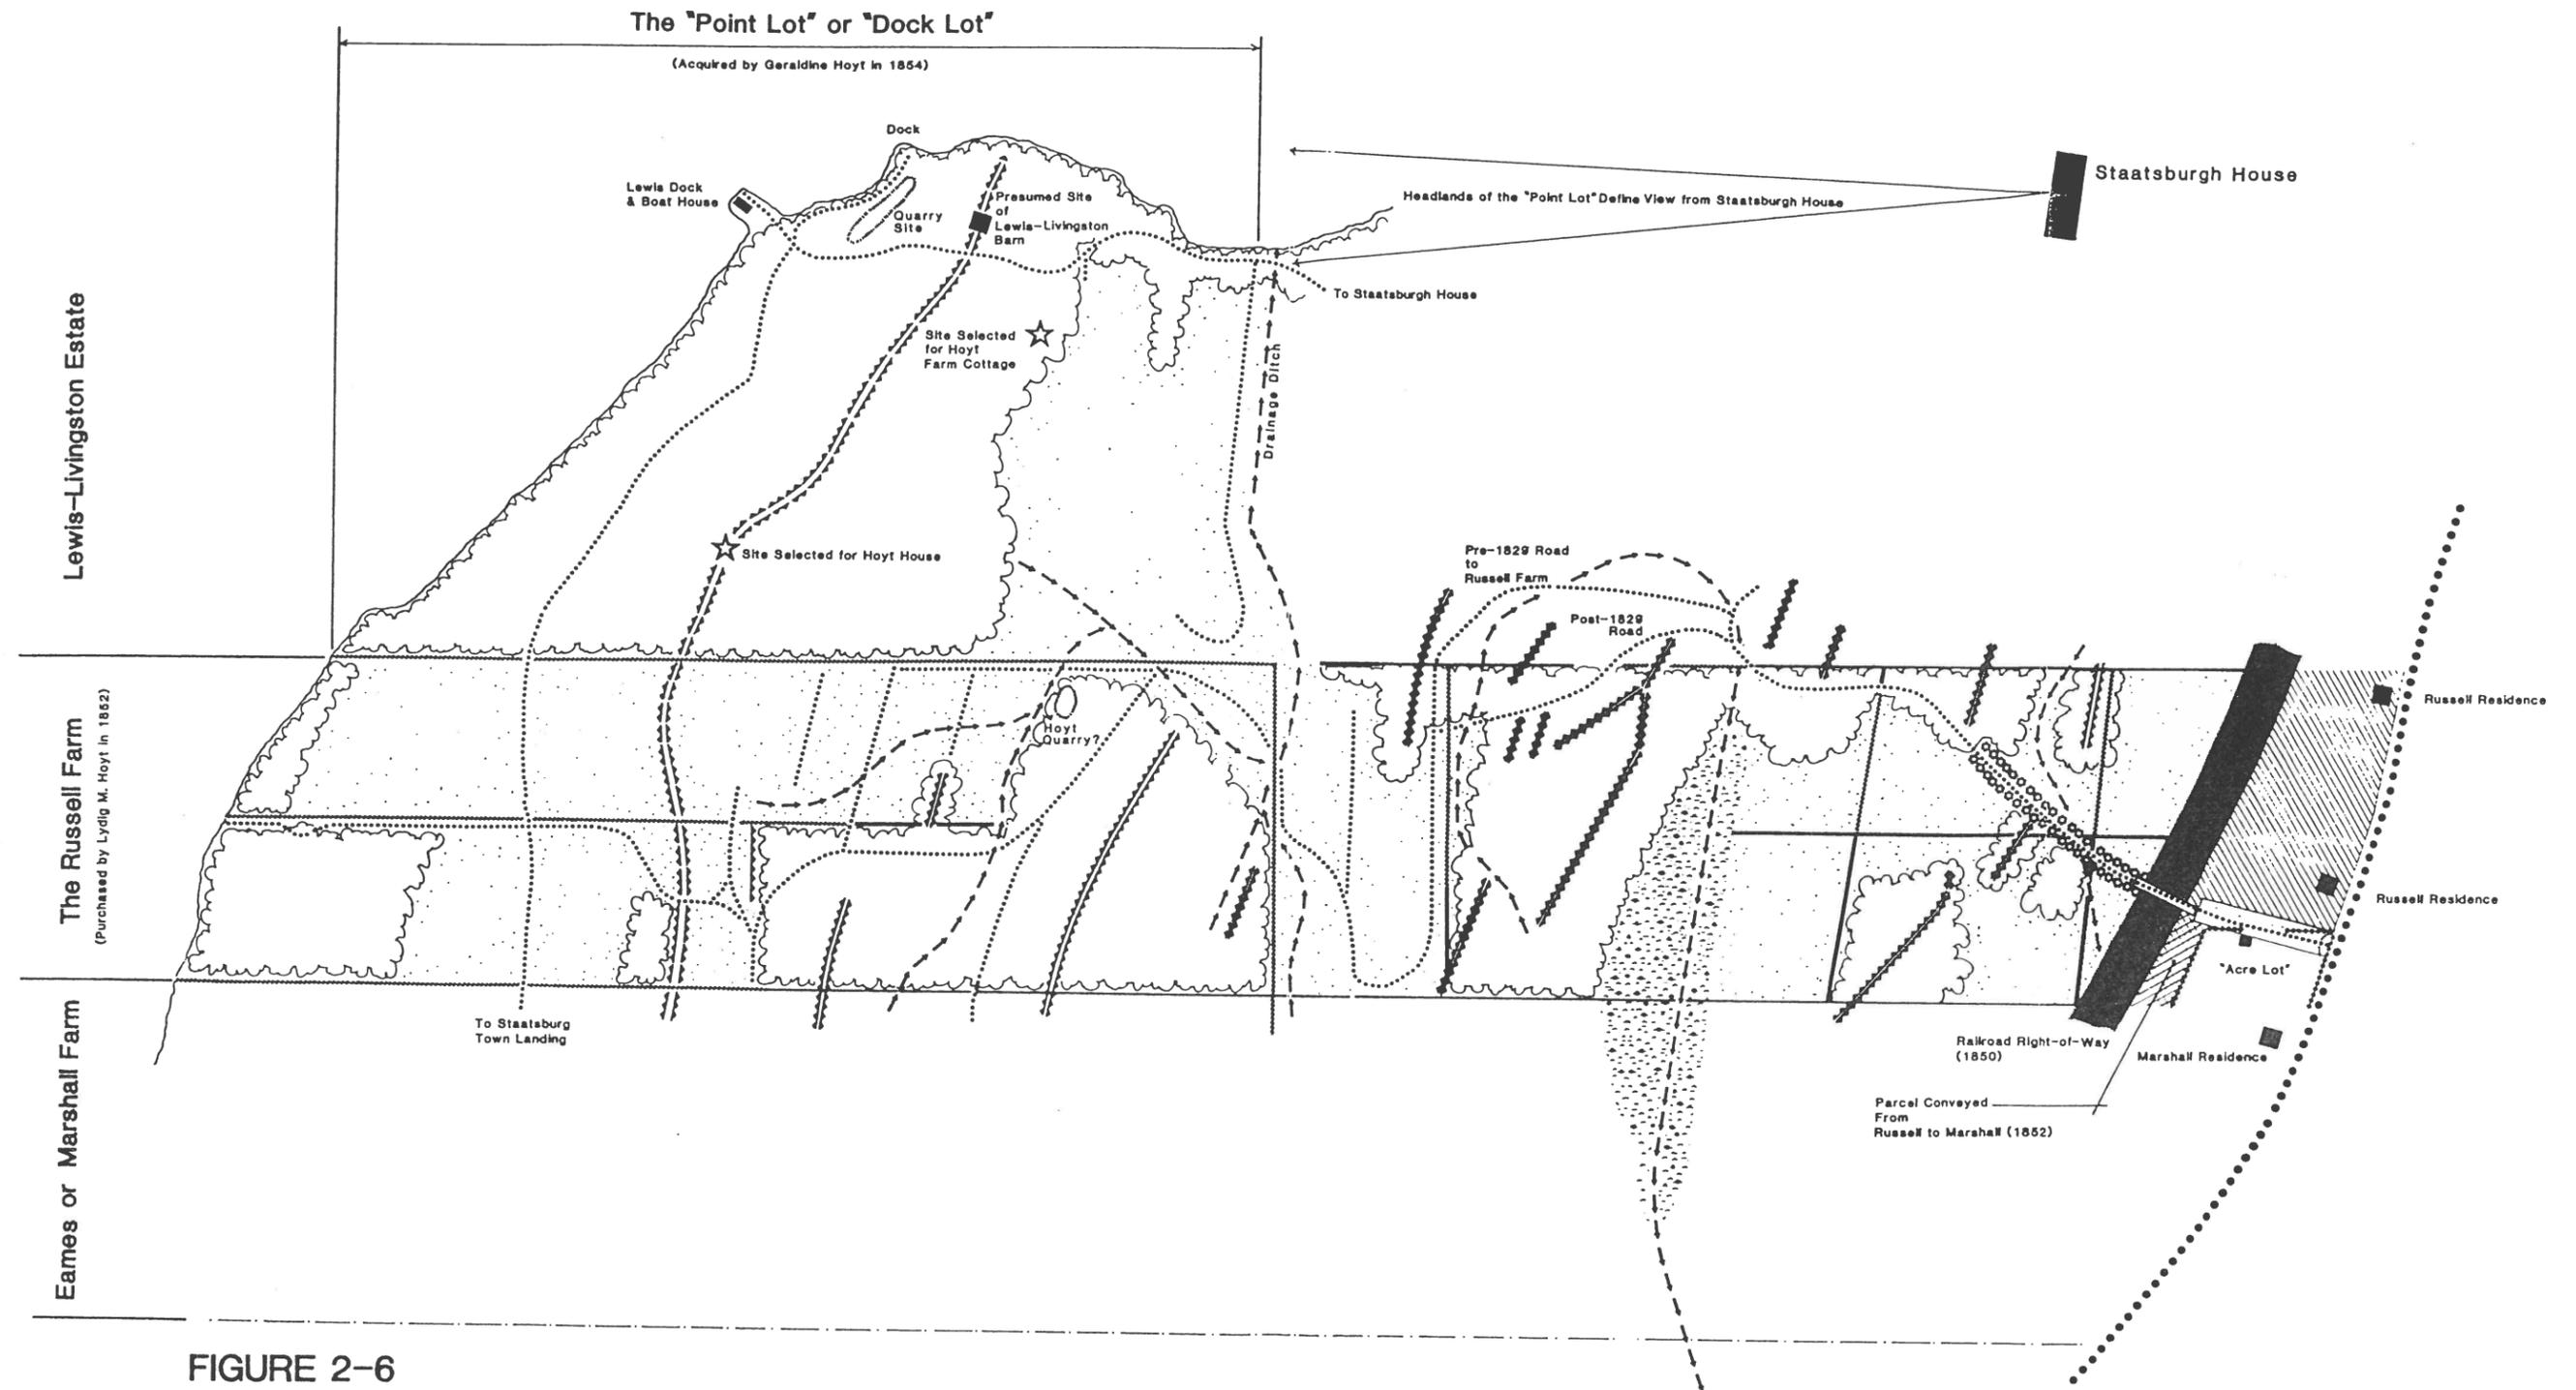
FIGURE 2-6
SITE ANALYSIS MAP

An Analysis of Pre-1852 Historic Landscape Patterns & the Natural Factors that May Have Influenced Site Development

In addition to the "missing" roads noted above, there is also subtle evidence of former farm/service lanes in other portions of the site. Please refer to Figure 2-6 (Site Analysis Map) and Figure 2-10 (Key Map of Circulation Features) for the location of these features.

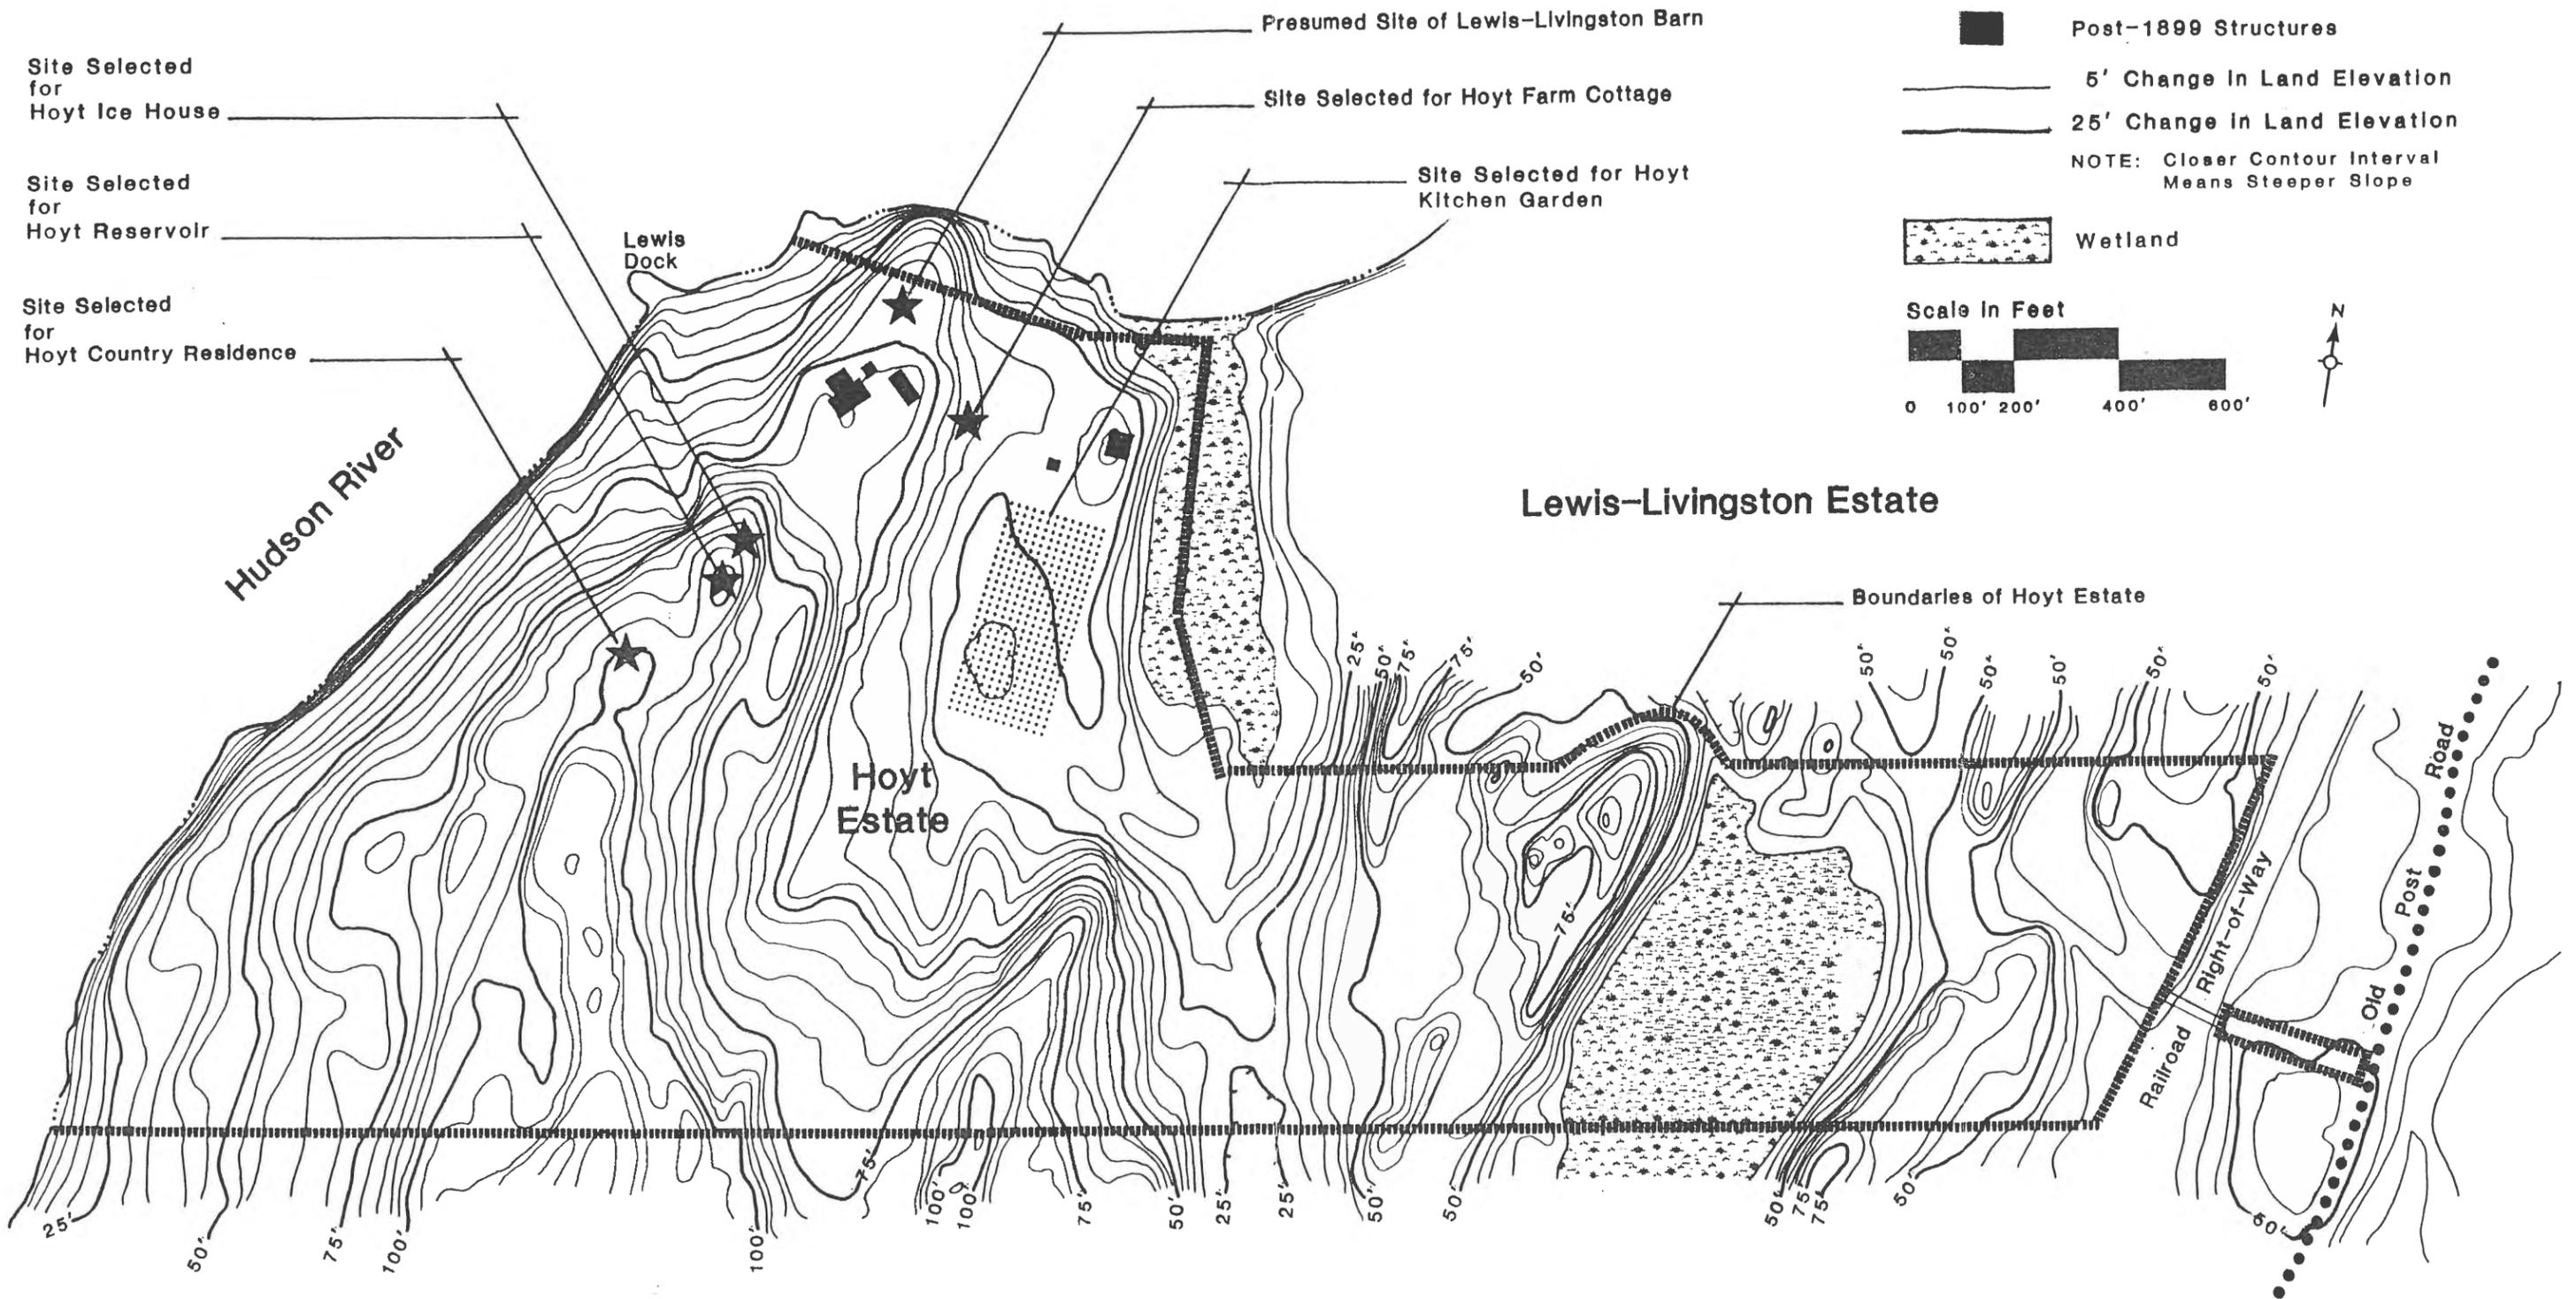
Figure 2-7 -- Land Form Analysis Map

Elevations along the approach drive generally stay within a range of 45 feet (from 20' to 65') as it negotiates the slopes and valleys between the railroad right-of-way and the third ridge; however, the drive rises more than 81 feet (from 20' to 101') as it ascends the eastern slope of the river ridge approaching the Hoyt House.

There are also a number of minor anomalous landforms (linear mounds, depressions, unnatural embankments, etc.) on the 91-acre site that seem to reveal evidence of significant historic landscape patterns. Many of these cultural features are noted in Figure 2-6; however, the nature and extent of these anomalies, and their possible association with other features, are discussed in subsequent portions of this chapter, particularly vegetation and structures.

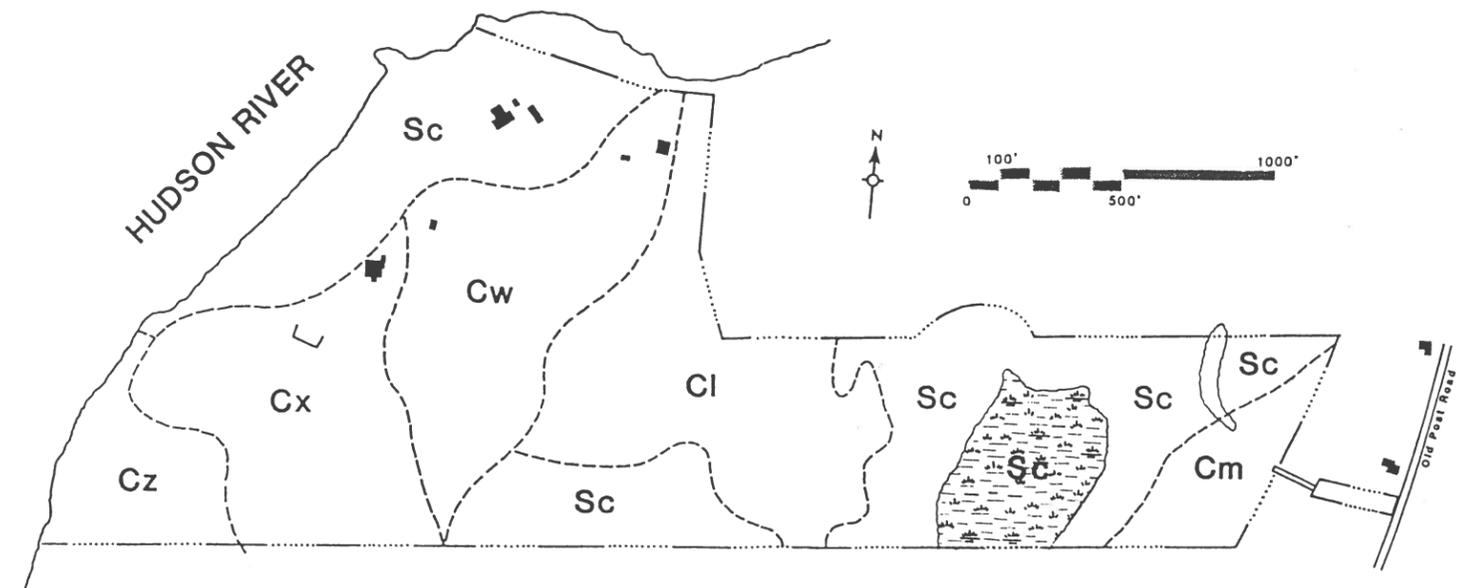
Figure 2-8: Soils Key Map and Chart.

Well-Drained, Nearly Level to Sloping & Deep over Bedrock		
<i>DERIVED FROM MEDIUM TO HIGH-LIME GLACIAL TILL</i>		
Cx Cossayuna gravelly loam, undulating & rolling phases (3-15% slopes)	A moderately well-drained soil with a depth to bedrock ranging from 2 to 10 feet with frequent outcrops; prone to erosion if cultivated over a long period of time.	The soil has minimal management requirements for pasture or cropland, and is readily reclaimable for good cropland. Oak, maple, hickory, dogwood and tulip-tree are the predominant native forest vegetation. Some ash, basswood, hemlock and beech are also present.
Cz Cossayuna stony silt loam, rolling phases (5-15% slopes)	A moderately deep well-drained soil that is irregular in relief and too strong for cultivation.	This soil type can support a pasture of fair quality with intense initial tillage and good management, but it is best suited to forest. Oak, maple, hickory, dogwood and tulip-tree are the predominant native forest vegetation. Some ash, basswood, hemlock and beech are also present.

<i>DERIVED FROM GLACIAL OUTWASH AND SANDY LACUSTRINE MATERIAL</i>		
Cl Colonie fine sandy loam, nearly level phase (0-3% slopes) and Cm Colonie fine sandy loam, rolling phase (5-15% slopes)	These soils are well-drained, light-textured, and relatively free of stones with a depth of bedrock ranging from 5 to 7 feet.	Colonie soils are moderately productive as cropland and pasture land, and are highly responsive to good management practices. Hemlock, hard and soft maples, white, red, black and chestnut oaks, hickory, black birch, beech and flowering dogwood are the predominant native trees in forested areas.
Well-Drained, Hilly, Moderately Steep & Deep Over Bedrock		
<i>DERIVED FROM GLACIAL TILL & OUTWASH</i>		
Cw Cossayuna gravelly loam, hilly phase (15-30% slopes)	A moderately well-drained soil that is susceptible to erosion if rapid surface runoff is not controlled on steeper slopes. Areas that are cultivated over a long period of time typically show signs of moderate erosion; however, it is readily reclaimable for good cropland.	A durable soil with minimal management requirements for pasture or crop land. Oak, maple, hickory, dogwood and tulip-tree are the predominant native forest vegetation. Some ash, basswood, hemlock and beech are also present.

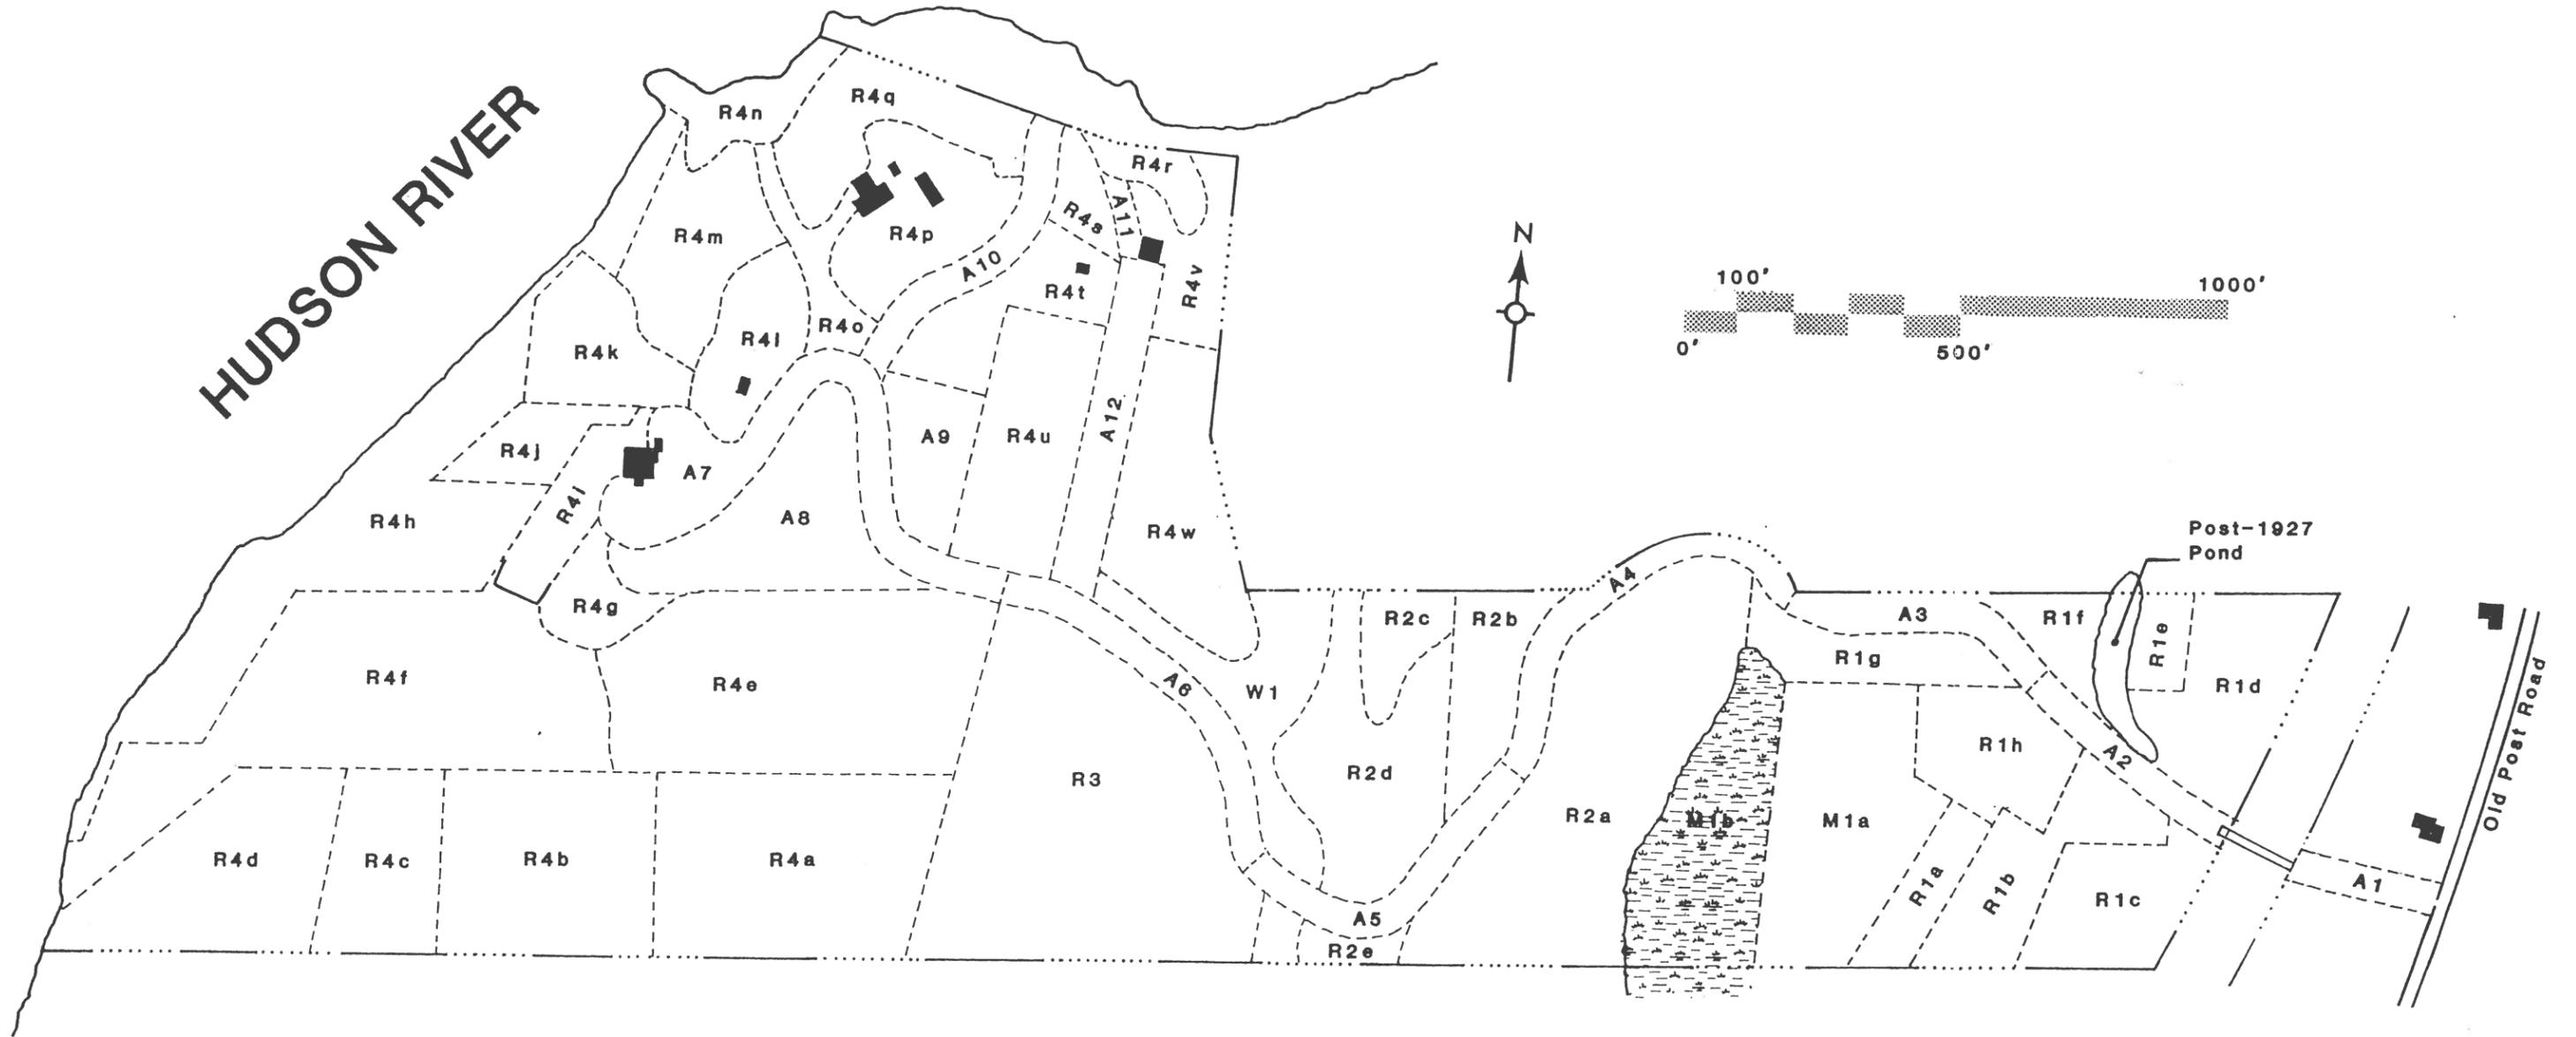
Figure 2-9: Key Map of Vegetation Zones.

These twelve zones document the existing condition of the property's avenue trees -- primarily regularly-spaced Sugar maples and native oaks -- that line the margins of the approach road and principal farm lanes. They begin at the bluestone entrance piers near the Old Post Road, and generally proceed from east-to-west across the site.
- ❑ The First Ridge [R1a - R1h]

Eight zones document the existing condition of vegetation on the slopes of a north-south ridge located between the railroad right-of-way and the upland marsh. This is the first of four such ridges on the 91-acre property.
- ❑ The Upland Marsh [M1a - M1b]

This T-shaped zone documents the condition of existing trees, shrubs and vines within a low-lying area that drains portions of the second, third and fourth ridges.
- ❑ The Third Ridge [R3]

Twenty-three zones surrounding the Hoyt House document the patterns and conditions of existing vegetation on the slopes of this massive ridge bordering the Hudson River.

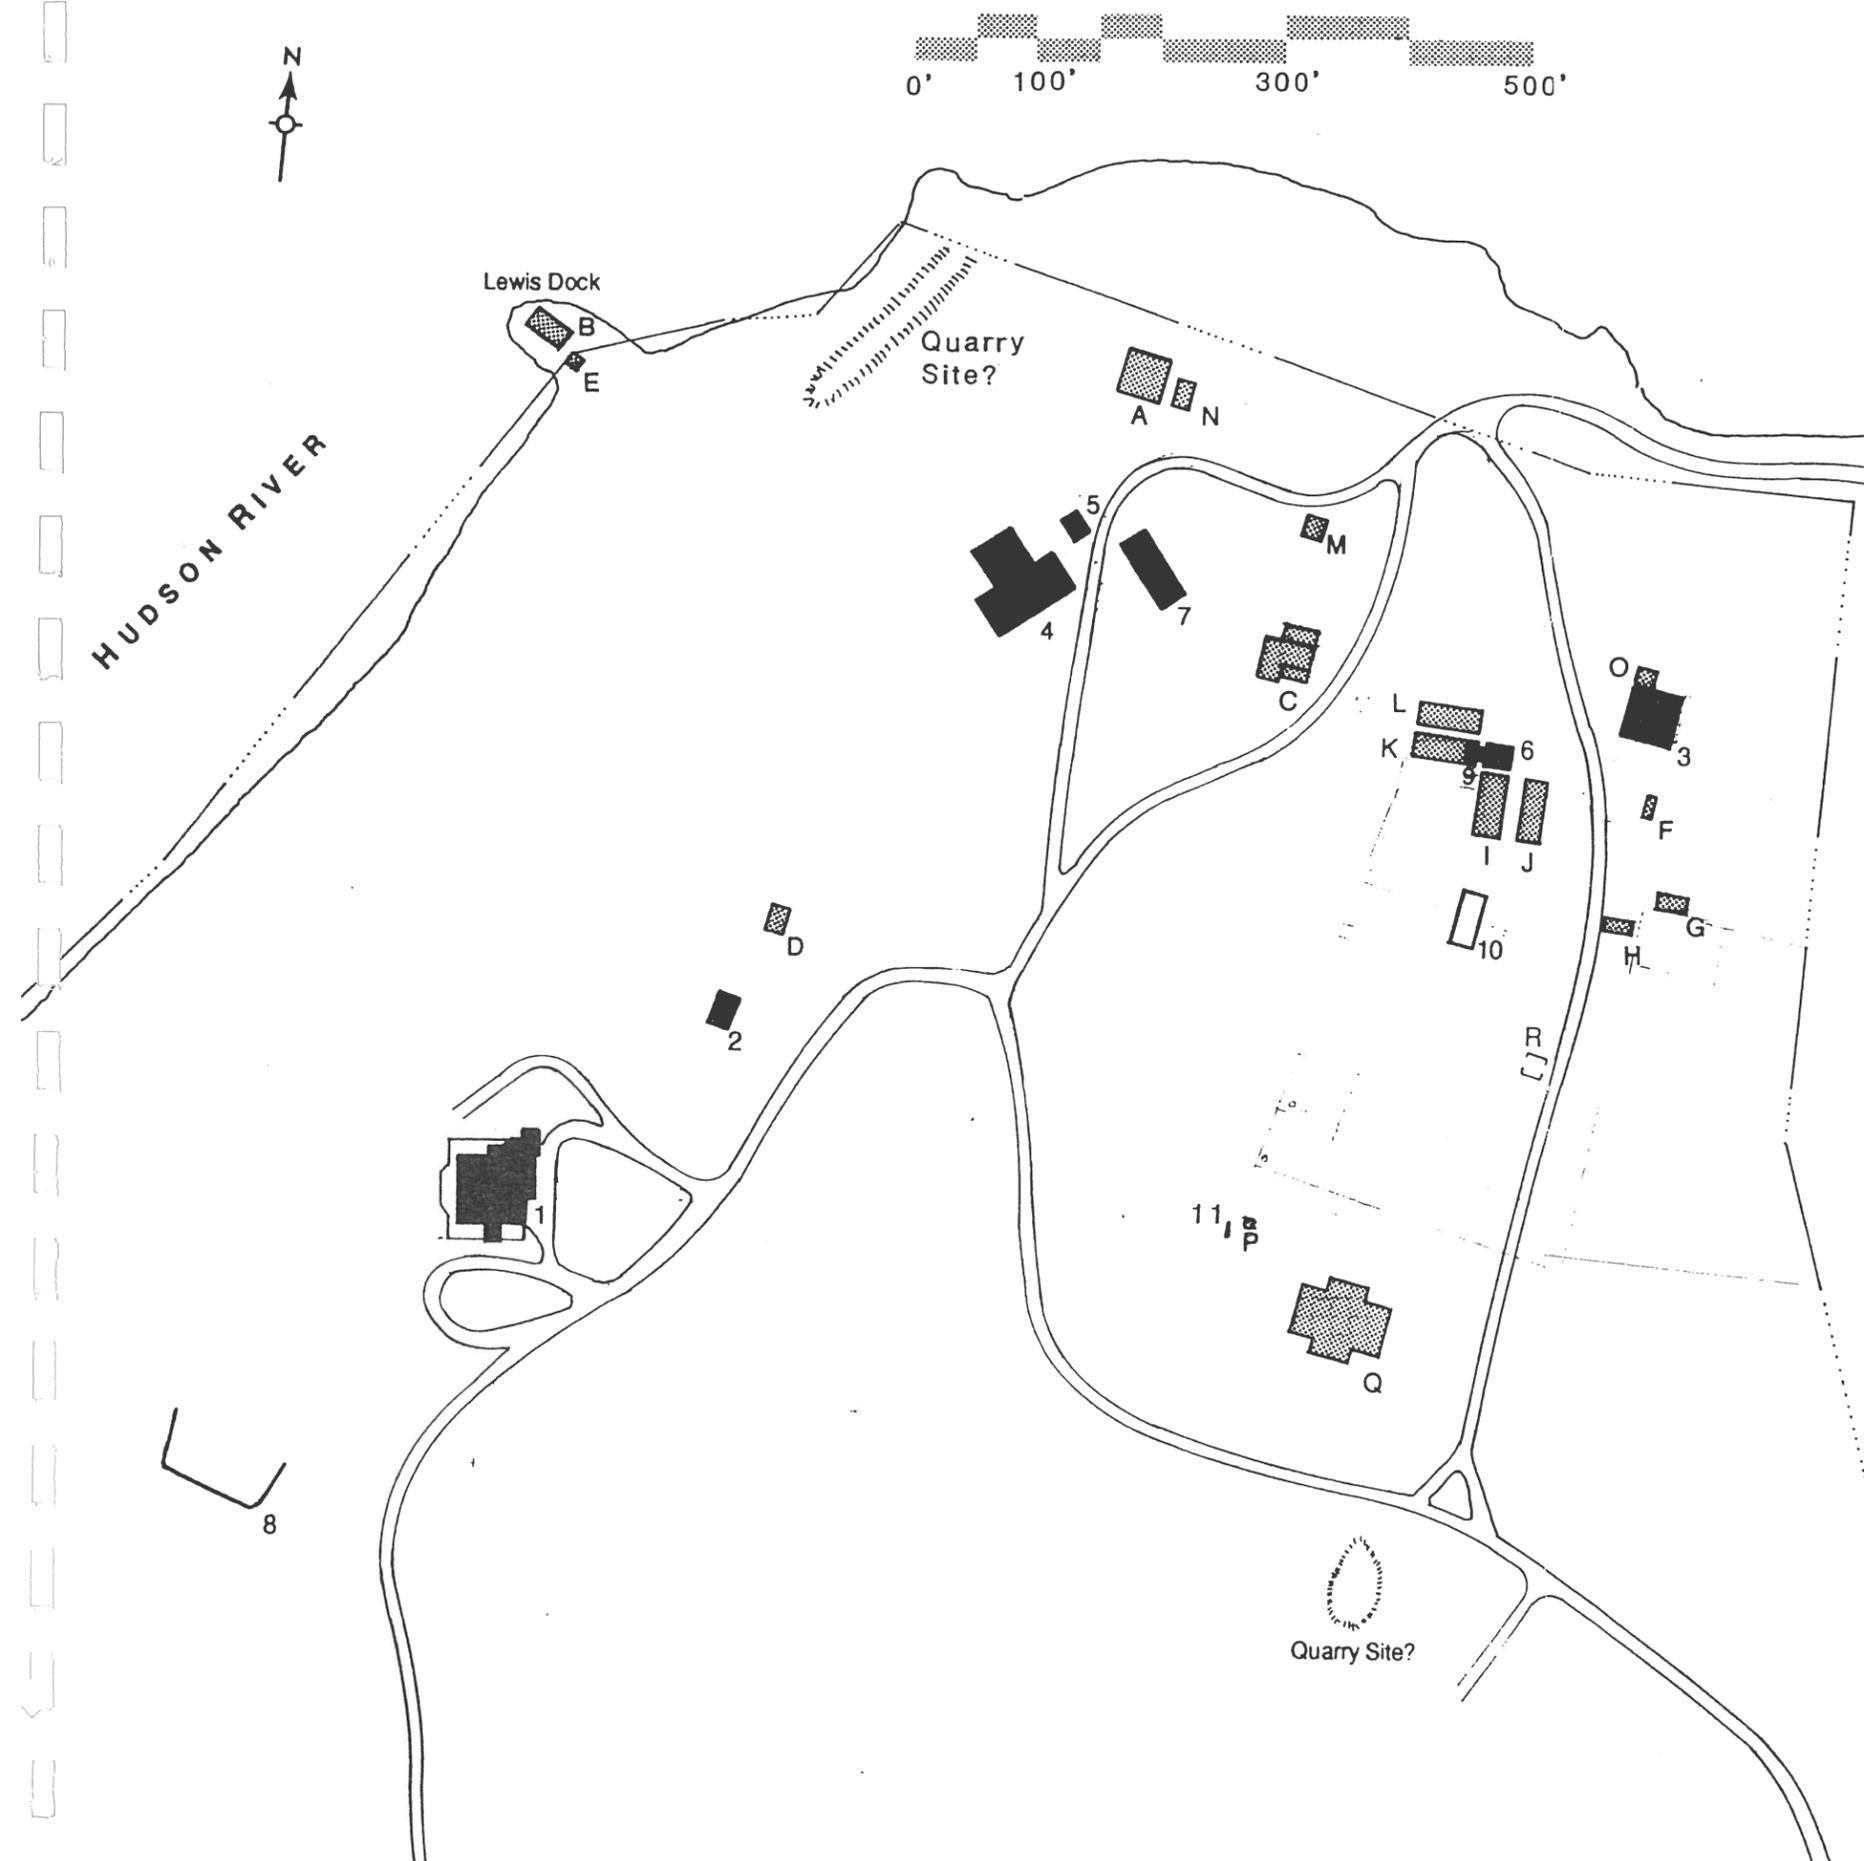
FIGURE 2-11
KEY TO HISTORIC BUILDINGS & LANDSCAPE STRUCTURES

Key	Building	Origin	Remarks/Documentation
1	Country House	1855	Designed by architect Calvert Vaux; first floor remodeled in 1905 according to plans of architect Robert P. Huntington.
2	Reservoir	1855?	Stone building used to store water for Hoyt residence; visible in 1935 aerial photo
3	Cow Barn	1899	Replacement for a large barn destroyed by fire in 1899.
4	Coach House & Stable	1899	Built shortly after 1899 fire; expanded in 1903.
5	Garage or "Auto House"	1903	One-car garage, also known as the "Mechanics Garage."
6	Potting Shed-Heating Plant	1905	Probably built in conjunction with the two greenhouses erected in 1905. Remodeled as a bath house circa 1959.
7	5-Bay Garage	1911	Two-story brick garage with hipped roof.
8	Brick Garden Wall	pre-1956	This wall served as a backdrop for a flower garden built on the site of a former tennis court between 1935 and 1956.
9	Greenhouse	c. 1959	9' x 9' lean-to addition on potting shed-bath house.

10	Swimming Pool	c. 1959	Built on the site of the estate's former kitchen garden.
11	Cistern/Spring Outlet?	?	Mortared stone wall at foot of slope; water source unknown.
12	Stone Gateway Piers	1855?	Located at entrance along Post Road. [Not shown on plan.]
13	Railroad Bridge	1910s?	Cantilever steel bridge over railroad tracks; probably 20th century replacement for original wooden span built circa 1851. [Not shown on plan.]

G	Farm Shed #2	1899?	mid-1960s	15' x 25' stone foundation; probably a livestock shed built in conjunction with 1899 barn.
H	Farm Shed #3	1899?	mid-1960s	12' x 12' stone foundation; probably a livestock shed built in conjunction with 1899 barn.
I	Greenhouse #1	1905	pre-1956	Site of first greenhouse on Hoyt estate [1 of 2].
J	Greenhouse #2	1905	pre-1956	Site of first greenhouse on Hoyt estate [2 of 2]
K	Greenhouse #3	1910	pre-1956	20' x 50' brick foundation; site of greenhouse added in 1910.
L	Mushroom House?	1910?	pre-1956	Possible site of structure noted in oral accounts?
M	Cottage Outbuilding?	?	pre-1956	14' x 14' stone foundation; roof & dormer are visible in post-1911 photo of 5-bay garage [HP-8].
N	Wood Shed	pre-1935	mid-1960s	visible in 1935 & 1956 aerial photos and documented on 1963 utilities plan; possibly built on or near site of original Hoyt barn.
O	Barn Shed	post-1899	mid-1960s	15' x 16' shed with dirt floor; 1963 utilities plan.

P	Reservoir	pre-1935	mid-1960s?	Near cistern; visible in 1935 & 1956 aerial photos and documented on 1963 utilities plan.
Q	Building Site?	?	post-1935	Possible site of a 40' x 75' building which appears to be visible in the 1935 aerial photograph.
R	Rustic Arbor	c. 1900	post-1935	Garden structure visible in historic photographs from 1916 [HP-11] and 1935 [HP-1].
