National Register of Historic Places Registration Form

DRAFT Charles D. & Elizabeth Lantry House Name of Property

Charles D. & Elizabeth Lantry House, ca. 1894

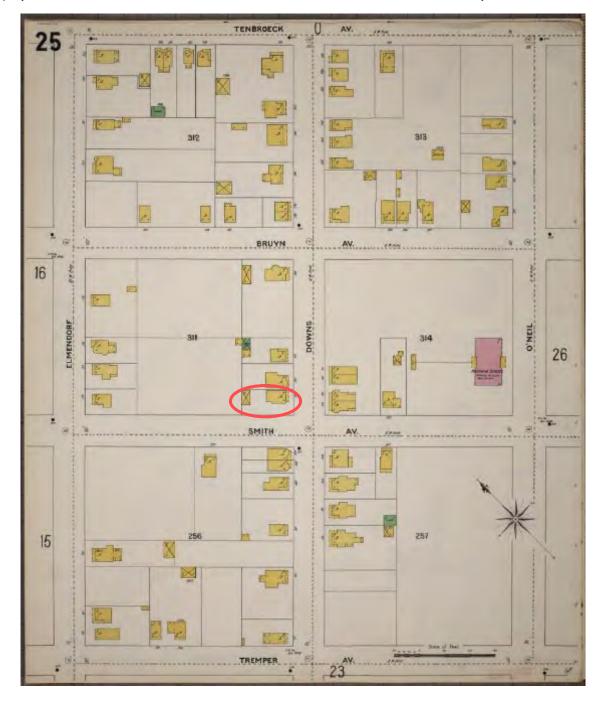
Figure 1: Sanborn Fire Insurance Map of Kingston, NY from 1899. The Lantry House and carriage house is circled in red. From: *Sanborn Fire Insurance Map from Kingston, Ulster County, New York.* Sanborn Map Company.

An 1887 Sanborn Fire Insurance Map does not document any area north of Tremper Avenue, indicating that little development was occurring in this area at the time. According to an 1899 Sanborn map, the area experienced further growth and development by the presence of additional commercial and residential buildings. Unlike the homes developed on Albany Avenue, which tended to be larger and of a higher architectural style, the streets to the southeast—including Downs Street and Smith Street, at the intersection where the Lantry House is located—were developed for middle-class workers and professionals and were often less decorative in style.

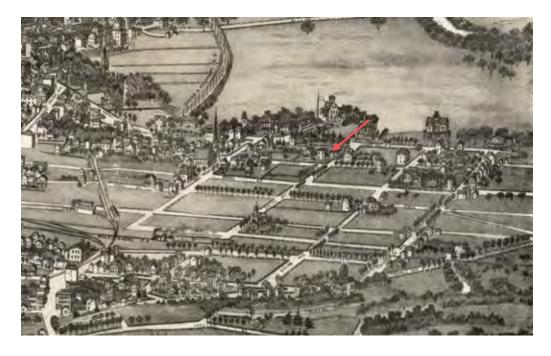
Figure 3: Section of a panoramic map showing undeveloped blocks east of Kingston's Broadway. The site of the future Lantry House is indicated by a red arrow. From: *City of Kingston, N.Y.* Published by L.R. Burleigh, Thomas Hunter, and Burleigh Litho, ca. 1875.

The area where the Lantry House is located originally supported farming operations well into the 1880s. According to a ca. 1875 panoramic map of Kingston by L.R. Burleigh, the lot on which the house was built was within a four-block, largely undeveloped area with minimal construction (Figure 3). Streets were laid out and named, indicating that the city was shortly preparing for its development. The surrounding blocks were more developed with a mix of residential, commercial, and institutional (mainly church) construction.

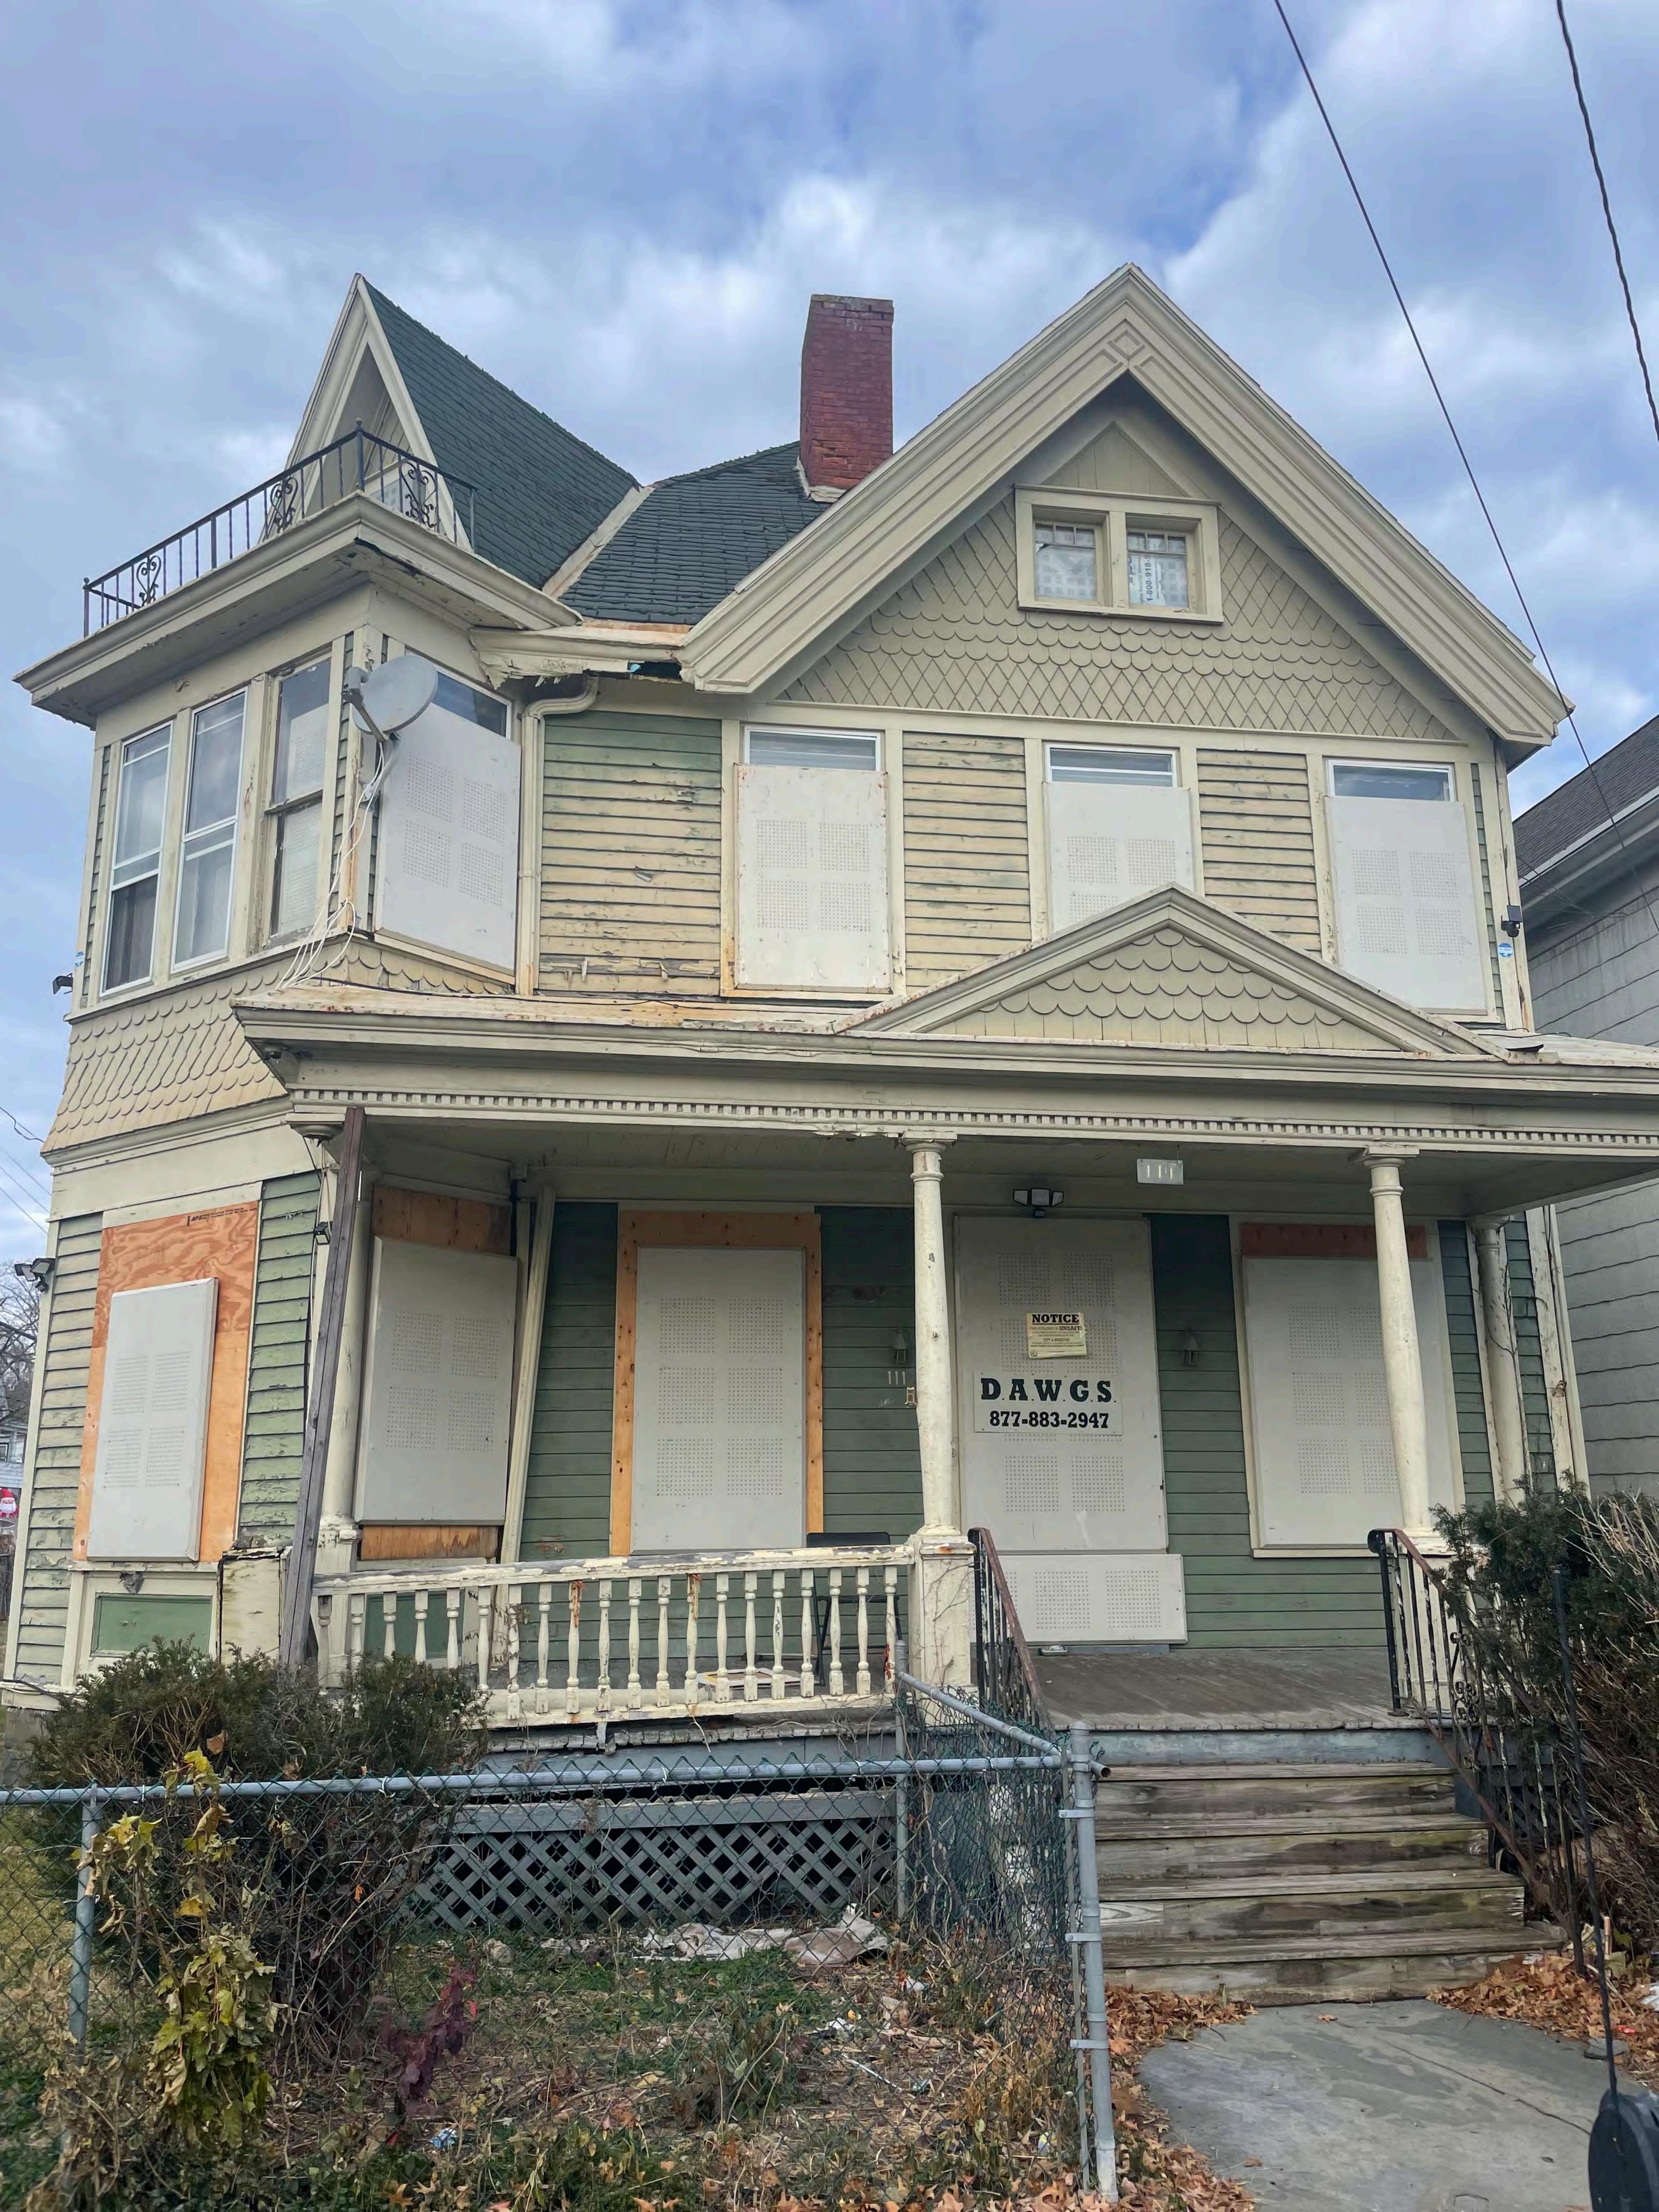
0001 of 0007: Façade (southeast elevation) of the Charles D. & Elizabeth Lantry House, view looking east.

The façade (southeast elevation) is three bays wide with an offset gable and a full-width, shed-roofed porch with sunburst designs in the roof ends. The porch has a central pediment and a denticulated cornice and is supported by slender classical columns atop a balustrade with turned spindles. The far south column is missing, and a two-by-four is in its place. The four-paneled front door is original and has an upper window. The gable has decorative bargeboards with a raised geometric pattern and contains a pair of small fixed-sash windows which each consist of a single pane of glass topped with a row of three small colored panes (Photo 1).

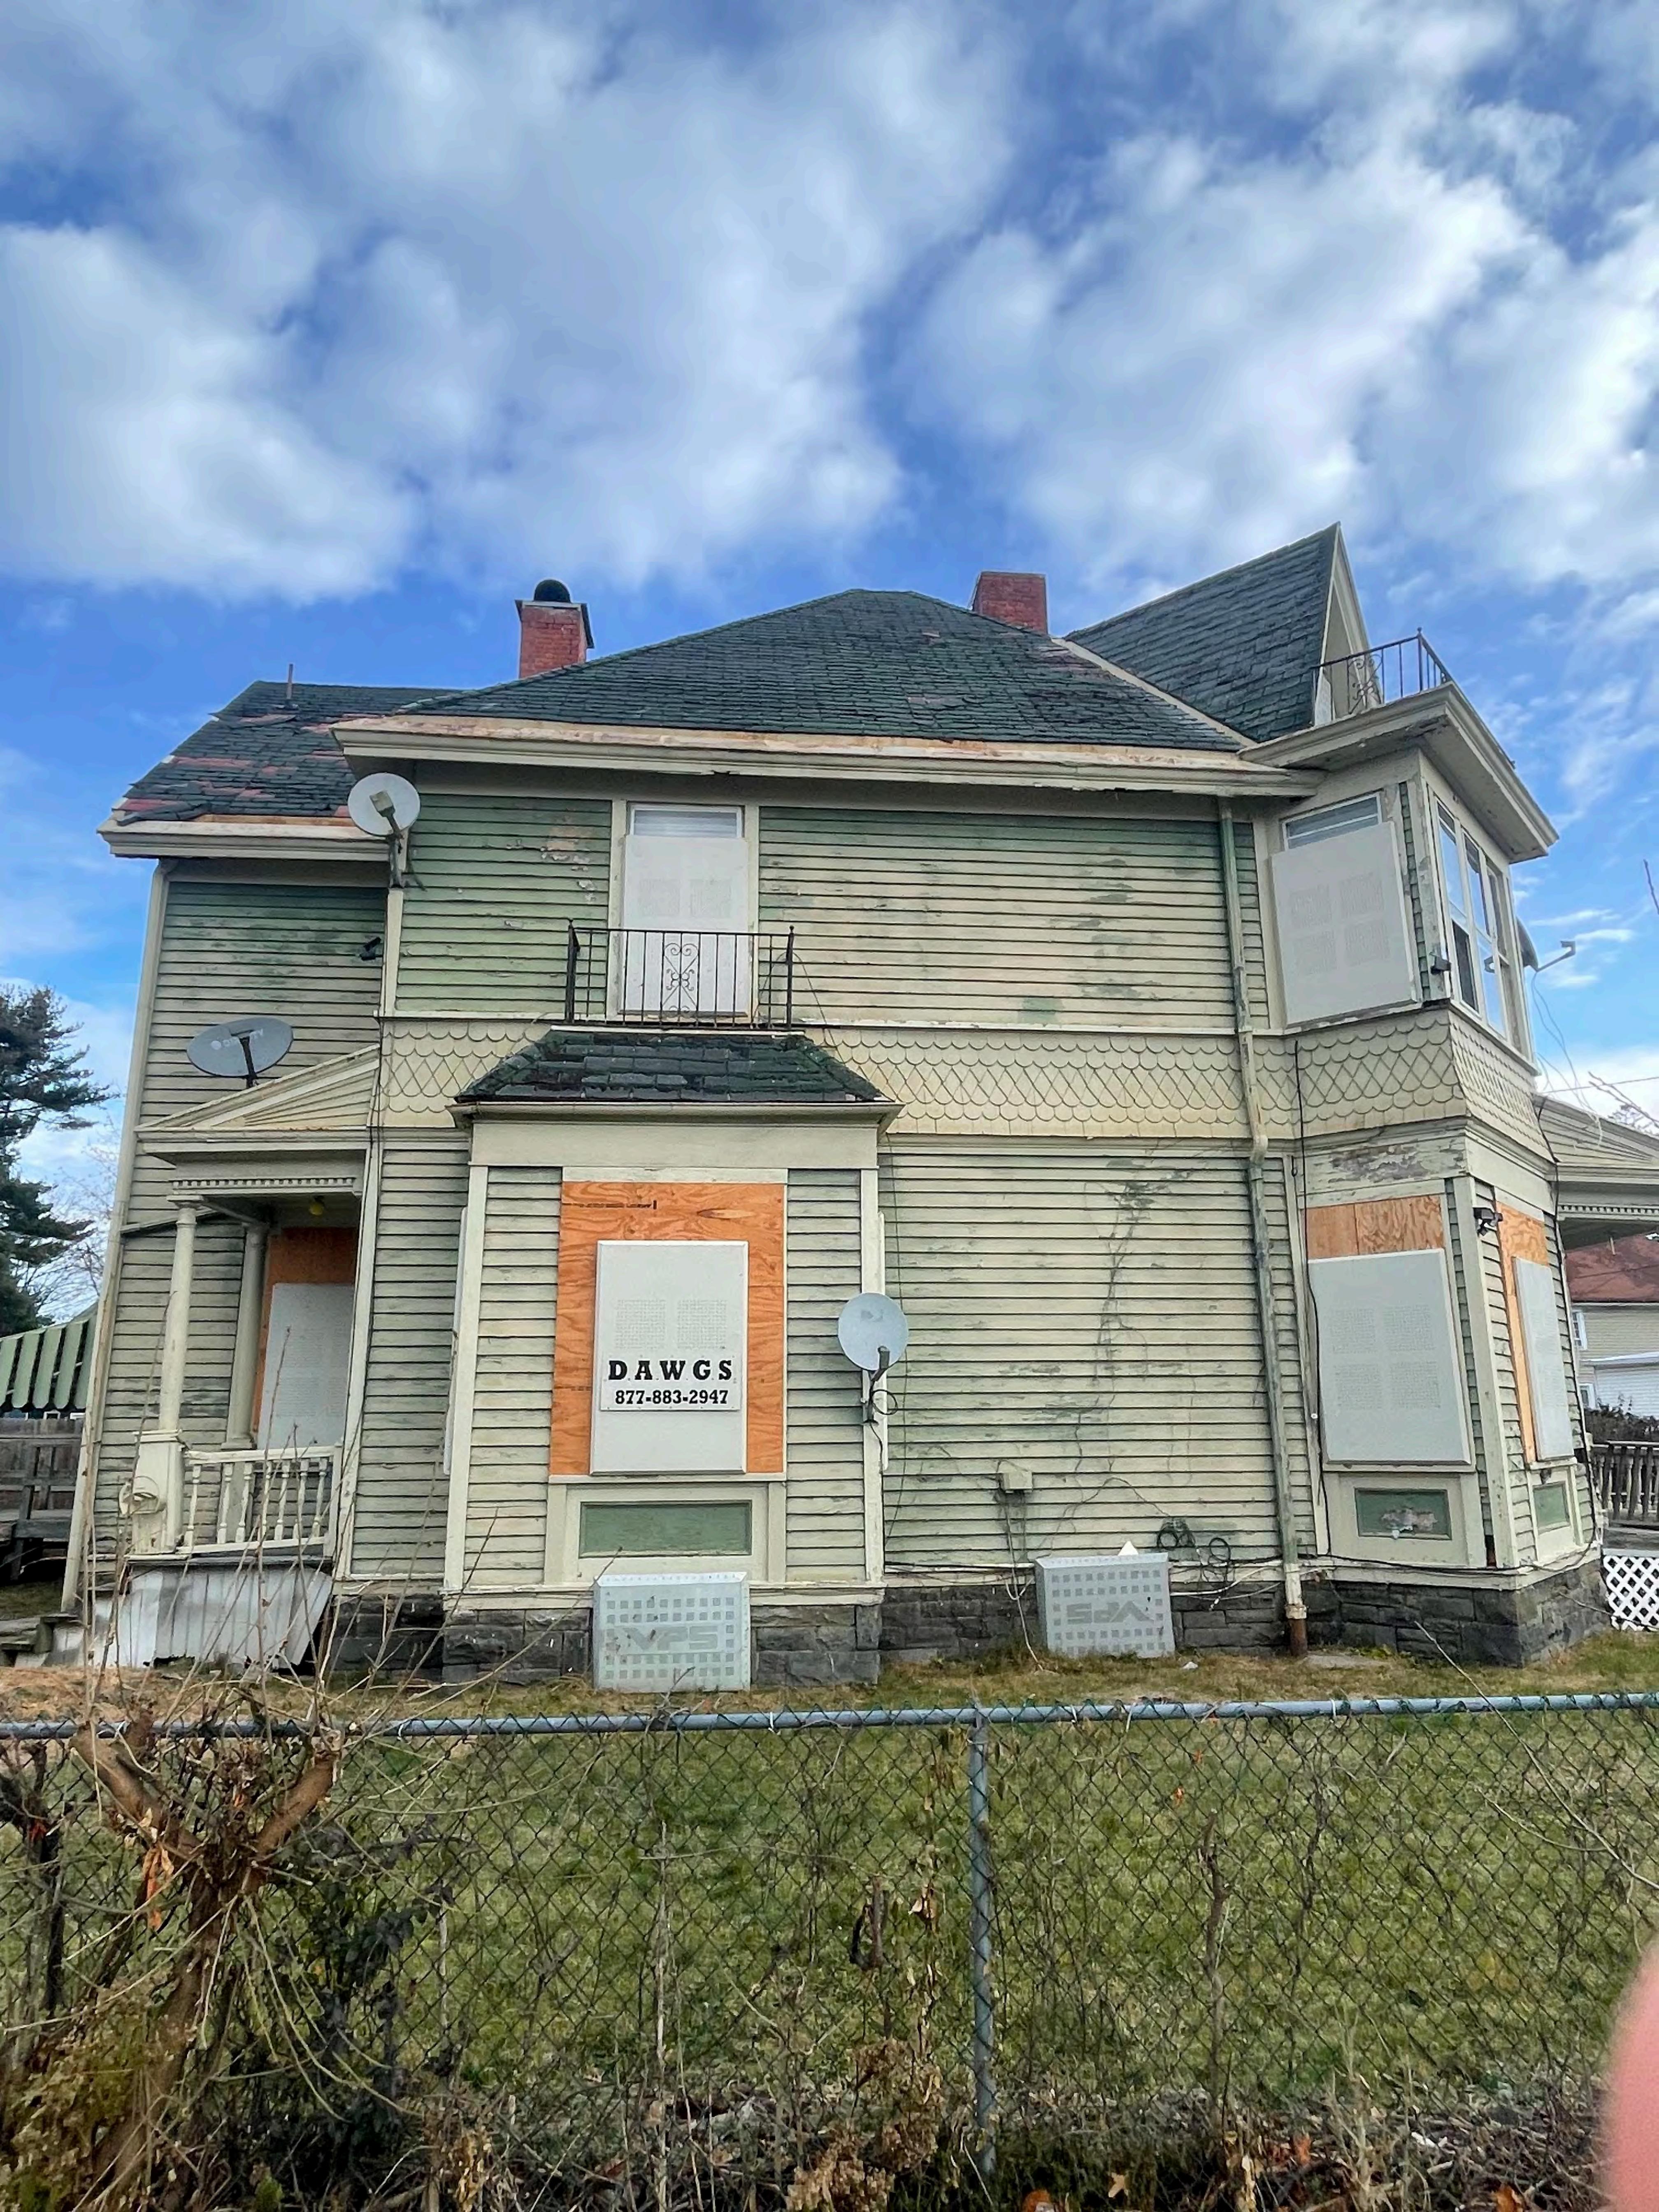
0002 of 0007: Side/southwest elevation with view of one-story box bay, view looking north.

The southwest elevation has a shallow, one-story box bay with a hipped roof and windows on all three sides. The roof is topped with an iron balustrade and there is a door on the second story providing access (Photo 2). Most of the rear (northwest) elevation is a single uninterrupted surface. There is one window on the first story and one on the second. The large gable end has a pair of small windows matching that on the front. At the northwest corner of the building is a single-bay shed-roofed open porch. The porch matches the detailing found on the front porch, including the denticulated cornice, classic-style columns, and supporting balustrade with turned spindles. There is a window above the porch on the second story. At the north end of this elevation is a small, one-bay, one-story projection containing a secondary entrance (Photo 3). This projection is topped with a pediment that contains shingles matching those in the gables. Access to the rear door is via a simple, non-historic wood porch.

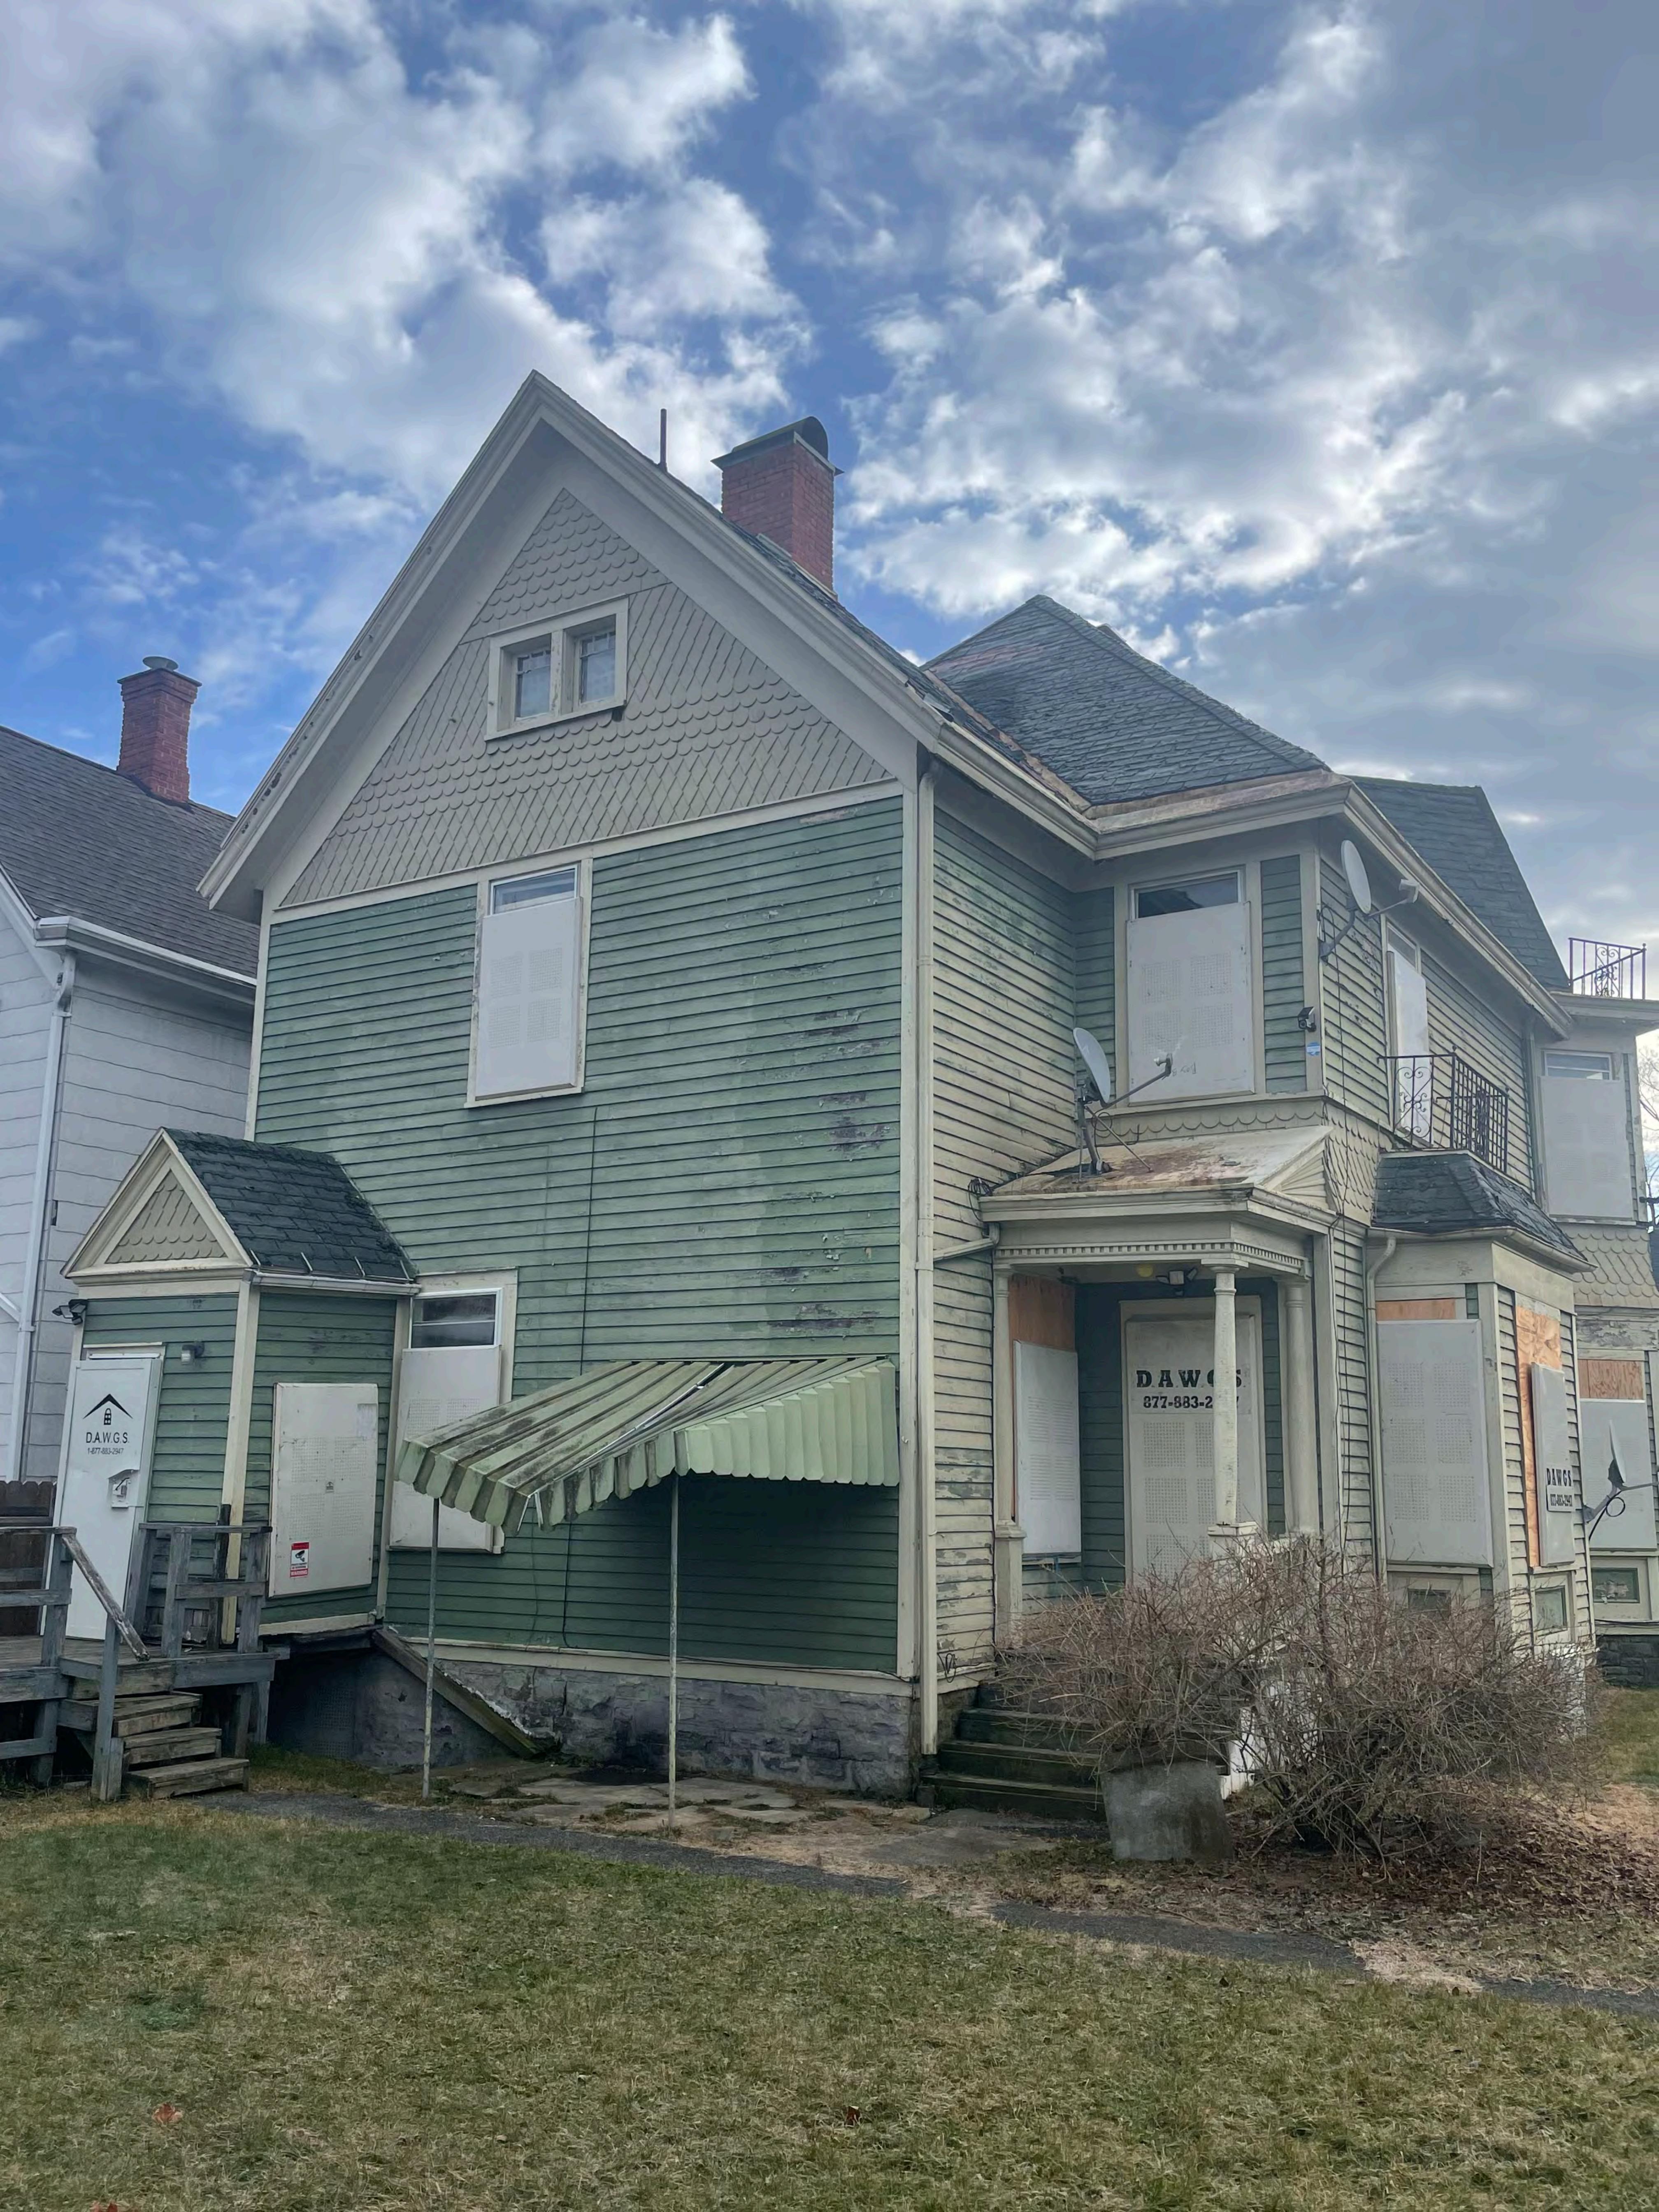
0003 of 0007: Rear/northwest elevation showing open porch with denticulated cornice and pedimented one-story rear entrance, looking west.

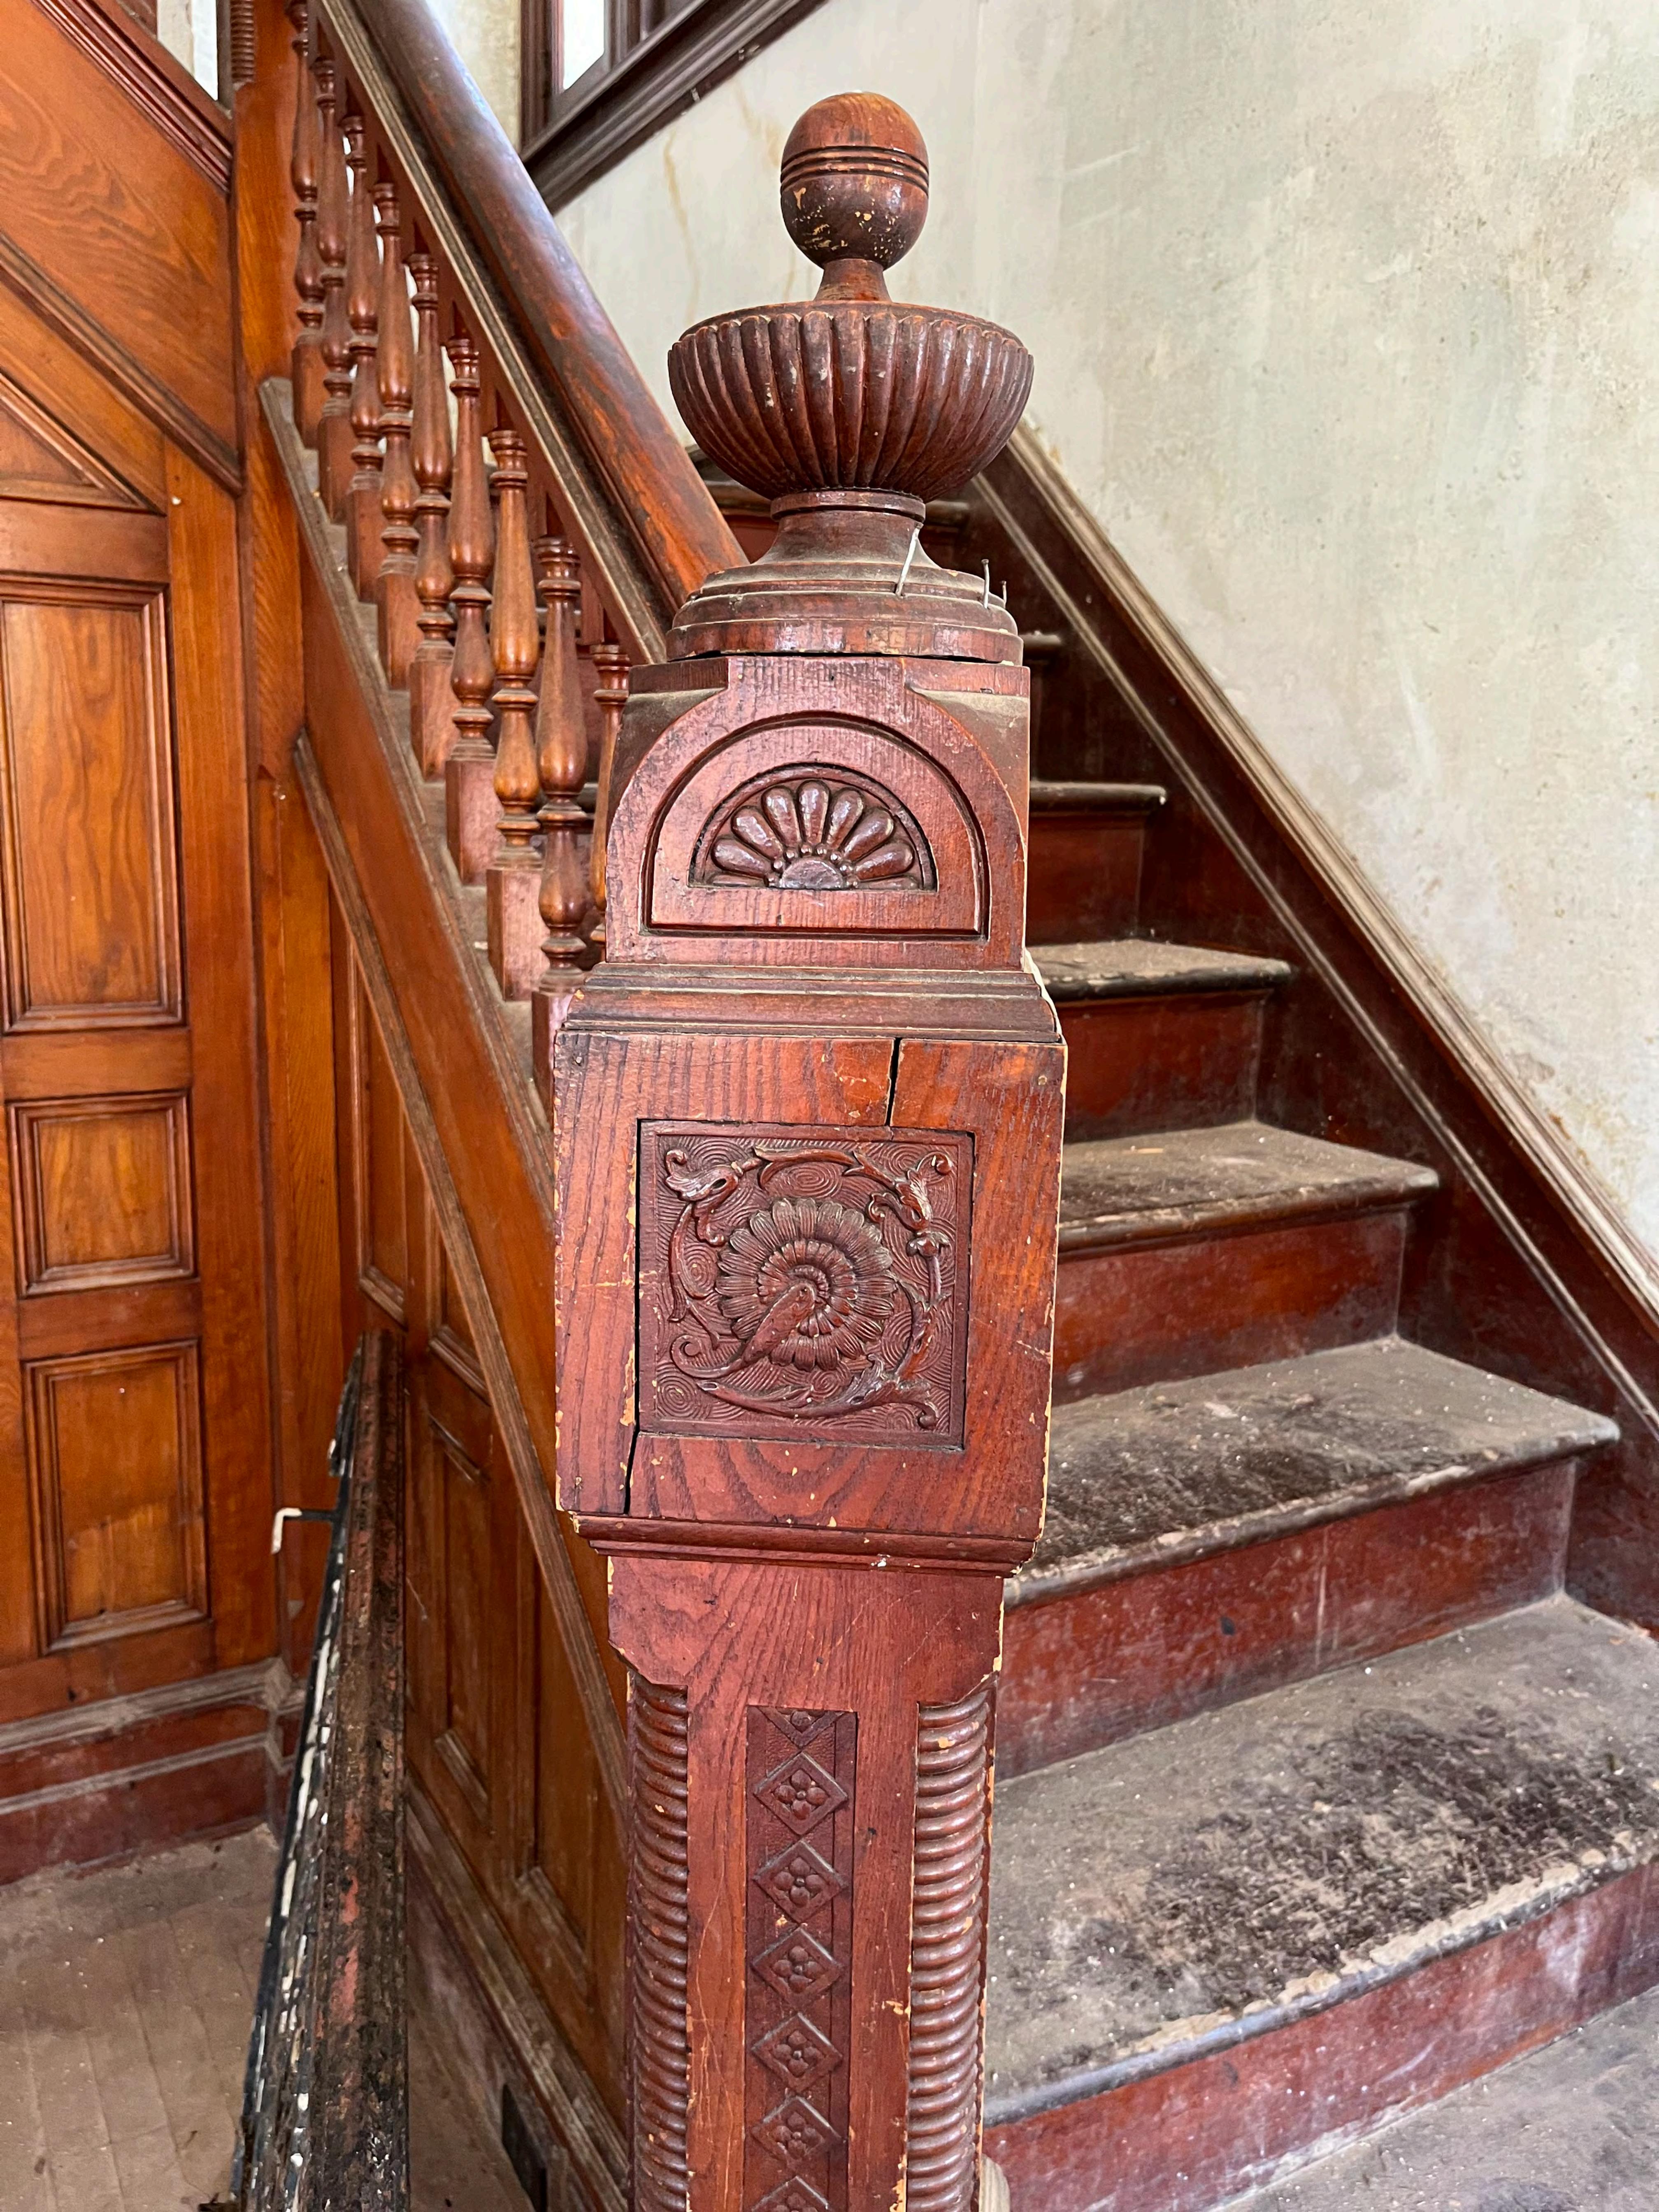
0004 of 0007: Original entry hall's wooden staircase with turned balusters and a decorative newel post with carved floral designs, pointing southeast towards the front door.

The front door leads to an entry hall with a fireplace and the main staircase. The staircase is wood and has turned balusters and a decorative newel post with carved floral designs (Photo 4). There is a small closet set beneath the stairs. The fireplace is red painted brick with a decorative cornice and large bluestone mantel and a brick hearth (Photo 5). On the wall opposite the front door, a doorway leads to a small rear hall which contains the narrow servants' staircase and opens onto the kitchen.

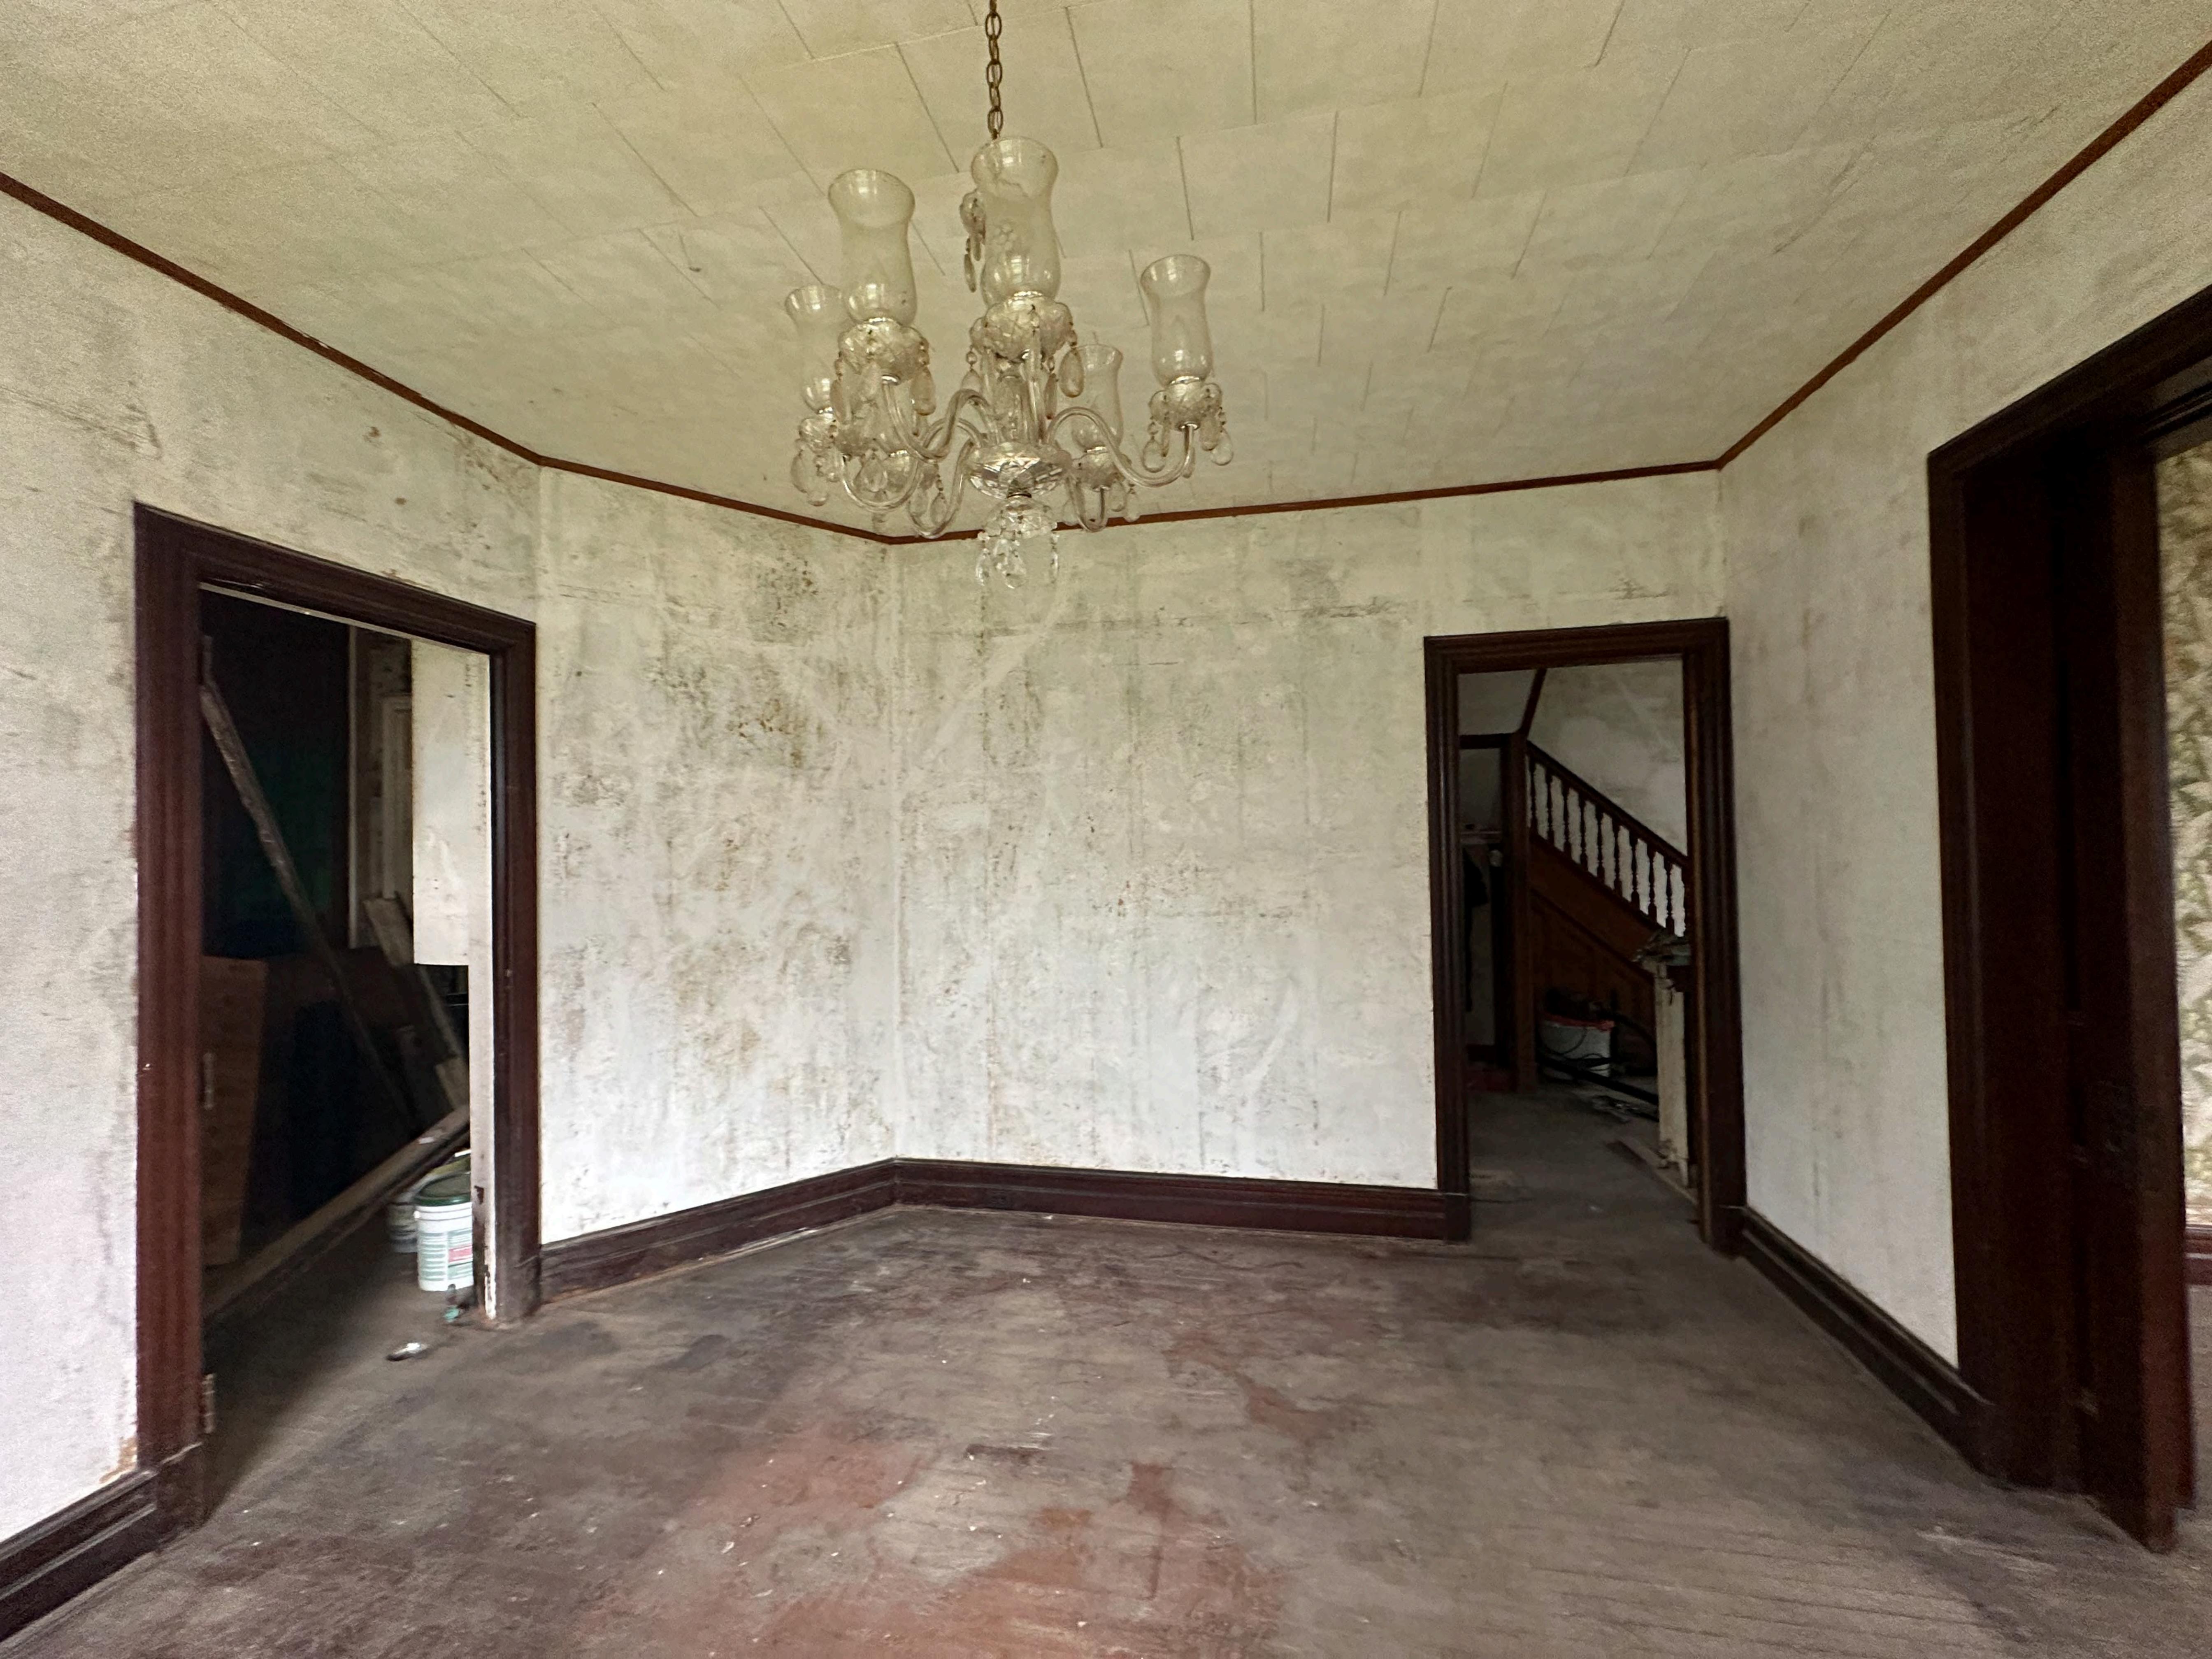
0006 of 0007: Former dining room on the west side of the house has walnut trim, plaster walls, and original wood flooring, also found elsewhere throughout the interior.

The dining room contains the side bay window and a rear entry door leading to the small side porch (Photo 6).
