# National Register of Historic Places Registration Form

historic name Roosa House

street & number 882 Berme Road

city or town High Falls (Marbletown)

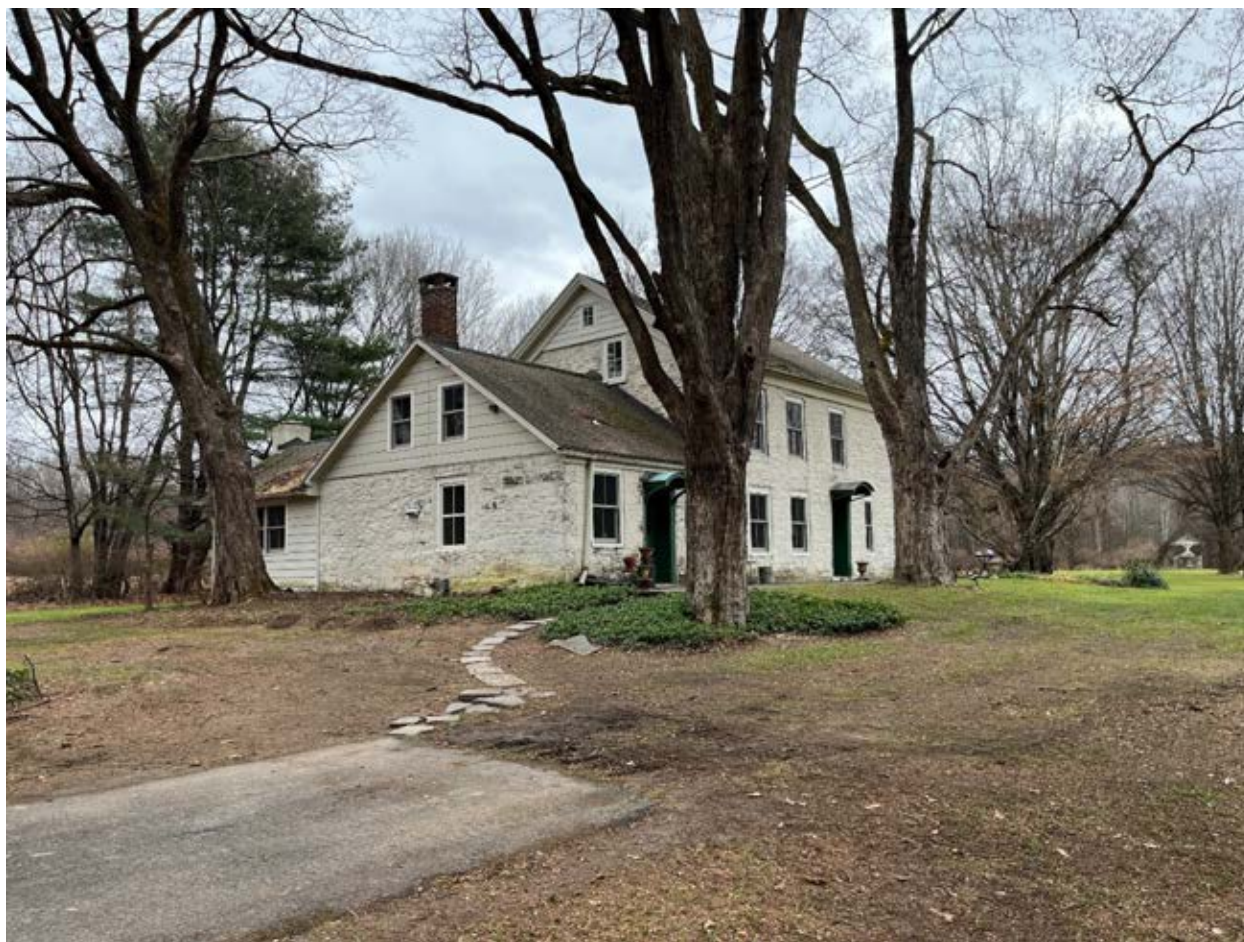
E-01: Primary Façade and west elevation, looking east

Attached to the west end of the original block is the earliest addition built circa 1810. It is a one-and-one-half-story kitchen wing with a side-gabled roof (Photo, E-01 and E-07). The entire wing is finished with coursed rubble stone that is visually similar to that of the original house but separated by a distinct seam in the façade's wall. Directly west of this seam is another Dutch-style door that provides access to the kitchen and is designed similarly to the main entrance, including a matching hood (Photo, E-03). West of this is another two-over-two wood window. The west (side) elevation of the addition has a two-over-two wood casement window on the first story with two additional three-over-three windows above it in the weatherboard-clad gable. A brick chimney emerges at the center of the roof's peak.

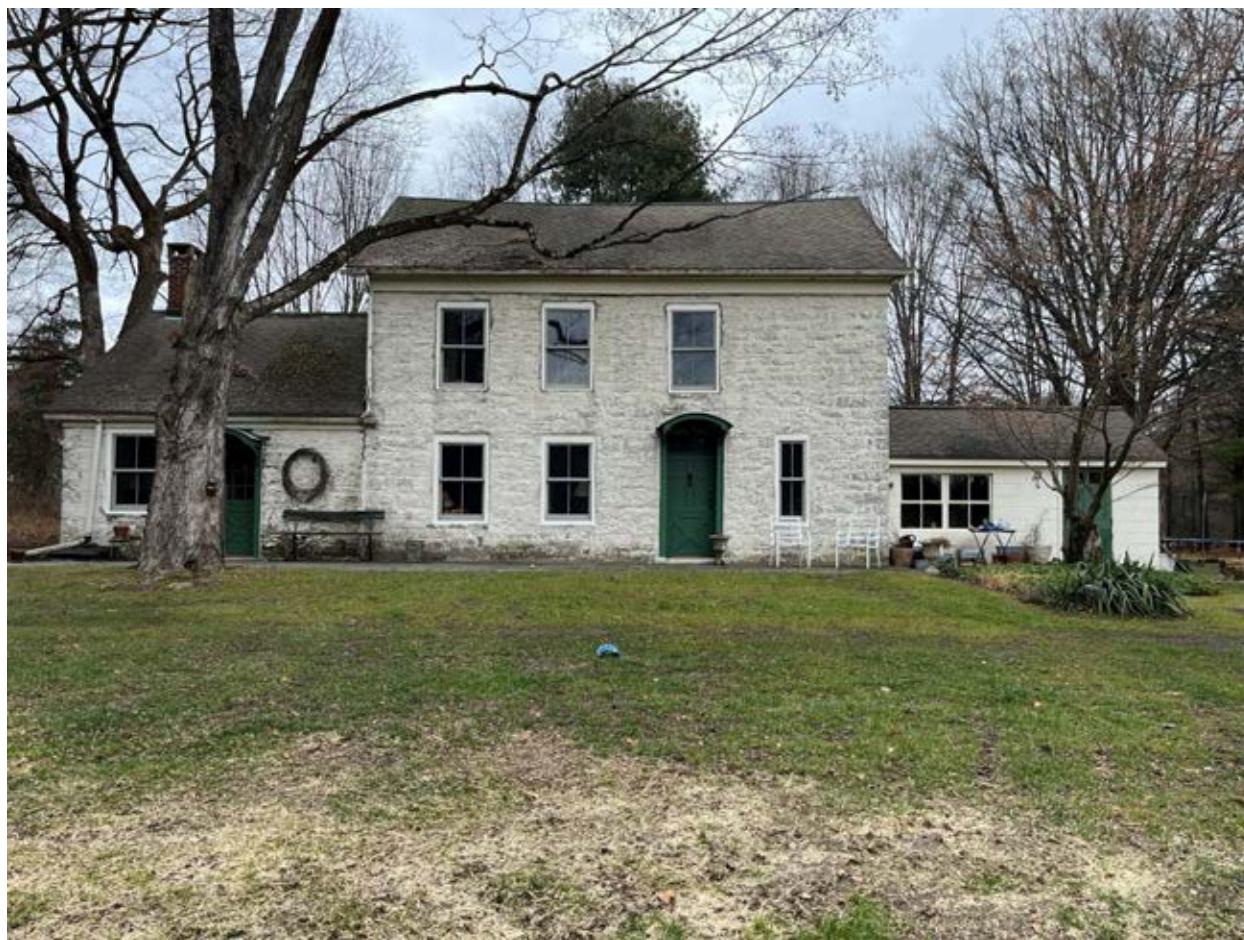
E-02: Primary Façade, looking northeast

All portions of the house, including the original structure and later additions, are covered with an asphalt shingle roof, maintaining a cohesive architectural style (Photo, E-02). The façade of the original portion of the house measures four bays in width and two stories in height. The main entrance is slightly recessed and off-centered to the east. The door itself follows a traditional Dutch design with wood paneling consisting of a cross pattern in the lower portion and four panels in the upper half. Above the door is a single-pane transom window, with a projecting curved wood hood painted green to match the color of the door. To the east of the entrance is a narrow two-over-two wood window. The remaining bays are filled with larger two-over-two double-hung wood replacement windows.

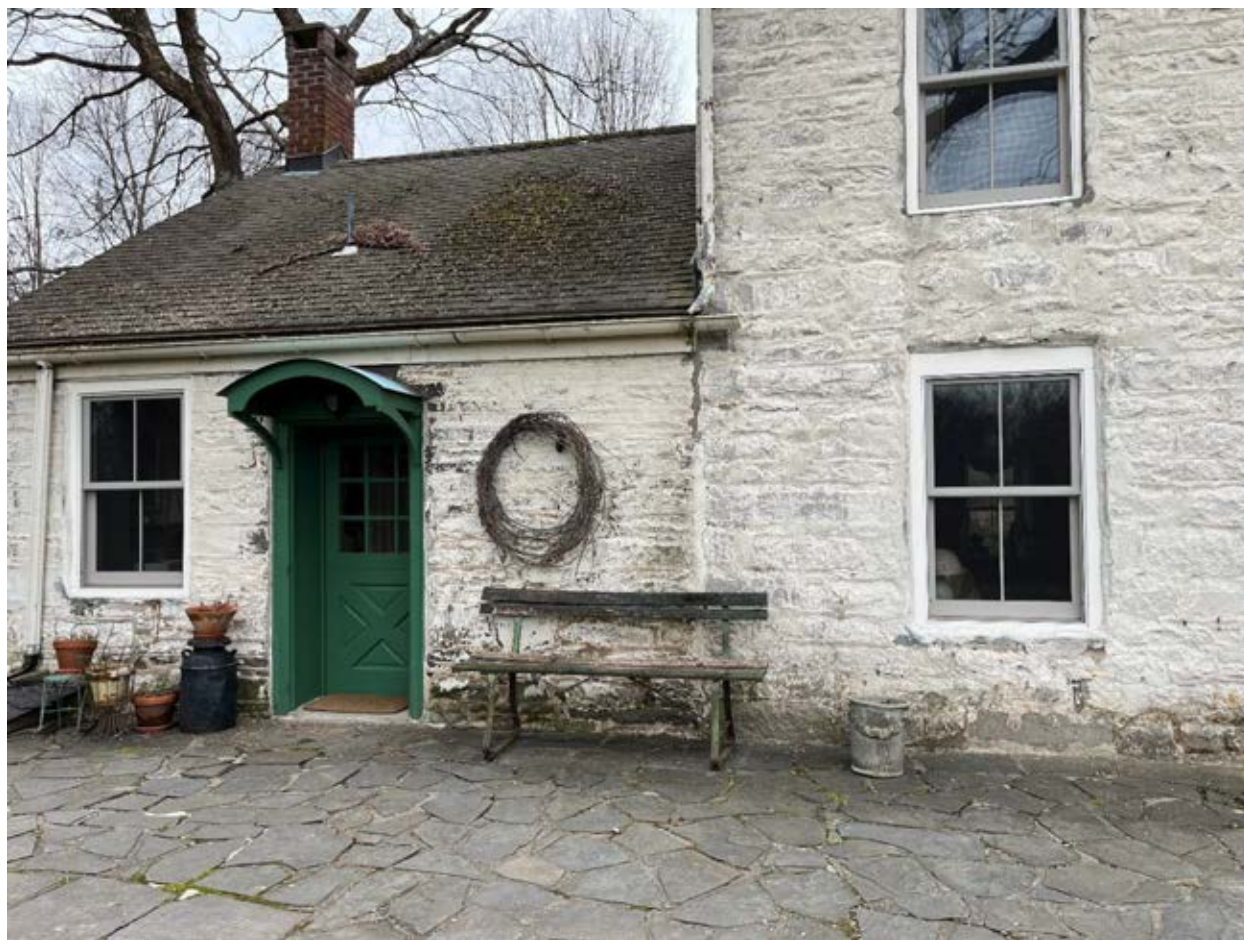
E-03: Primary Façade, Detail of west addition looking north

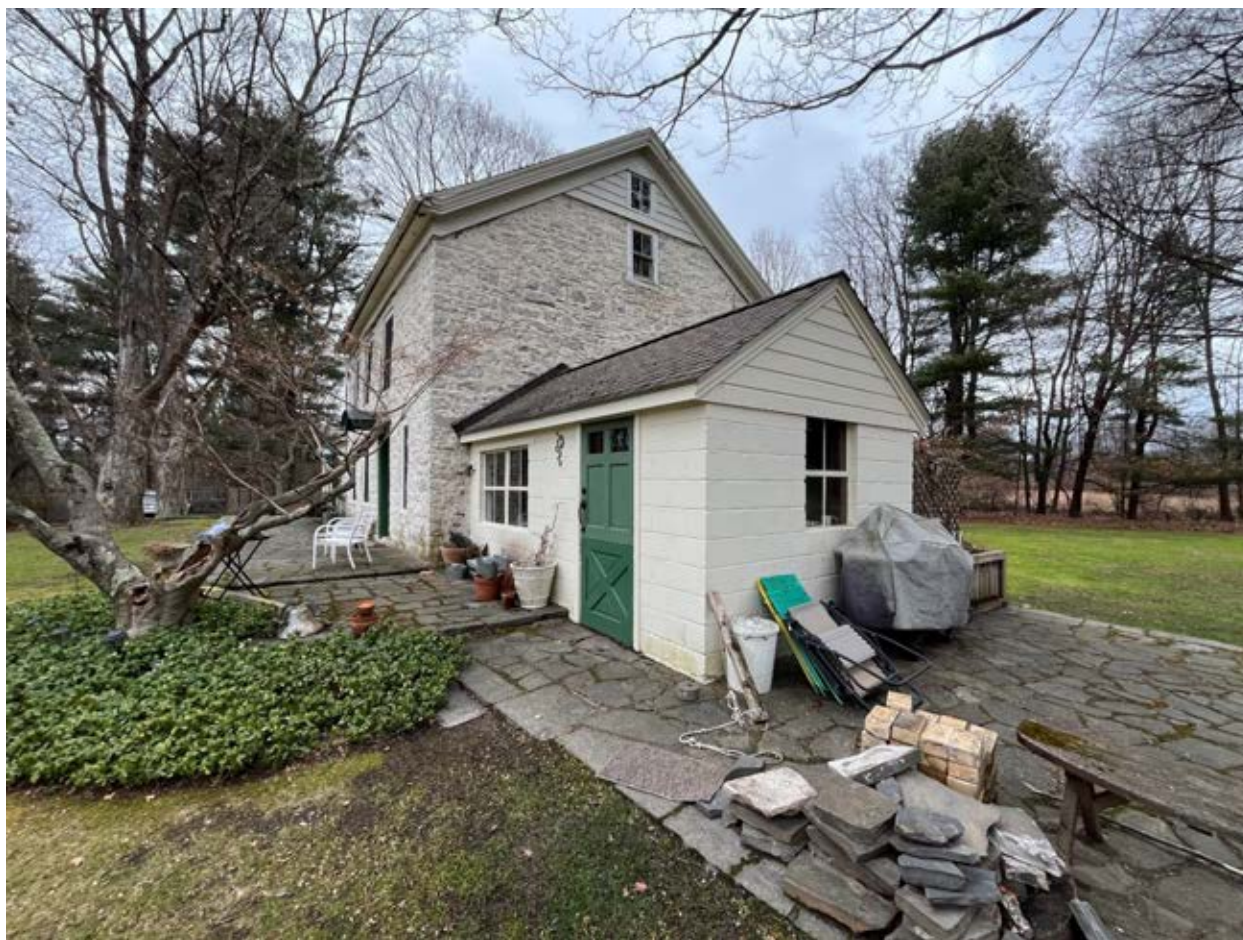
E-04: Side (east) Elevation, looking north

The smallest and most recent addition was built circa 1970 and is a one-story block located off the main block's east elevation to provide additional storage space (Photo, E-04). It was built using concrete blocks and

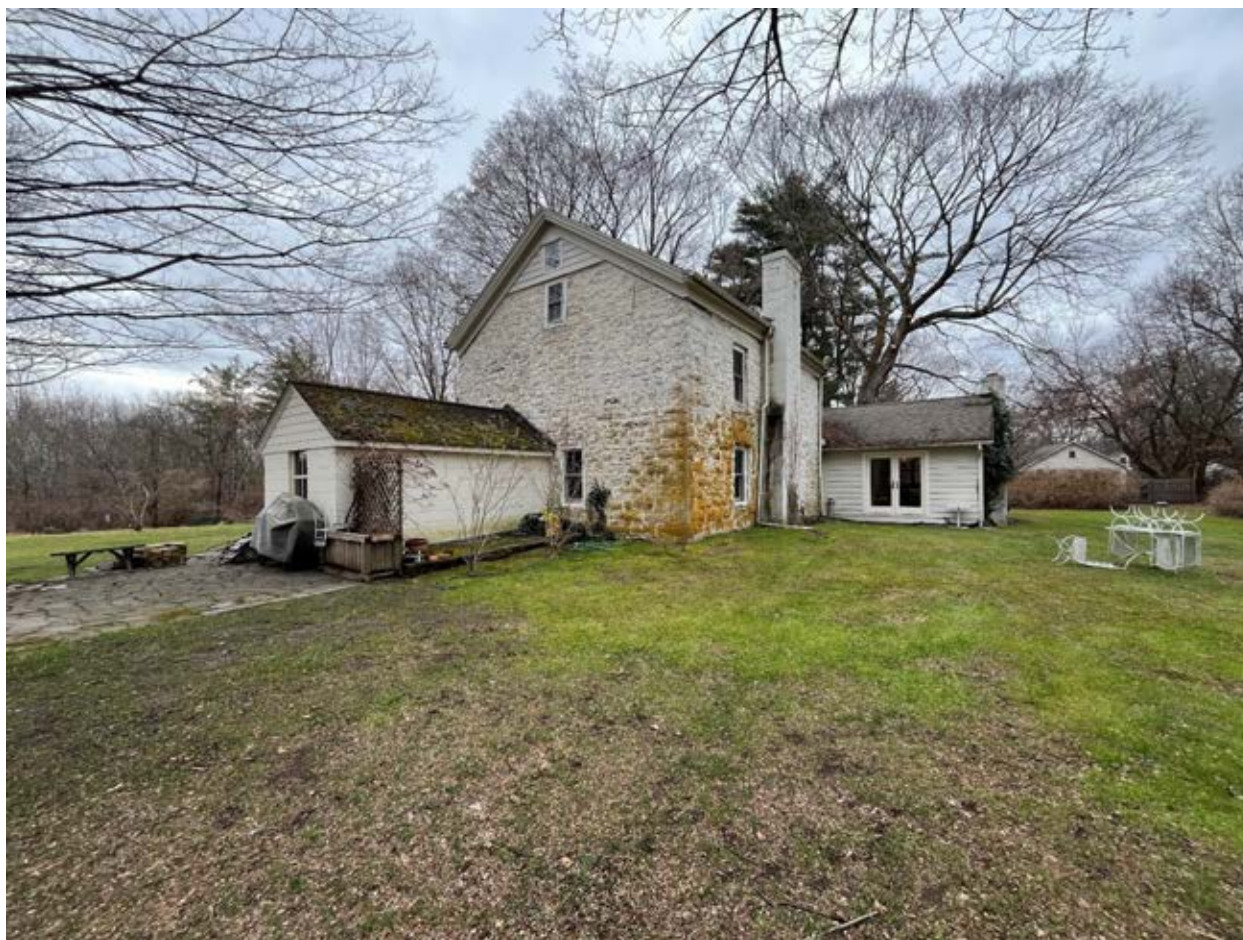
E-05: Side (east) and Rear (north) Elevations, looking west

The east (side) elevation of this portion of the house has stone walls and weatherboard siding on the top gable portion with windows: one on the lower stone portion and one in the gable. Both windows are two-over-two wood casement windows. The west (side) elevation is similar, with paired two-over-two casement windows on the third story. The north (rear) elevation has a large, full-height brick chimney flanked by two-over-two double-hung wood windows on both stories. All of the windows in the house have recently been replaced with Marvin historic wood windows to meet energy savings standards, but the overall design remains true to the late-eighteenth-century Dutch influence.

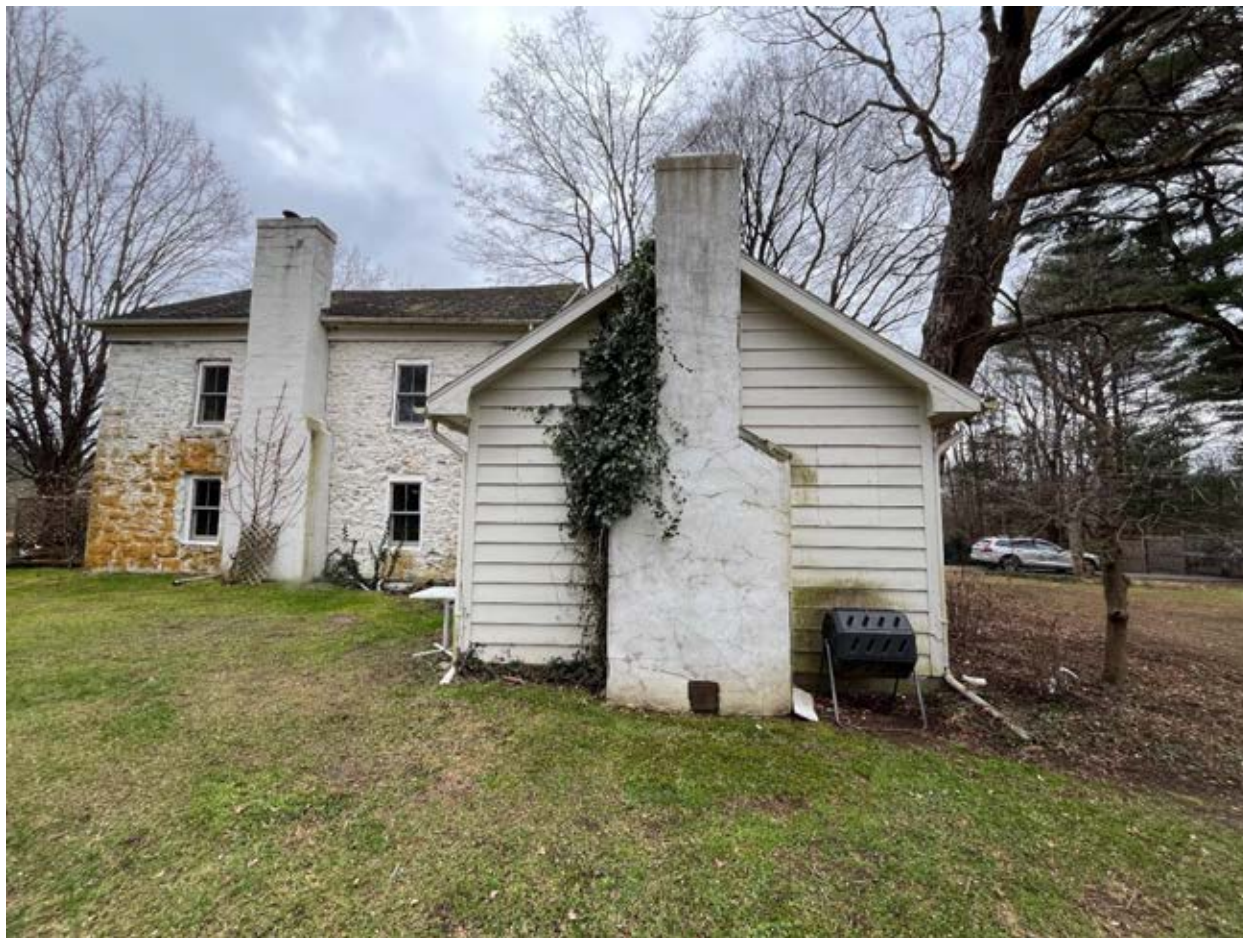
E-06: Rear (North) elevation, looking southwest

Directly behind the west end addition to the north is a small single-story, one-bay wing addition built circa 1950 (Photo, E-06). It has a concrete block foundation and a gabled roof that is clad in weatherboard siding on all sides. Its rear elevation has a centered brick chimney covered in plaster. Two former window openings flanking the chimney have been covered with weatherboard siding. The wing's west elevation has paired two-over-two wood double-hung windows. The east side has French doors with simple wood trim.

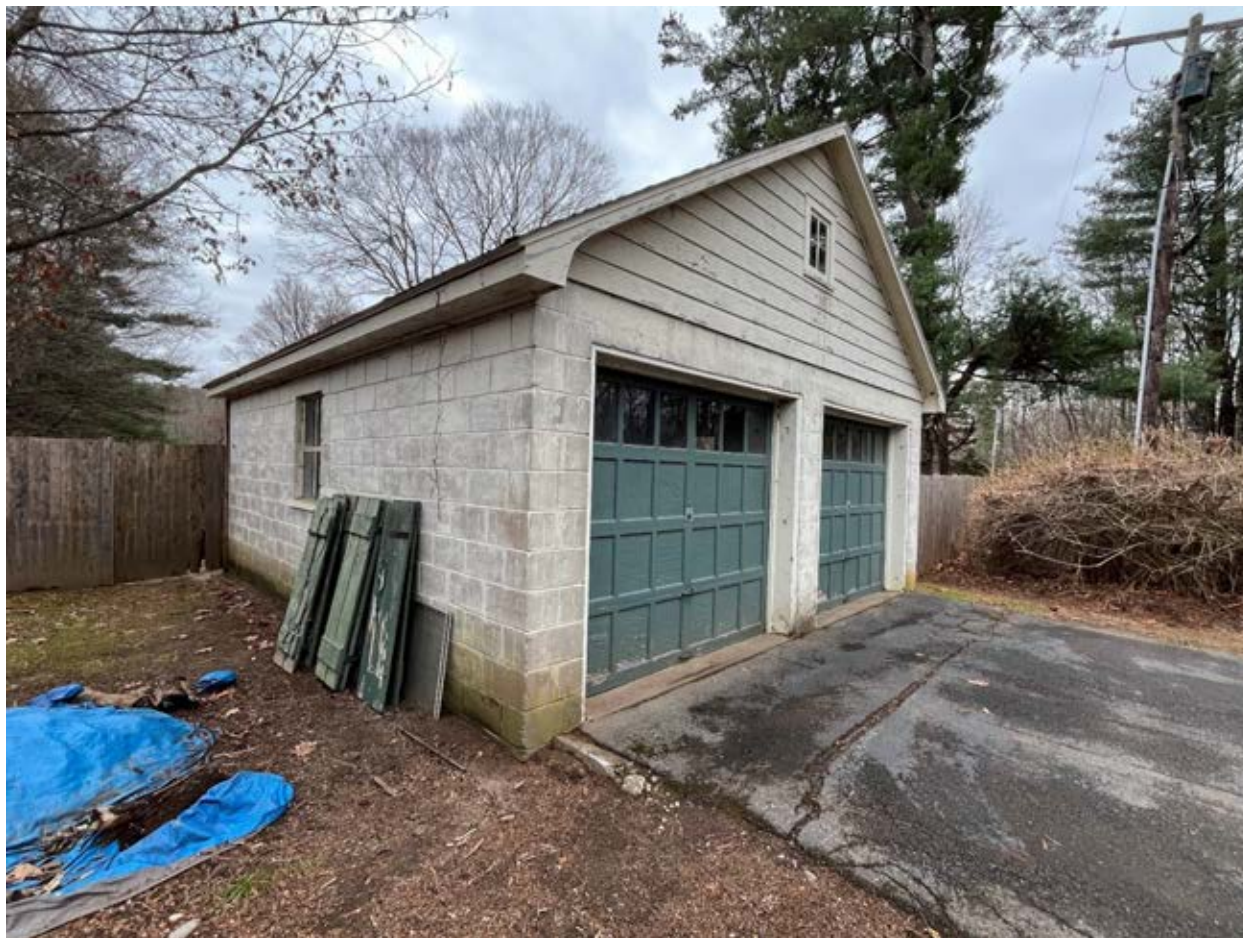
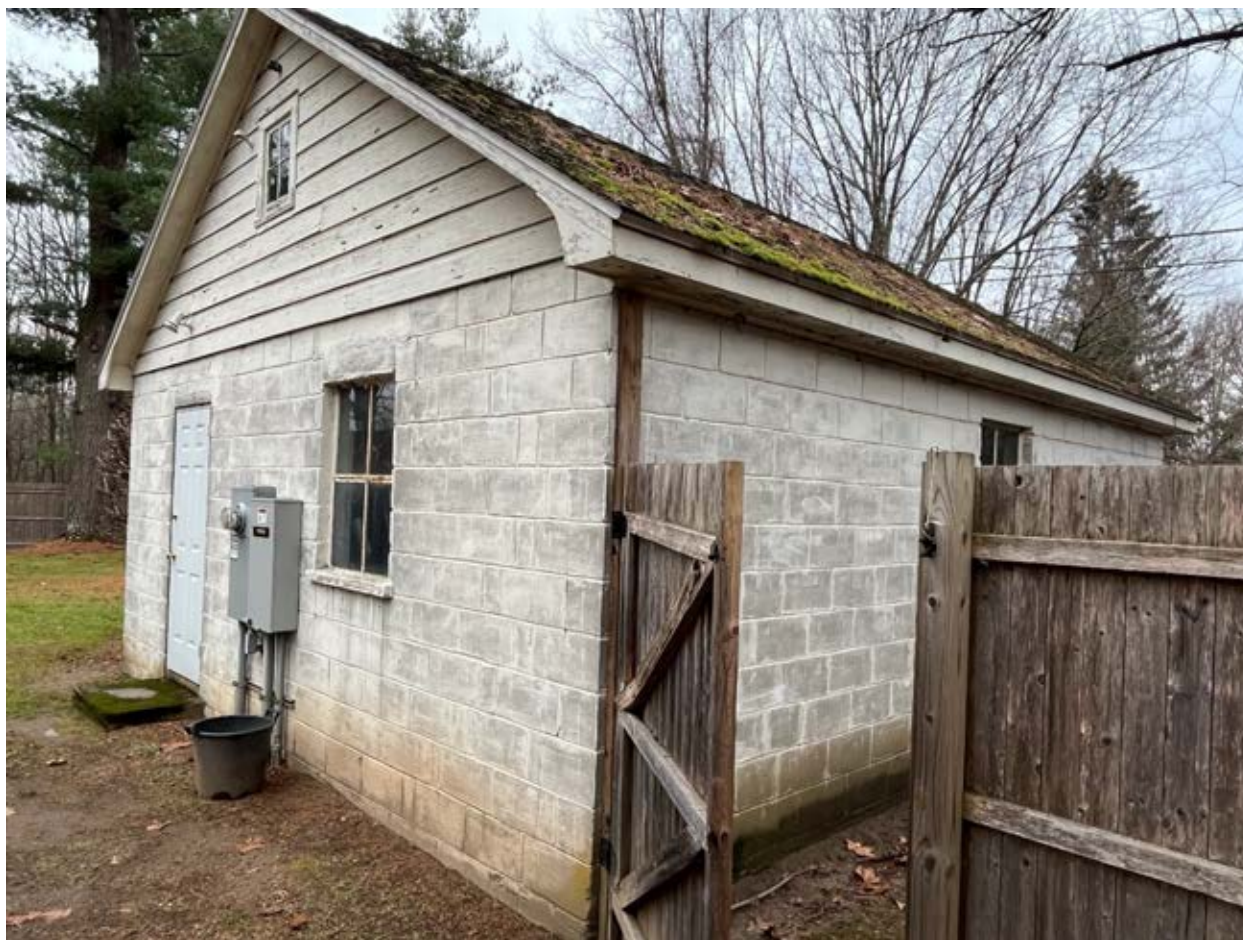
Built circa 1950, the non-contributing garage on the property is a one-and-one-half-story outbuilding constructed of concrete block walls with a front-gable asphalt shingle roof (Photos E-08 and E-09). Its façade faces Berme Road and has two wooden garage doors with square lattice patterns and six windows each. The front and rear gables are clad in weatherboard siding. Fenestration consists of three two-over-two wood windows on the side and rear elevation with simple stone sills. The interior has a poured concrete floor, concrete block walls, and exposed wood ceiling rafters.

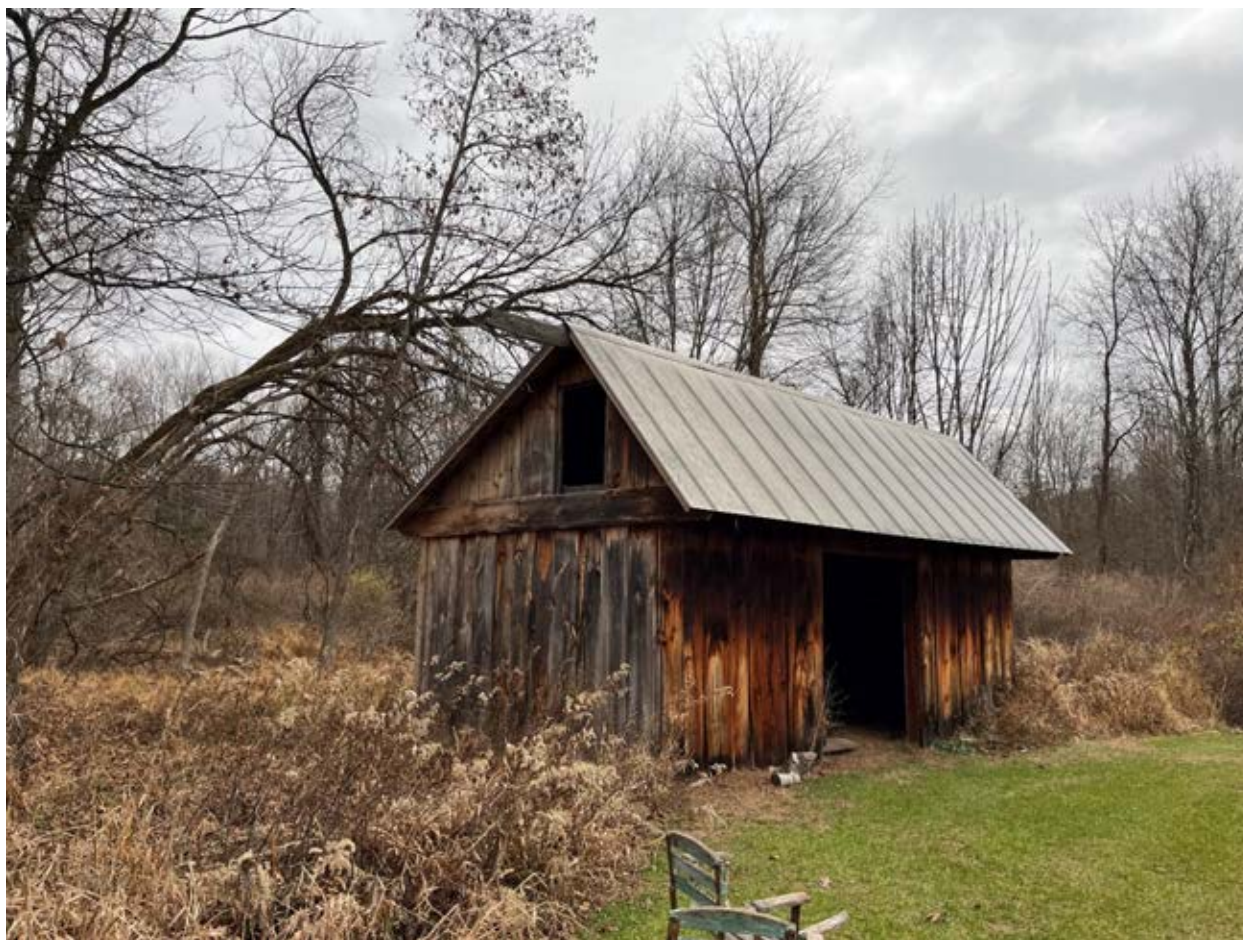
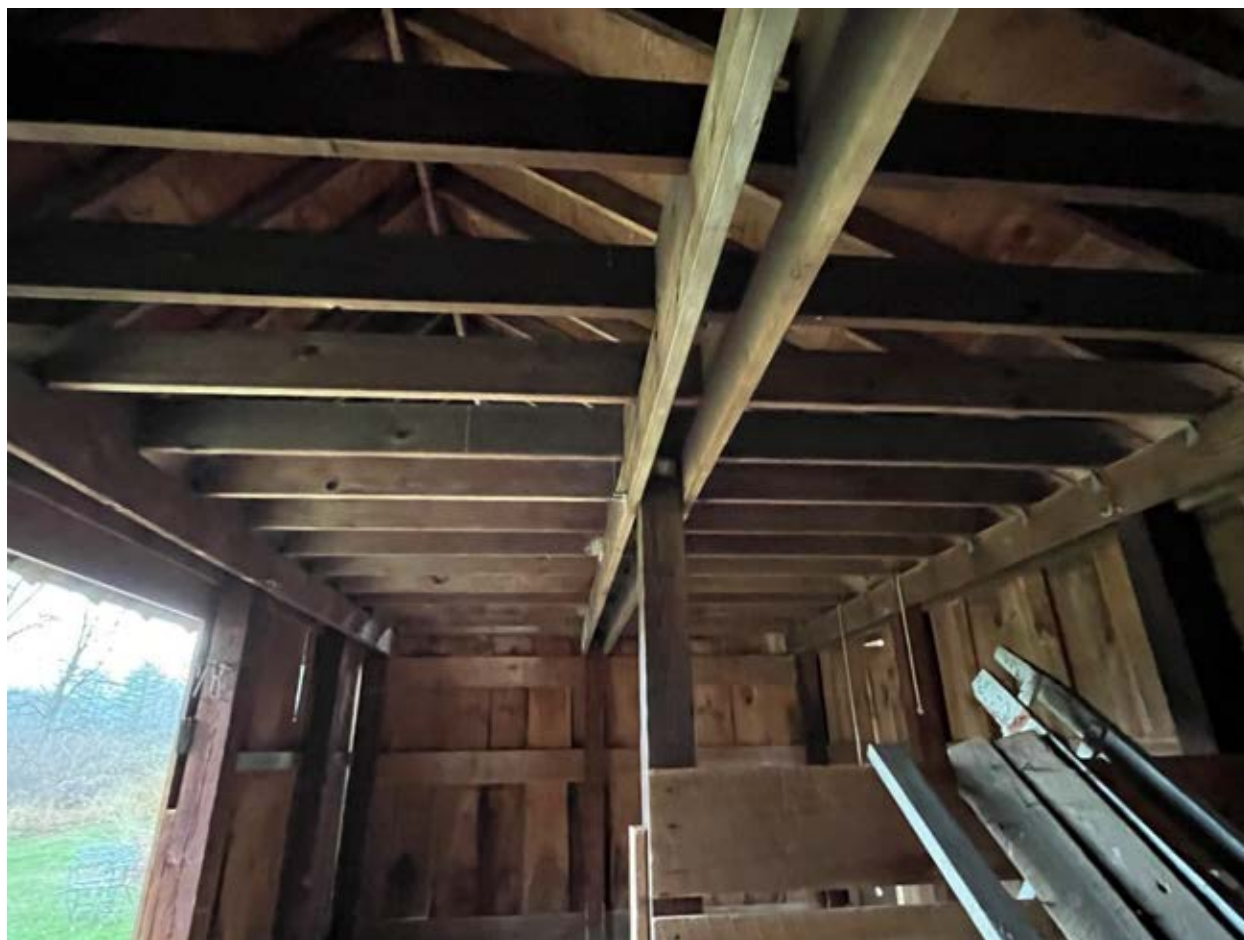
In the northeast corner of the property stands a non-contributing barn built in the 1970s (Photo, E-10 and E-11). It is a modest one-and-one-half story, wood frame rectangular block, clad in unpainted vertical wood siding. Its asymmetrical side-gabled roof is standing seam metal and has a slight overhang which exposes the structural wood rafters beneath it. The south elevation has a central square opening. The west elevation contains a rectangular unglazed window opening in the gable, with the barn's ridge beam projecting above it. The interior is an open-plan room that has earth flooring and unfinished framing on its walls. The unfinished ceiling has a series of joists separated in two rows by two strutting beams. A square post in the center of the room serves as a structural support for the roof above it. The post also supports a partition wall in the middle of the space consisting of five wide timber planks adjoined to the rear interior wall.

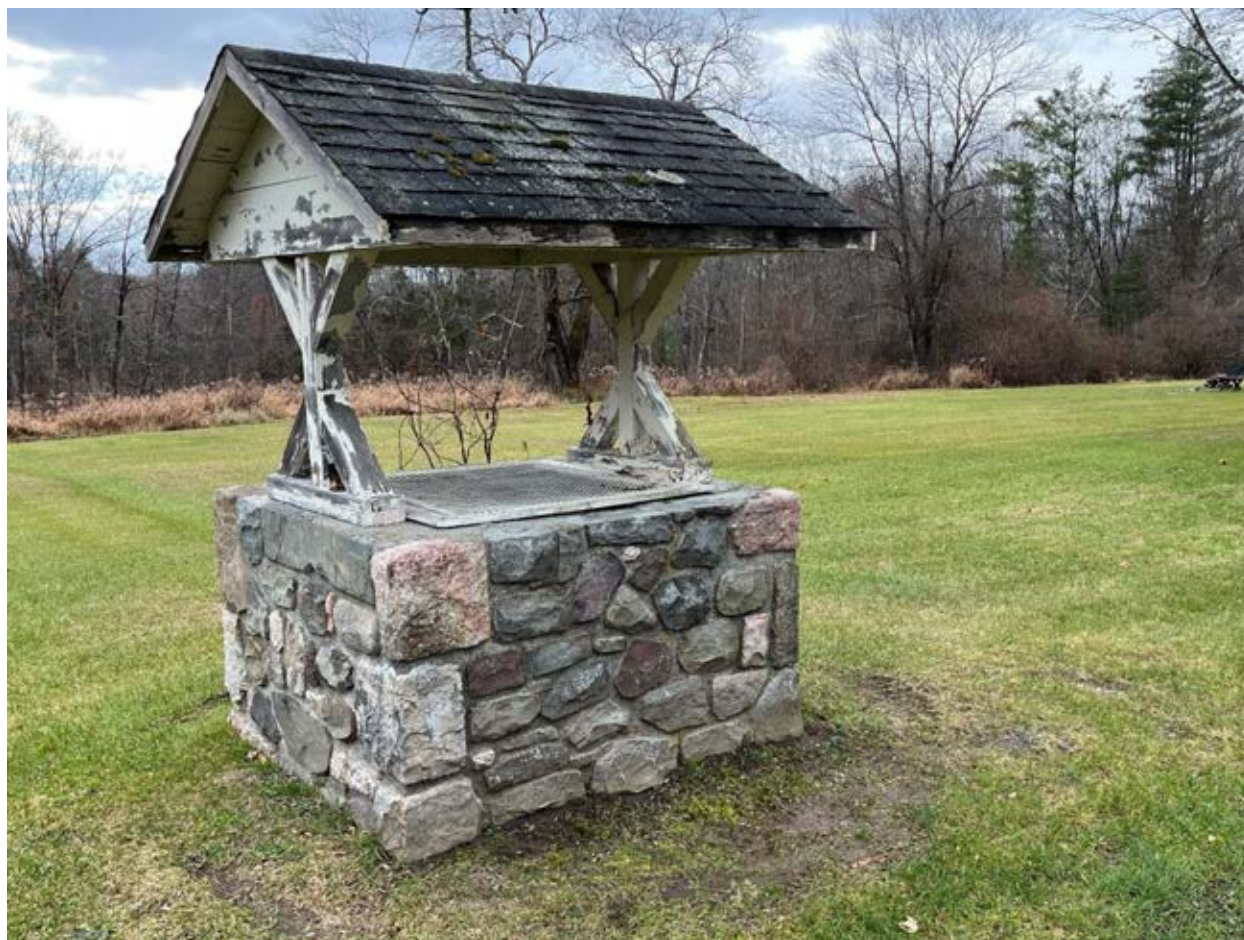
E-12: Well House, looking south

Behind the main house on the rear lawn is a square non-contributing well house with an unknown construction date (Photo, E-12). It is made of concrete with irregularly shaped rubble stone and is covered by an asphalt

shingled gable roof supported by two wooden cross-braced posts. The well itself is cylindrical and made of rubble stone covered by a metal grate.

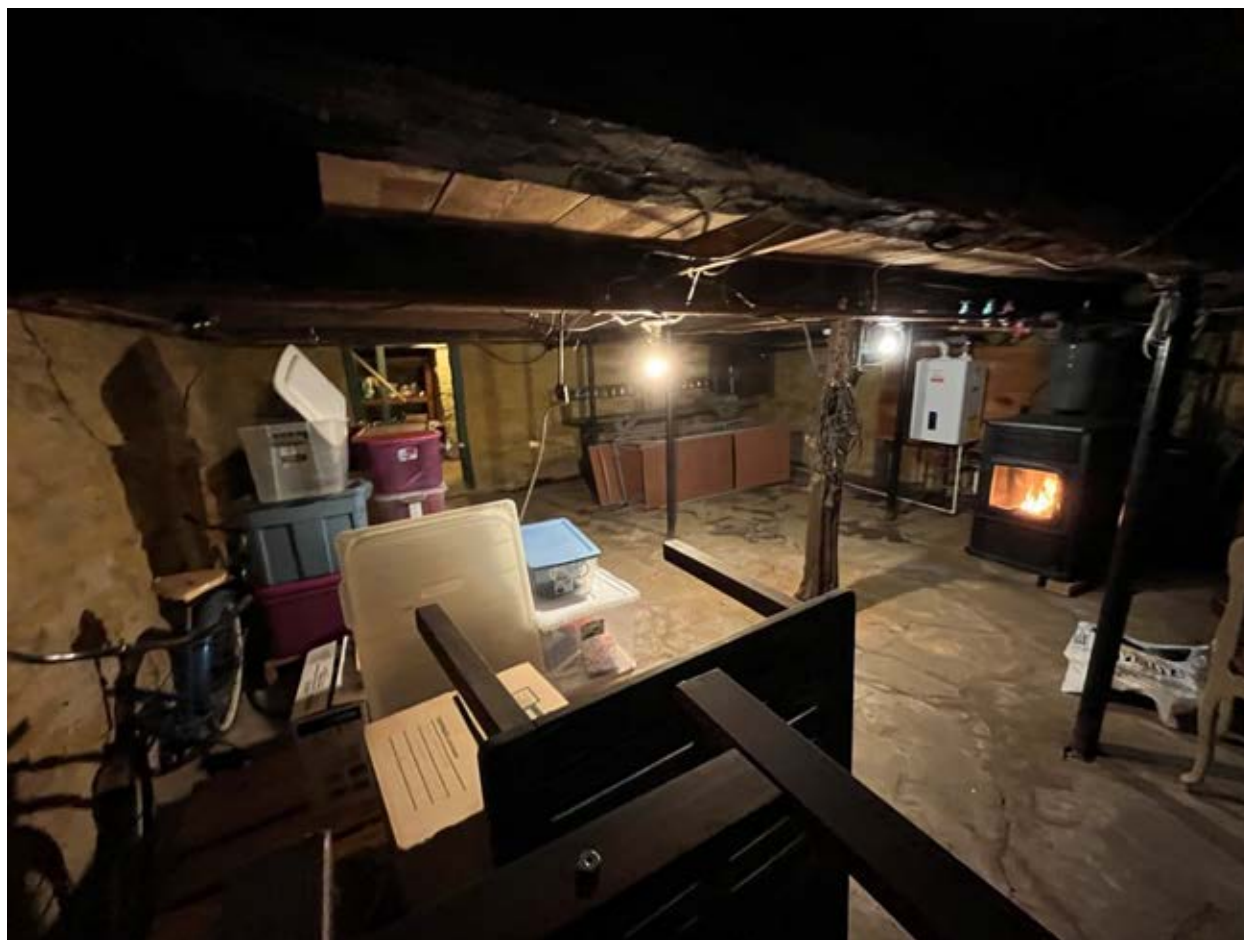
B-01: Basement under main house, looking north

The basement consists of a series of unfinished rooms beneath the original portion of the house and its earliest addition (Photo, B-01). Its access is via an interior single-run, open riser wood stair in the kitchen. This stair leads into a square room that branches off to two rooms to the north and east into a large rectangular room that has a wood-burning furnace on its north wall, adjacent to other utilities. A secondary, likely original, stone stair to the east in this room connects the basement to the interior of the circa 1970 storage shed addition. The main features of this space include stone flooring and stone walls throughout. The ceiling is exposed, revealing the wood plank flooring above. It is supported by square, rough-cut heavy timber beams and a series of square wood and metal posts.

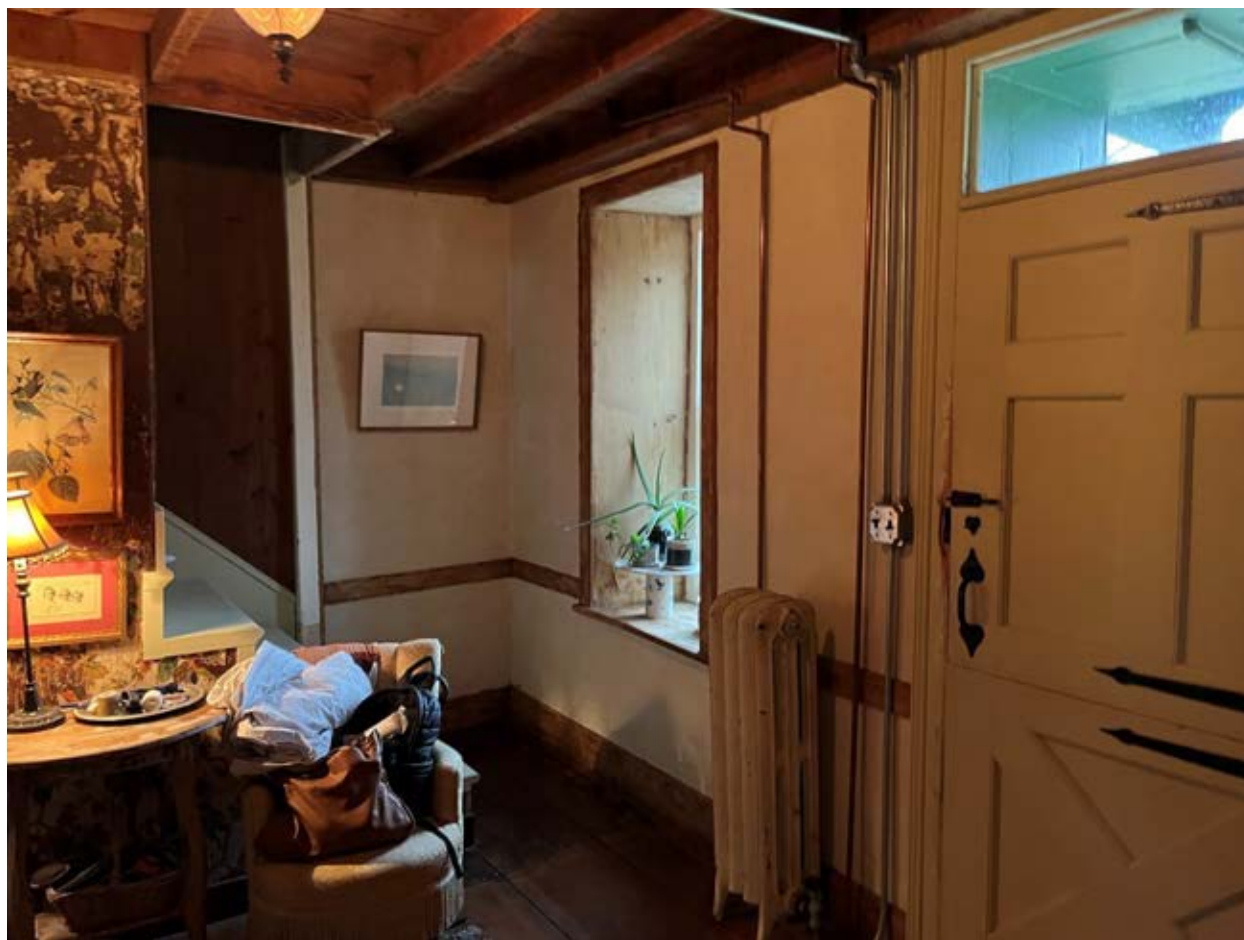
1-01: Entry Hall, looking south at primary entrance

The first floor is defined by a side entry hall that leads to the principal rooms of the house (Photo, 1-01). It is finished with original wide wood plank flooring, plaster on lath walls, and a ceiling with exposed timber beams that appear to have been cut by hand due to the presence of ax and hand tool marks. The walls in this room are decorated with a continuous original wood chair rail and baseboards. A single-run enclosed wooden stair on the east wall leads to the second floor, with a storage space beneath the stairs. In the twentieth century, a newer staircase was situated on top of the original staircase. The original walls contain traces of layered nineteenth-century wallpaper, which conceals the staircase to the west from the rest of the room.

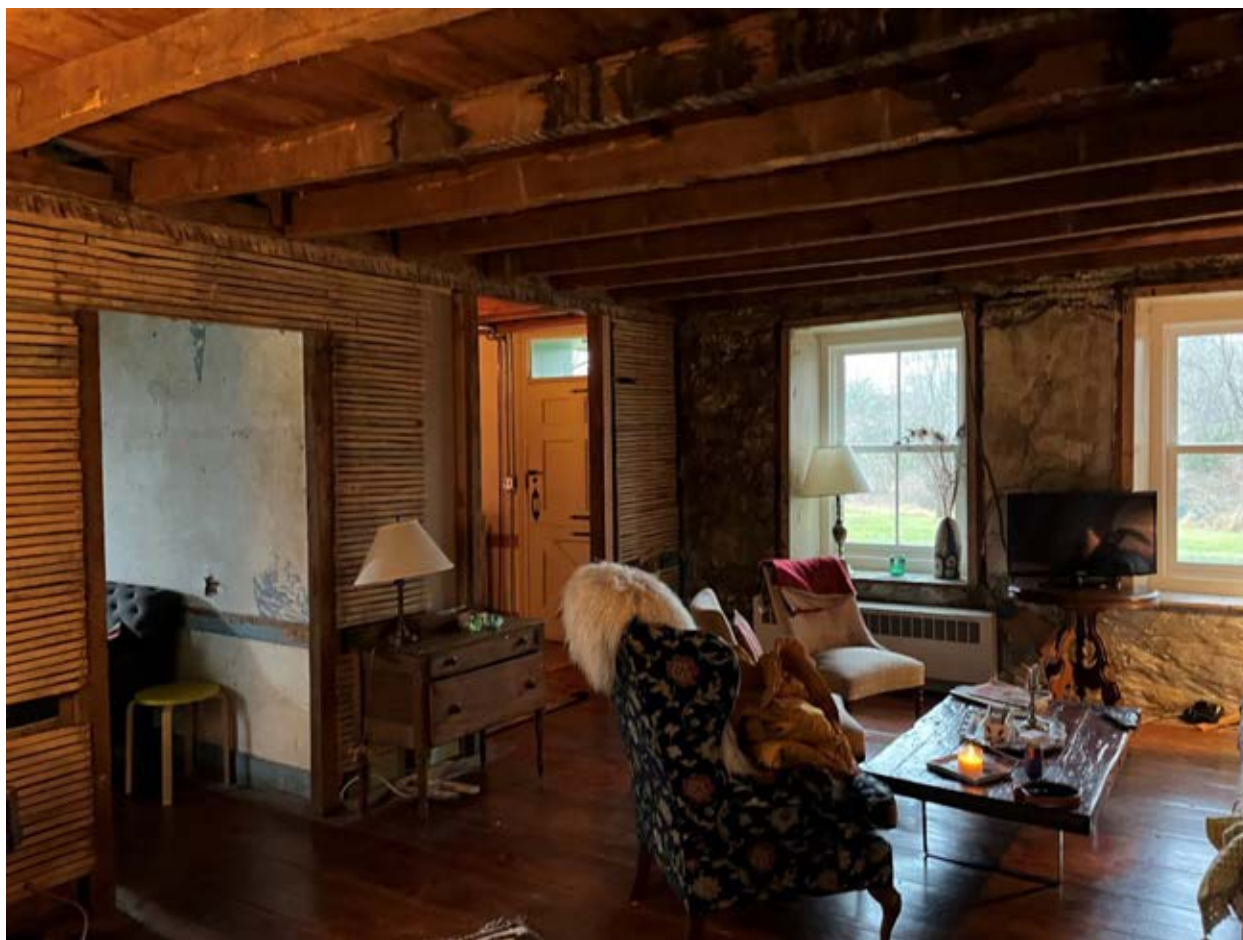
1-02: Living Room, looking south

West of the side hall is the living room, which is a partially finished rectangular room with deep-silled windows on the north and south walls (Photo, 1-02). The original finishes of wide wood plank flooring, plaster on lath walls, and a ceiling with exposed timber beams are also used in the living room (Photo, 1-03). Three of the walls in this room are stone with remains of plaster. The east wall presumably has its original lath, but the plaster was removed by a previous owner and is in the process of being replaced in kind. North of the hall doorway is another doorway that leads east to a secondary living space with similar finishes. The exterior walls in this room are stone and partial plaster and the interior walls have original plaster, chair rails, and baseboards. Opposite this doorway on the west wall of the living room is a presumably nineteenth-century doorway that connects the living room to the kitchen and might have been the location of the original fireplace.

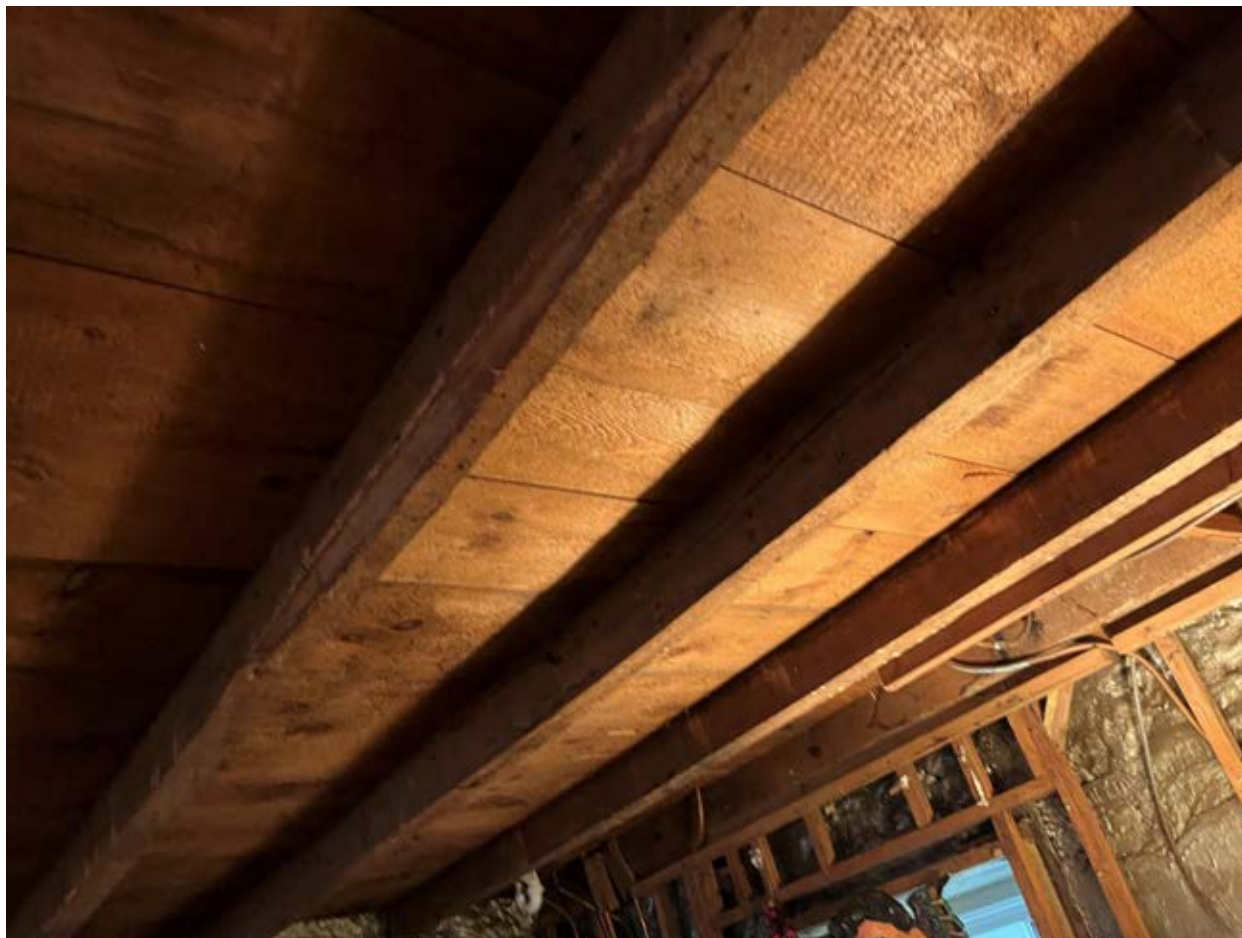
1-03: Living Room, detail of original timber beams

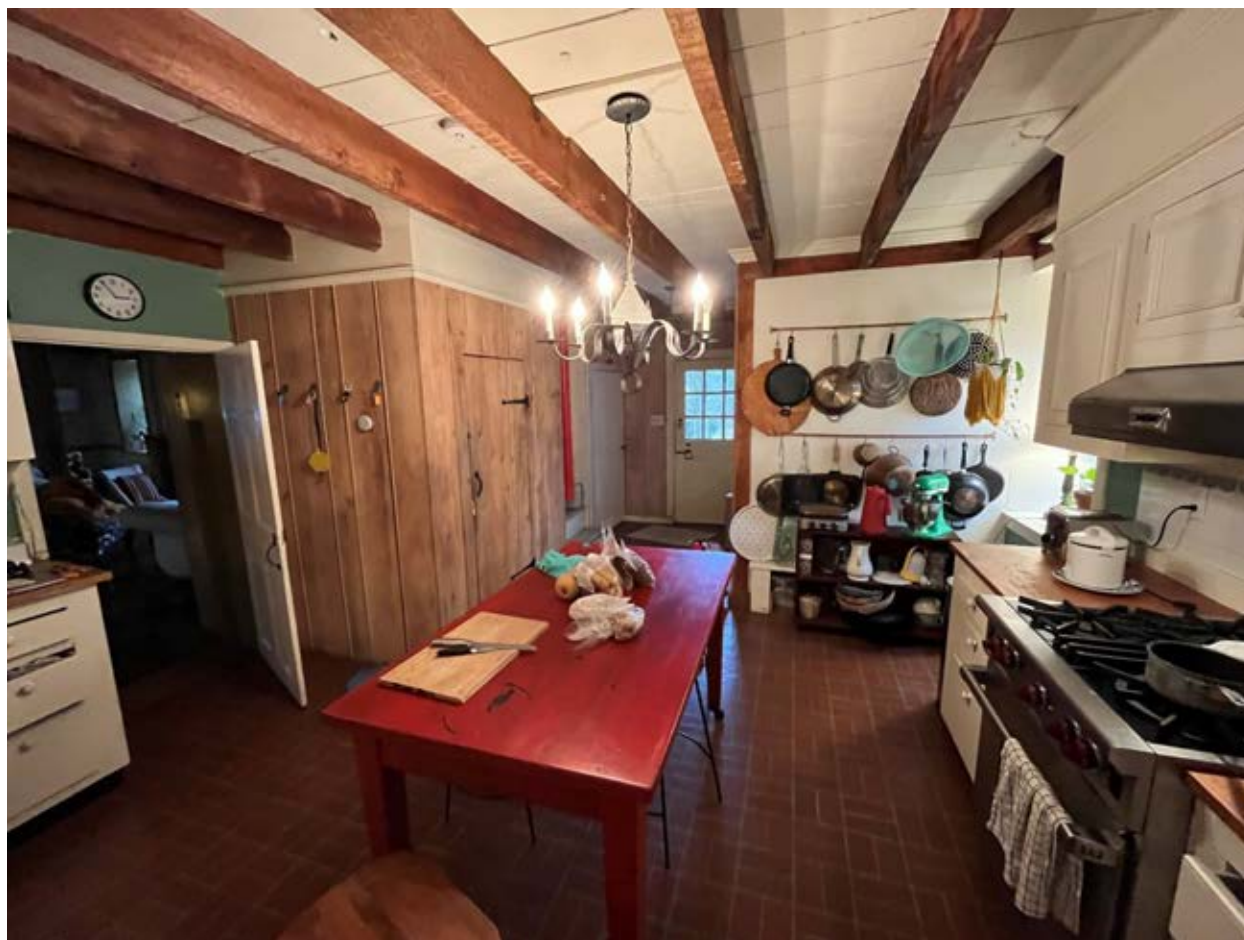
1-04: Kitchen, looking south

The kitchen, within the circa 1810 addition, is a rectangular room featuring tile flooring with a basket weave design (Photo, 1-04). It has plaster walls and rough-cut timber beams, oriented in a north-south direction, supporting a painted wood plank ceiling. The kitchen has a built-in pantry and an exterior door located on the south wall. West of this door is a small, contemporary half bathroom and to the east is a door leading to the basement stairway, beside which two steps lead up to a small landing with a folding door. The stairway continues from the landing to one of the second-floor bedrooms (Photo, 1-05).

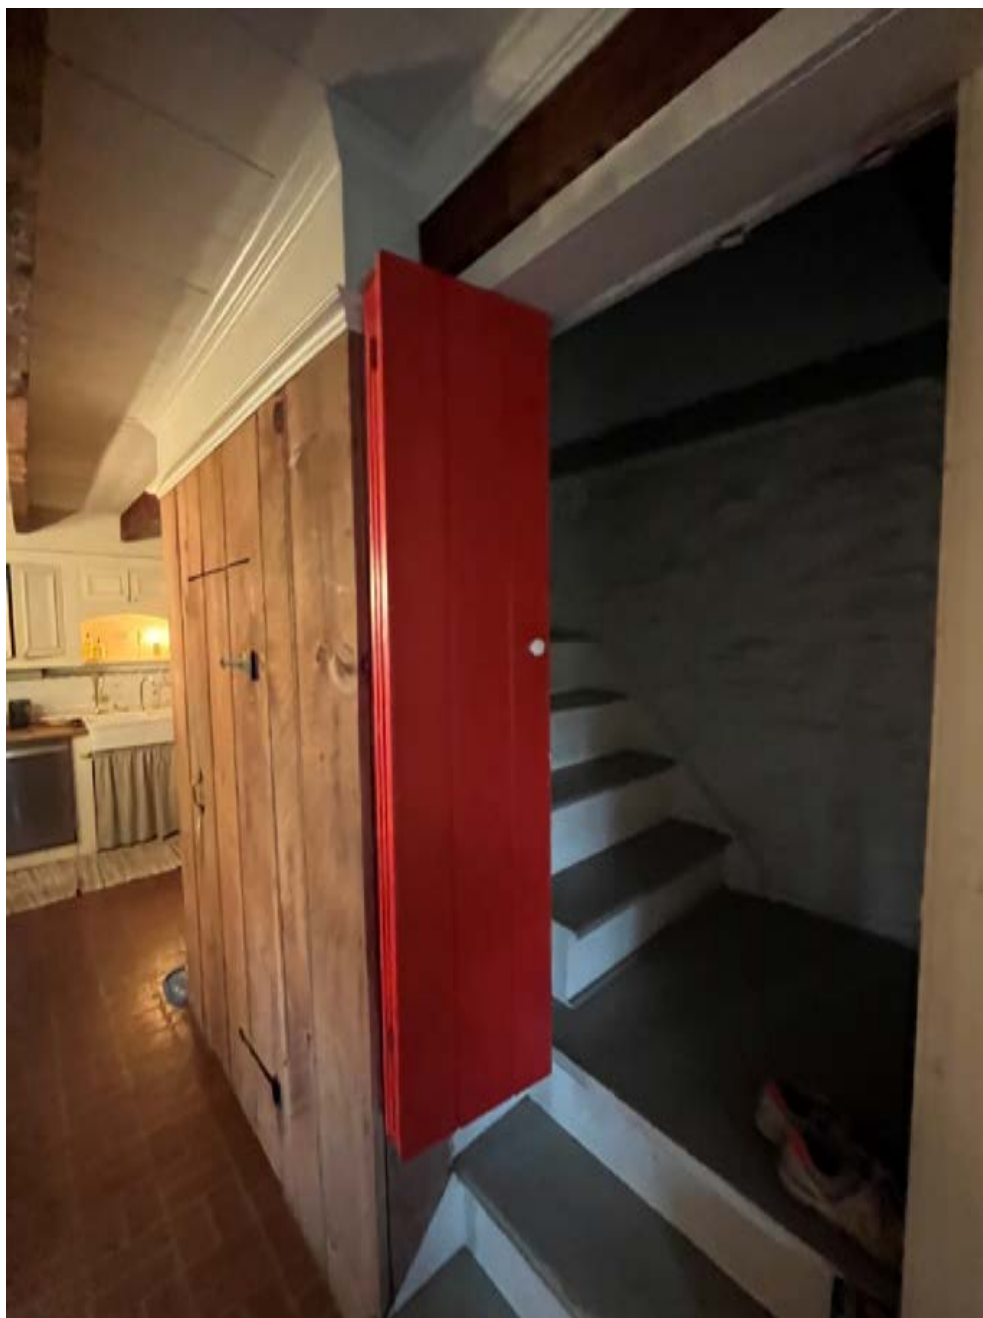
1-05: Kitchen, detail of secondary stair looking east

The secondary bedroom features a similar design as the rest of the second floor (Photo, 2-03). The room has stained hardwood flooring and has short knee walls and a low-sloped ceiling. The west exterior wall has a projecting chimney finished in plaster flanked by two-over-two wood windows. The four corners of the room each have built-in storage spaces concealed by wooden access doors. To the east, the stair leading to the kitchen is concealed by a wood-paneled partition.
