# National Register of Historic Places Registration Form

historic name Roosa House

street & number 882 Berme Road

city or town High Falls (Marbletown)

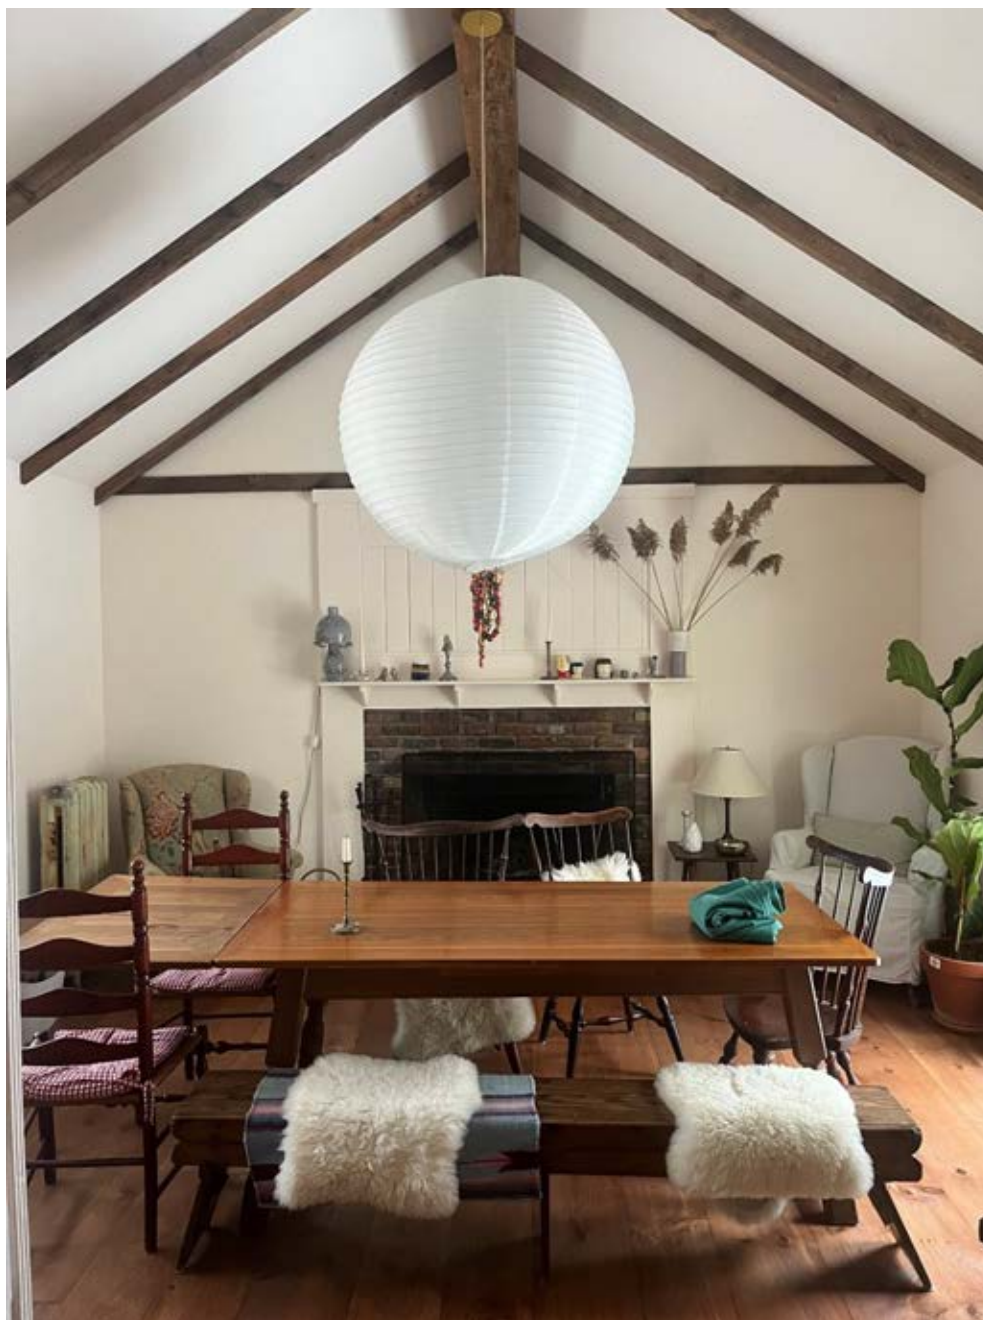
1-06: Dining room, looking northeast

Connected to the north end of the kitchen via a square doorway is the dining room, which occupies the entire circa 1950 rear addition (Photo, 1-06). The room is defined by contemporary hardwood flooring, plain plaster walls and a vaulted ceiling with exposed wood rafters. A modern light fixture is also suspended in the center of the room. Centered on the north wall is a brick fireplace with a bracketed wood mantle painted the same color as the walls.

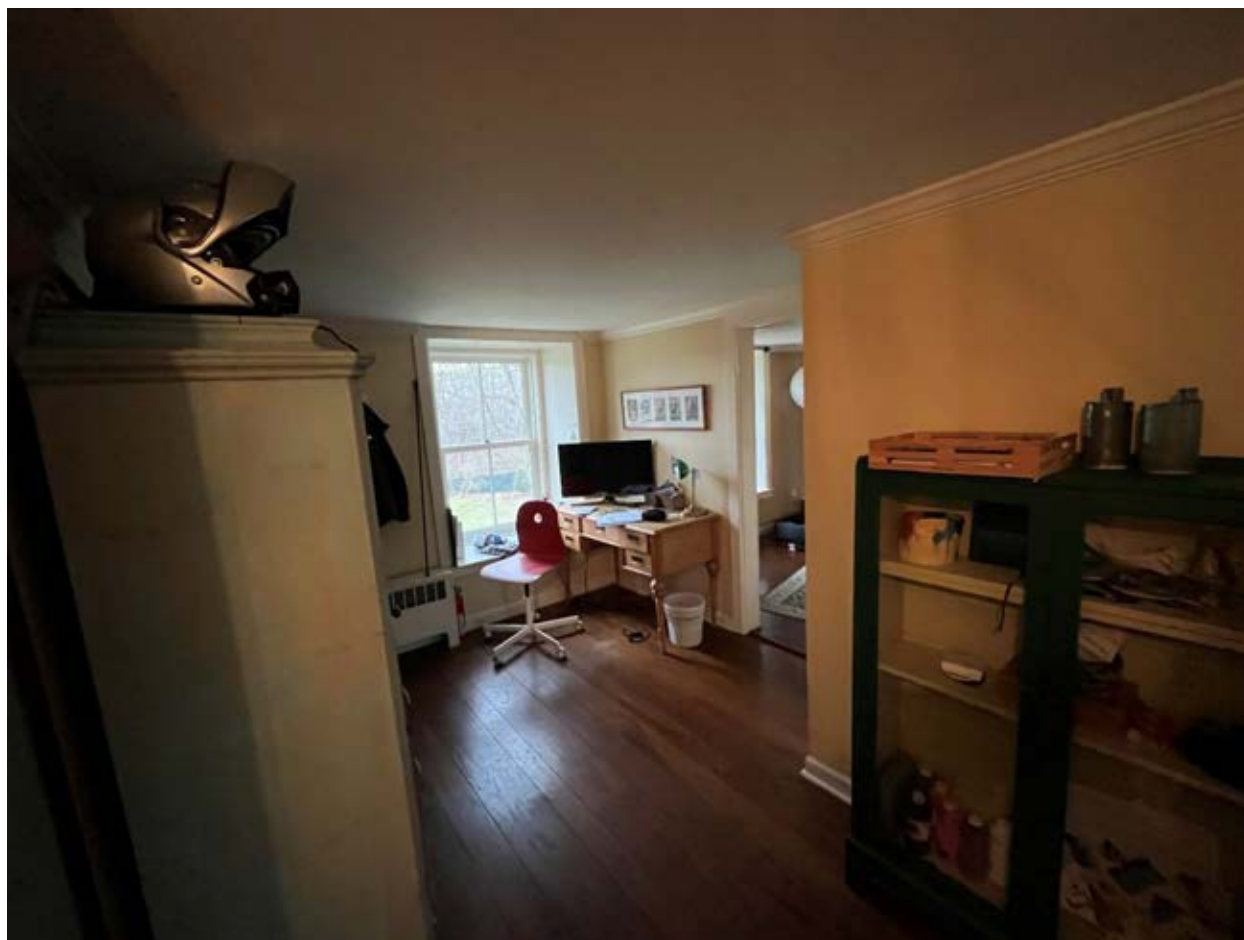
2-01: Second-story hall, looking west

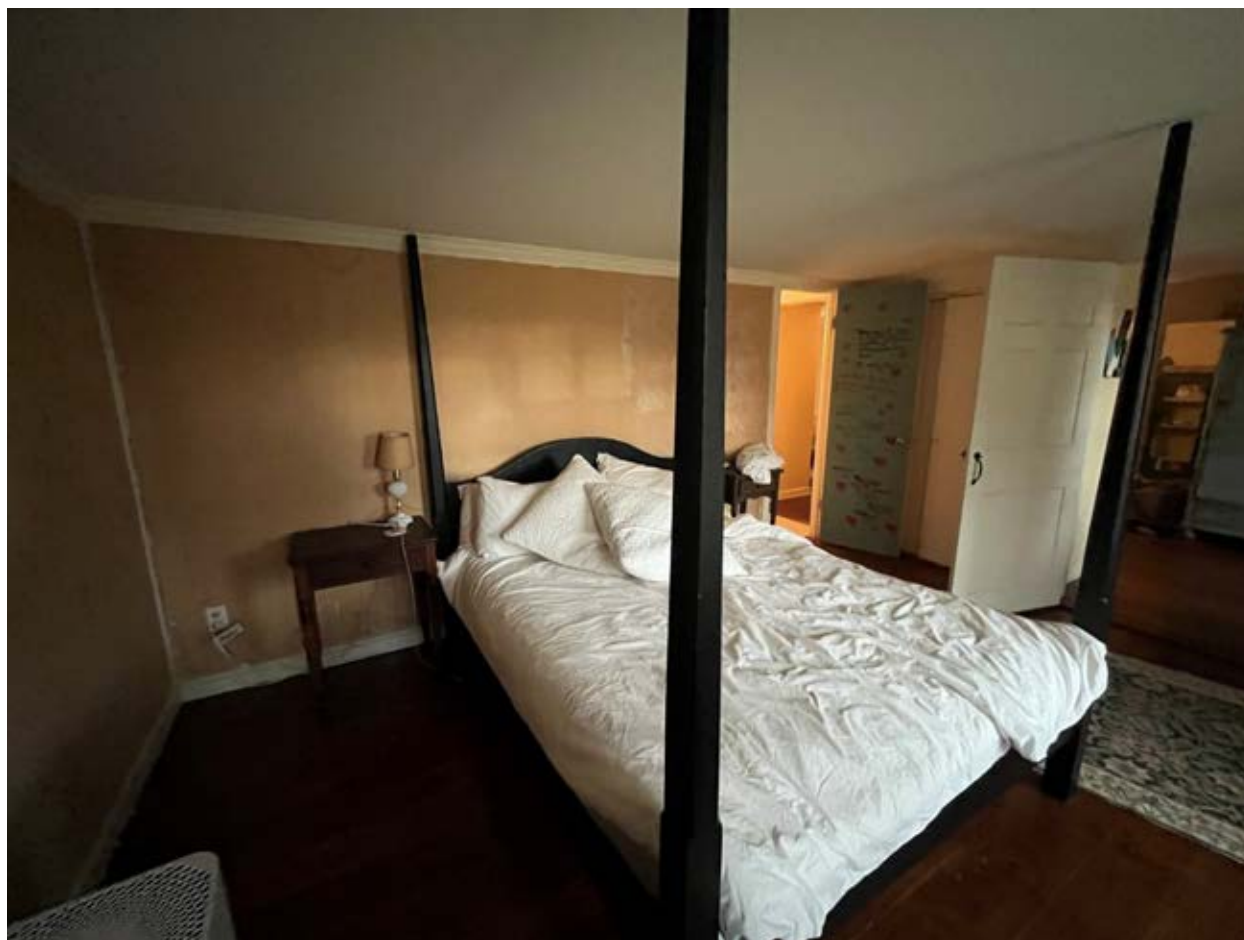
2-02: Master bedroom, looking east

The bedroom has two windows on its south wall and a flush-painted wood door to the west leading to the bathroom (Photo, 2-02). The bathroom has contemporary finishes, tile flooring, and simple wainscoting walls. A smaller doorway measuring four feet in height on the west wall of this room cuts through the original stone wall and leads to a secondary bedroom, directly above the kitchen.

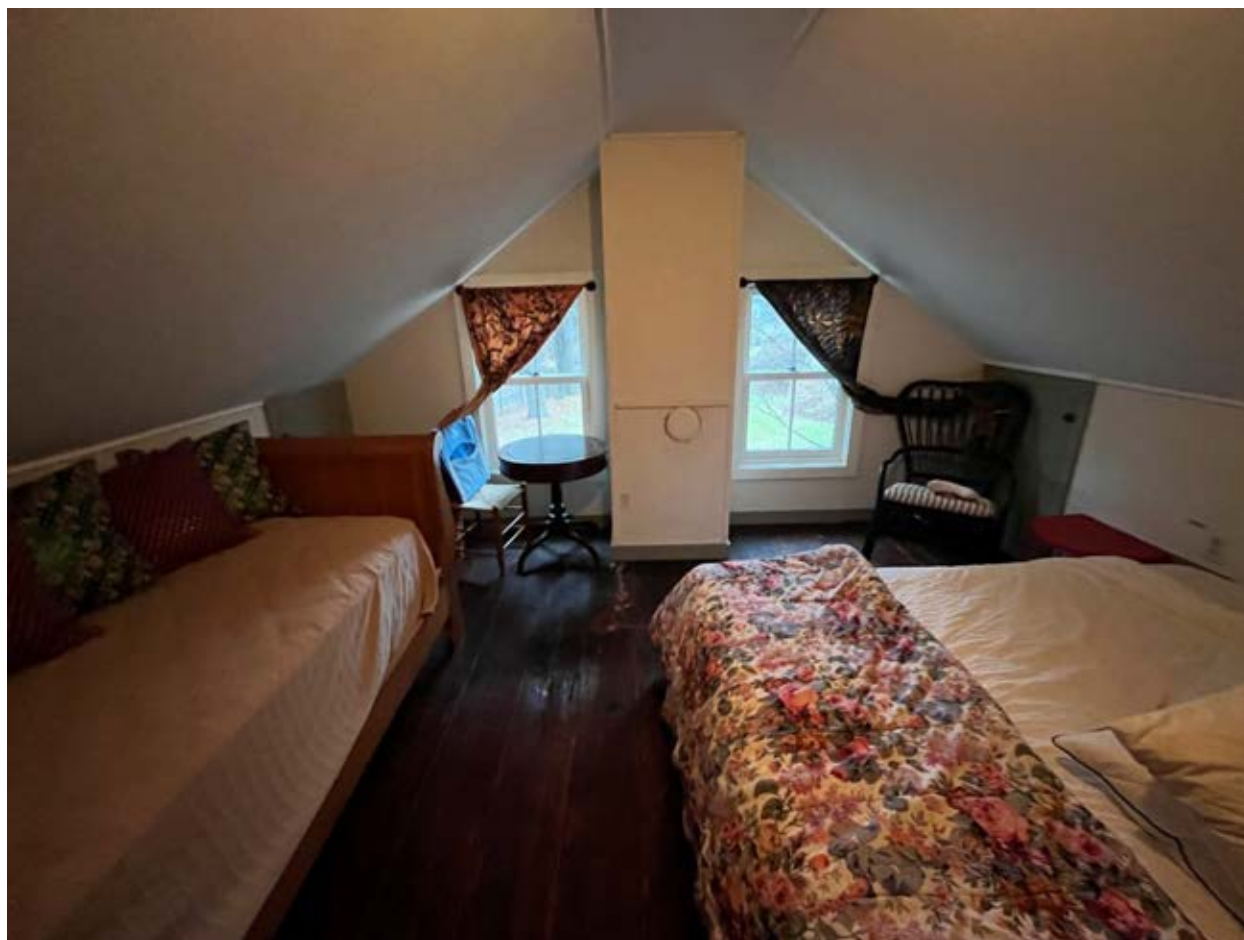
2-03: Secondary bedroom, looking northwest

The secondary bedroom features a similar design as the rest of the second floor (Photo, 2-03). The room has stained hardwood flooring and has short knee walls and a low-sloped ceiling. The west exterior wall has a projecting chimney finished in plaster flanked by two-over-two wood windows. The four corners of the room each have built-in storage spaces concealed by wooden access doors. To the east, the stair leading to the kitchen is concealed by a wood-paneled partition.

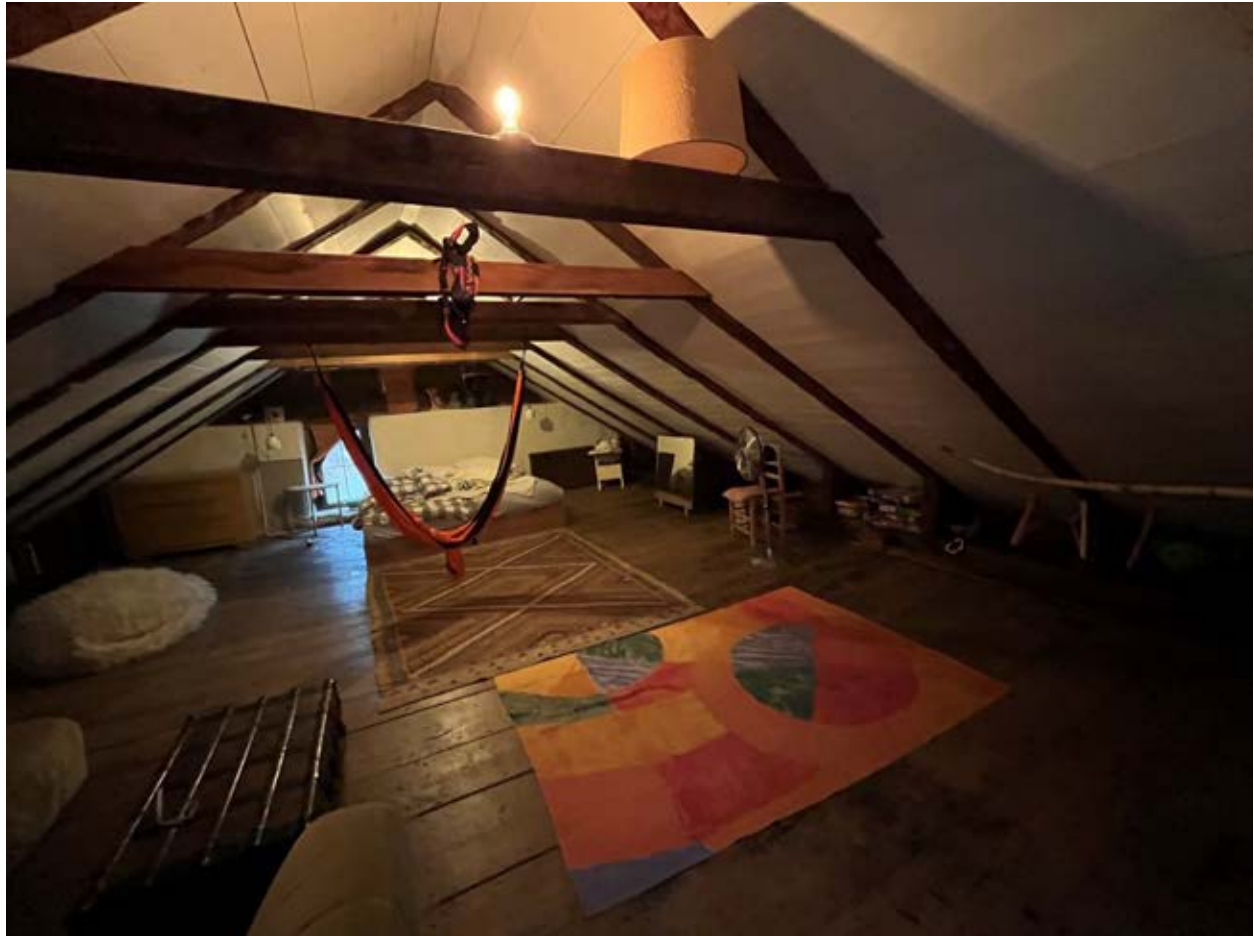
3-01: Attic, looking north

The attic space above the original portion of the house has been converted into a combination bedroom and living space (Photo, 3-01). The room follows the shape of the gabled roof above, finished with original wood plank walls accented with heavy timber trusses that line the room. The plank floor is similar in material and design to the first story, indicating that it was likely an original feature.

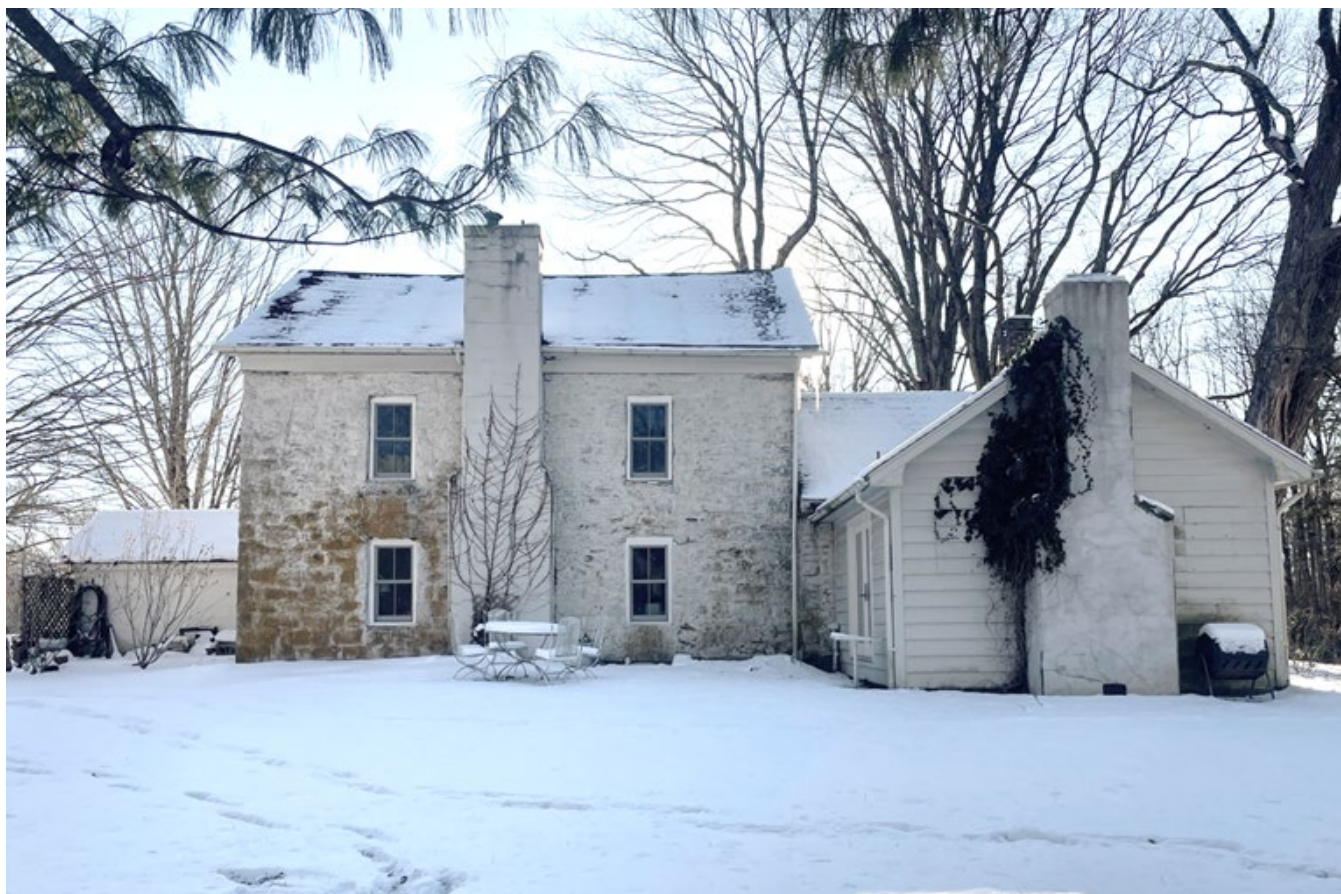
Figure 1. Roosa House, exterior back view looking southwest, 2025. Ippolita Ferrari.

The Roosa house was built using a combination of bluestone and limestone and laid in an ashlar pattern. Most of the exterior stonework on the house is light-colored. However, there are yellow and brown discolored stones on the northeast corner of the rear main portion of the house, brought on by years of rot from an ivy wall (Photo, E-05 and Figure, 1). It was removed before the current owners purchased the house and the discoloration is not noticeable from the front.

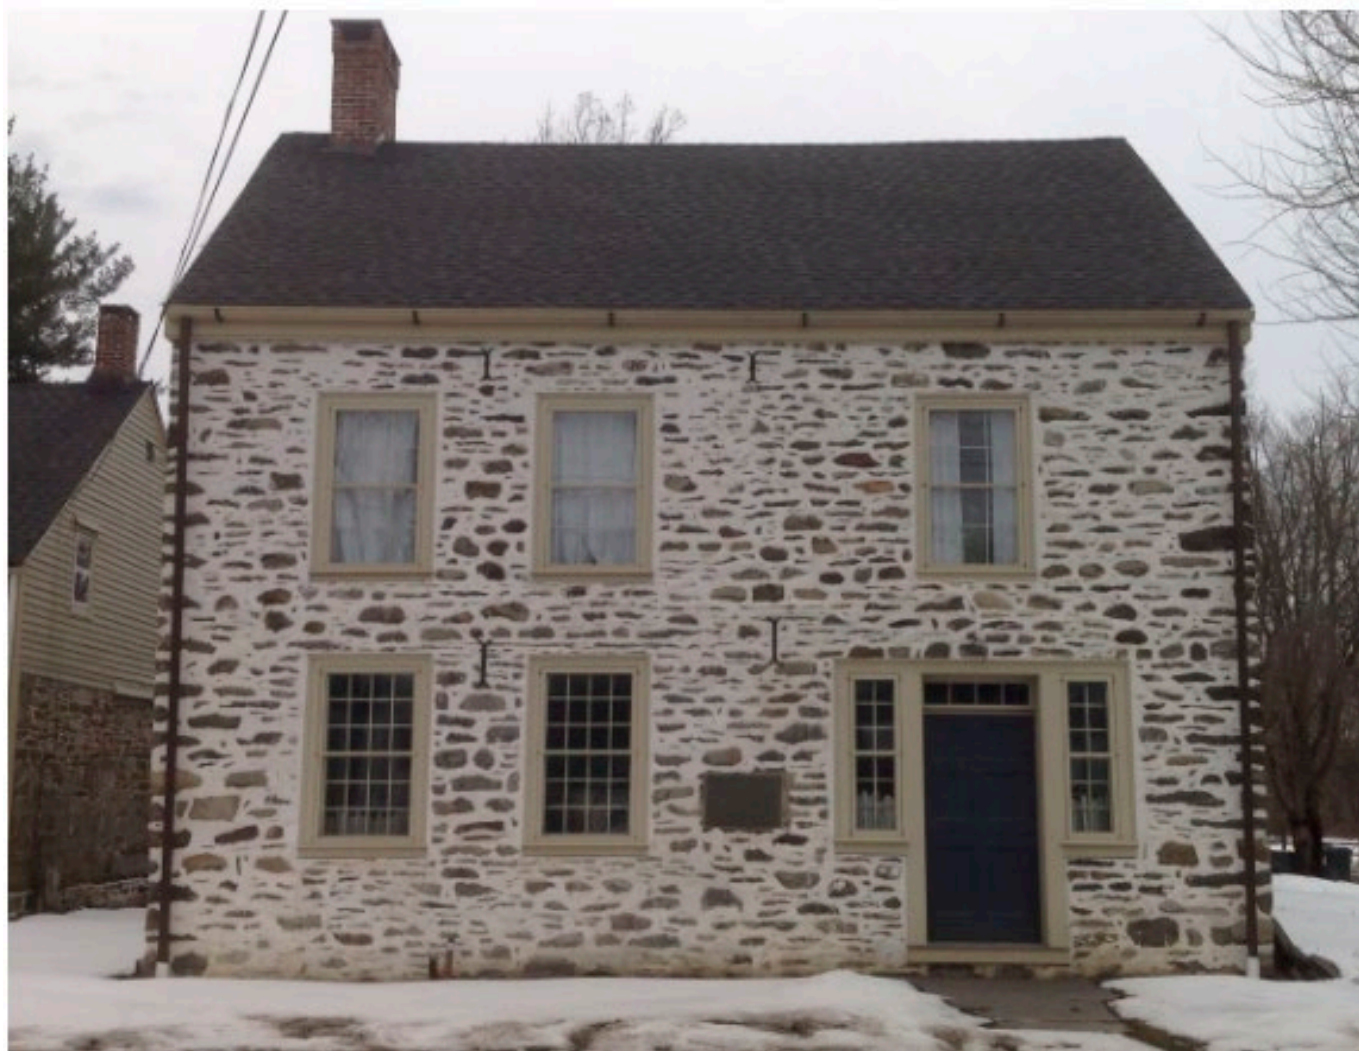
Figure 4. John Lounsbery facade, 2019. New York State Historic Preservation Office.

The two-story, side-passage-plan John Lounsbery House (NRHP, 1988) was built circa 1798 and is located at 3700 Main Street in Stone Ridge (Figure, 4). It has traditional Dutch Colonial features but is more symmetrical in the contemporary manner of the Federal style. It is another two-story masonry, three-bay wide, institutional/former dwelling with Dutch Colonial and Federal style characteristics. It has an asphalt shingled side gable roof with two interior brick chimneys and stone wall construction and foundation. It too has a side hall entry with sidelights around the door and it has twelve-over-twelve windows. Its stone walls were laid with small, random-sized stones, in contrast to the carefully laid limestone ashlar of its neighbors, including the Roosa House, which suggests the exterior was originally plastered or whitewashed to update its appearance.<sup>19</sup>

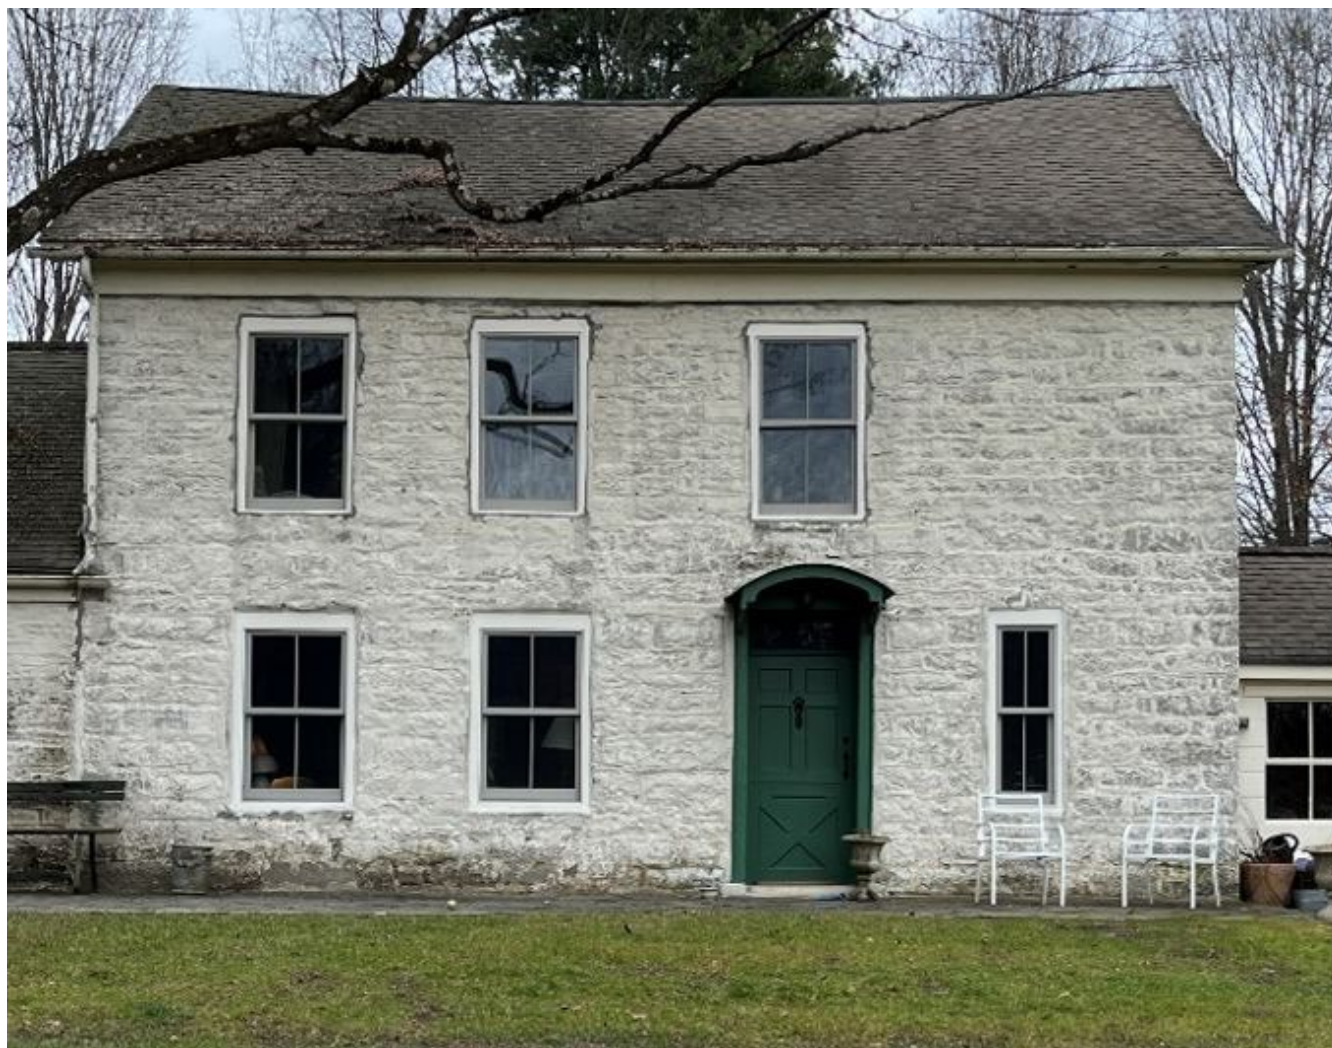
Figure 5. Roosa House Façade of Original Portion, 2024. Photographed by Ippolita Ferrari.

The Roosa House was built in four distinct phases of development to accommodate its continuous use as a single-family residence since circa 1790. The original house is a two-and-one half-story, coursed rubble stone block with a stone foundation and asphalt shingle side-gabled roof. A slightly smaller, one-and-one-half-story projection erected circa 1810, extends to the west, with additional, more contemporary additions present to the east and north behind the façade. The foundation of the original block and first addition is historic rubble stone. Its more recent additions have foundations made of concrete blocks.
