## **Diving Inspection Report**

Re: Underwater Investigation of the Poughkeepsie Railroad Bridge  
McLaren File No. 106158

BRIDGE DIVING INSPECTION AND CONDITION REPORT

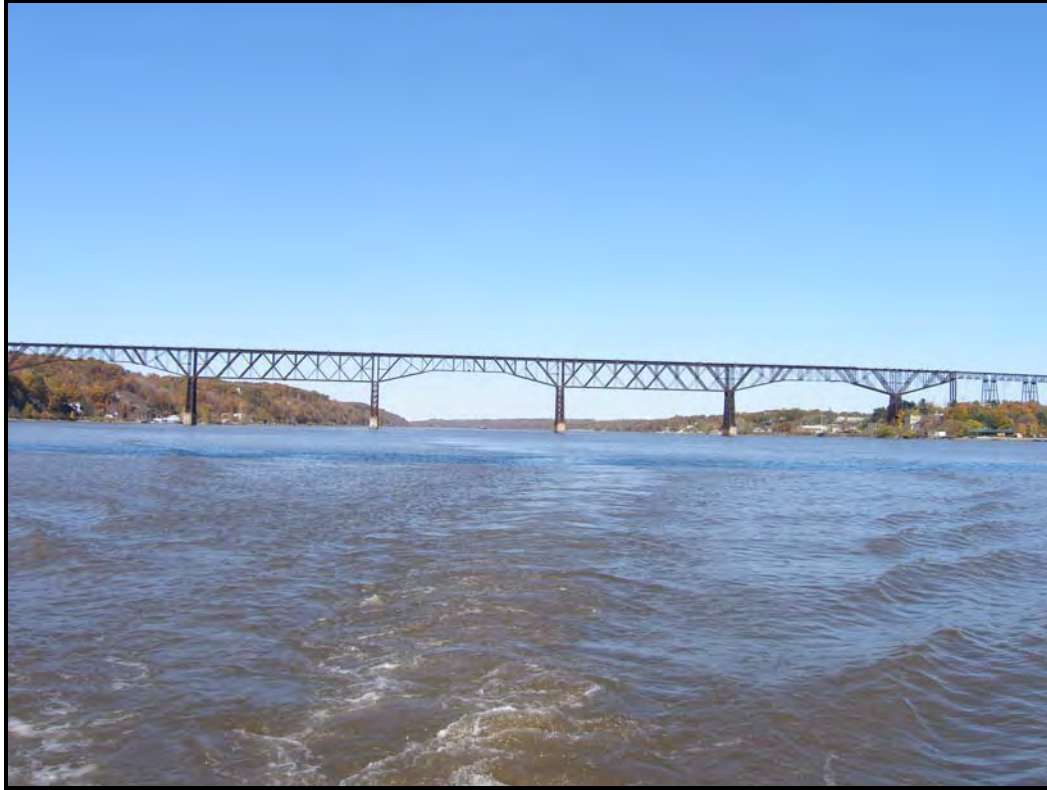
Photo 1 – Overall view of the river spans of the bridge, looking north.

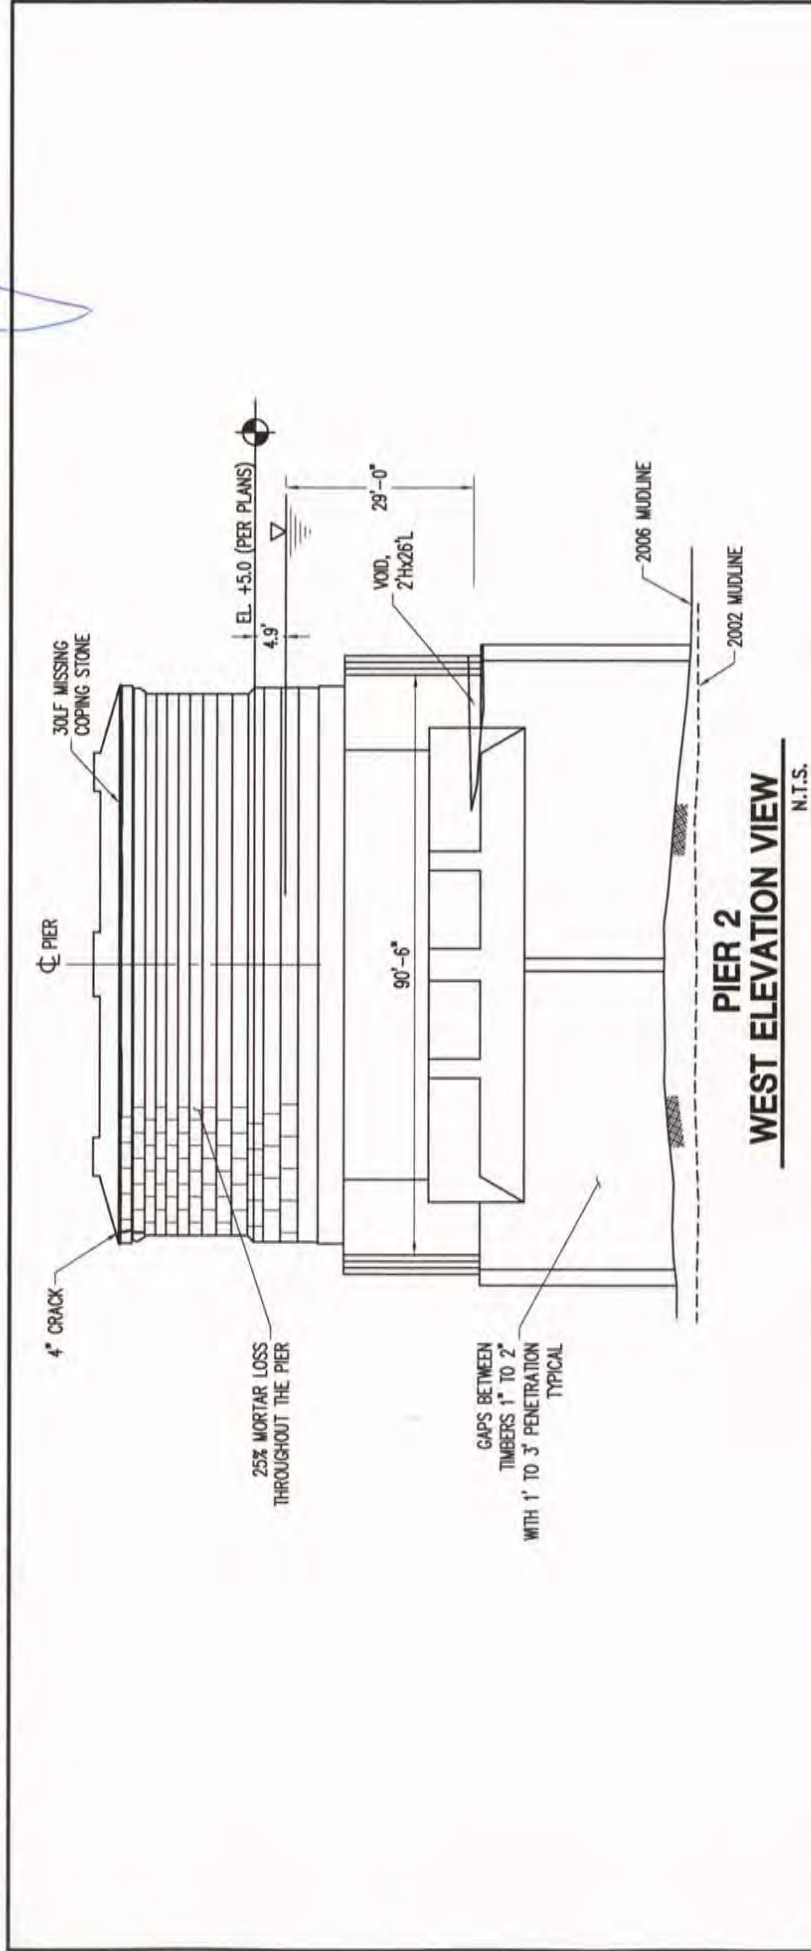
UNIT: PIER 2

Depth: (ft) 2006	61.0	59.0	63.0
Depth: (ft) 2002	64.0	64.0	64.0
STATION: (ft)	0+00	0+50	1+00
VIDEO TIME:	Not taken due to poor visibility		
UNDERMINE HORIZ./VERT.	NONE		
FOUNDATION TYPE:	STONE & GRAVEL WITH CONCRETE FILLED TIMBER CRIB		
REMARKS:	N/A		
PILE TYPE:	N/A		
PILE LENGTH:	N/A

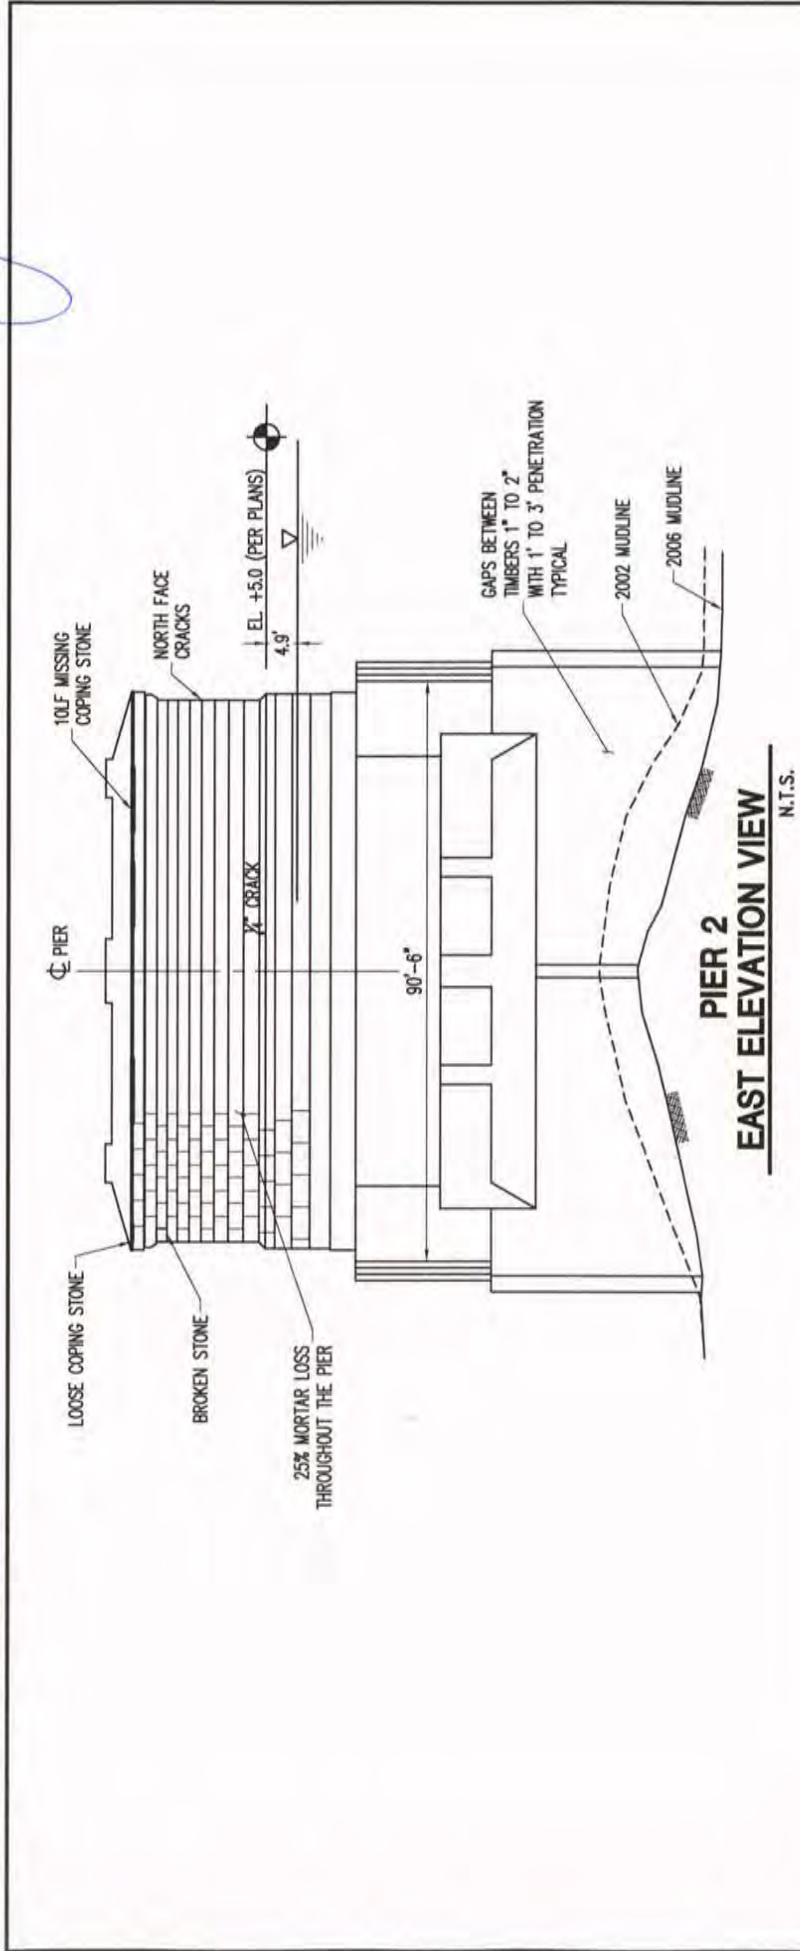
Depth: (ft) 2006	63.0	53.0	66.0
Depth: (ft) 2002	63.0	47.0	63.0
STATION: (ft)	1+00	0+50	0+00

VIDEO TIME: Not taken due to poor visibility

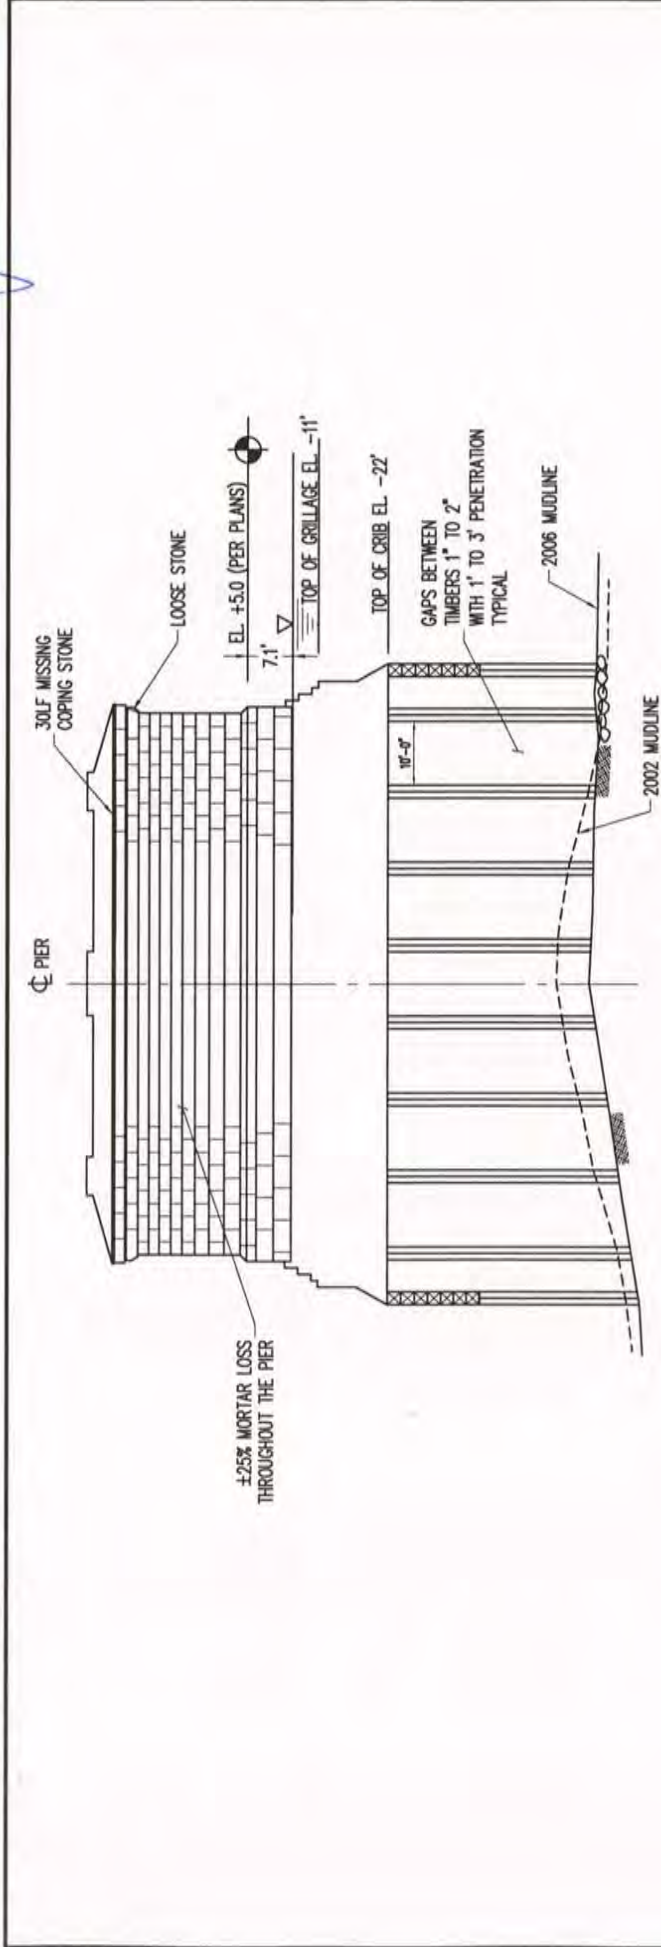
**PIER 3**  
**WEST ELEVATION VIEW**  
N.T.S.

Depth: (ft) 2006	54.0	46.0	47.0
Depth: (ft) 2002	52.0	41.0	49.0
STATION: (ft)	0+00	0+50	1+00

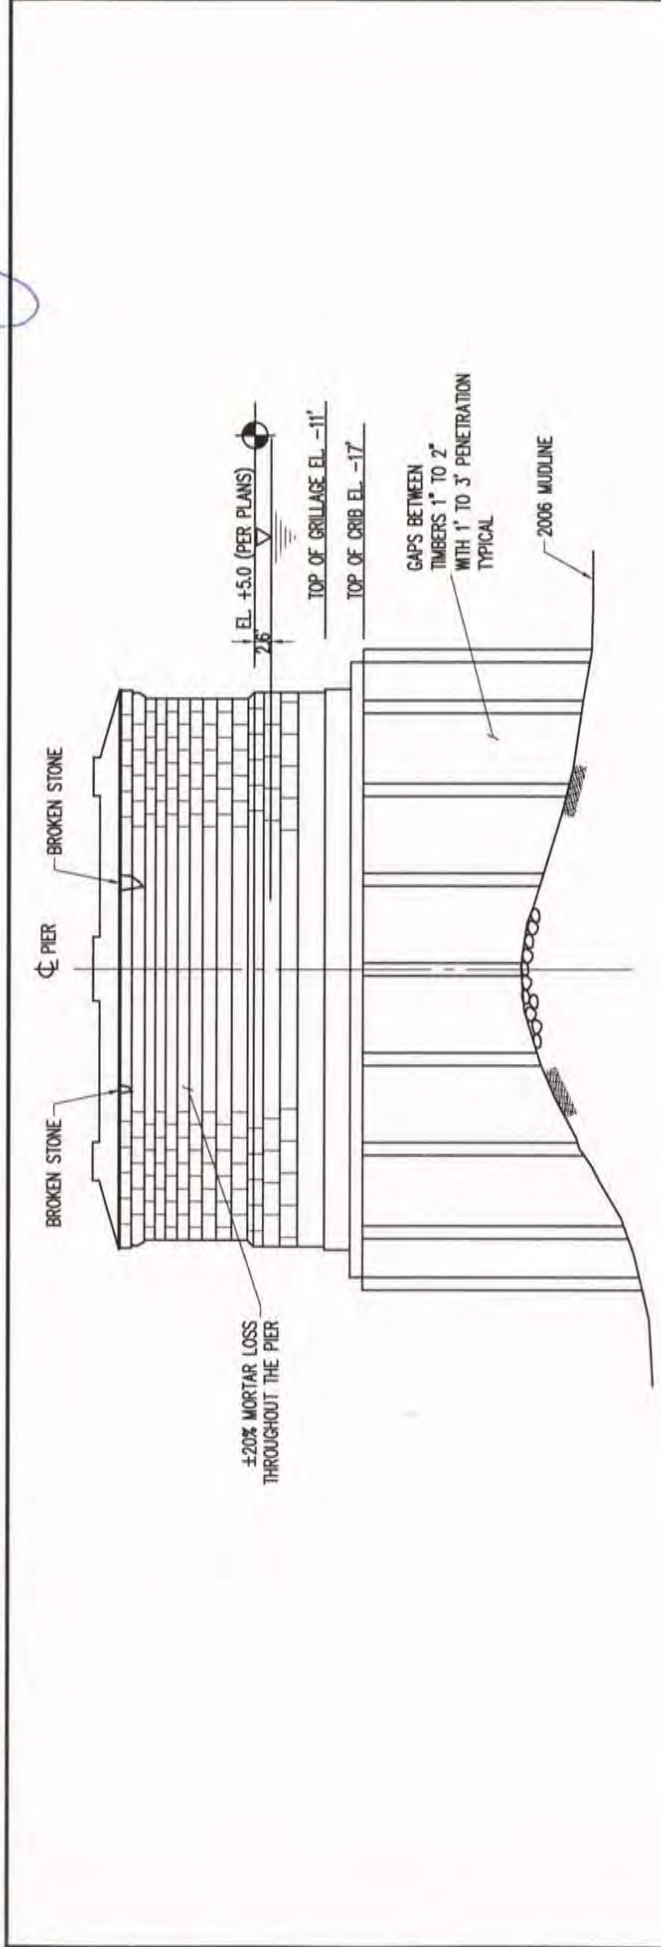
**PIER 4**  
**WEST ELEVATION VIEW**  
 N.T.S.

Depth: (ft) 2006	58.0	39.0	50.0
Depth: (ft) 2002	N/A	N/A	N/A
STATION: (ft)	0+00	0+50	1+00
VIDEO TIME:	Not taken due to poor visibility		
UNDERMINE HORIZ./VERT.	NONE		
FOUNDATION TYPE:	STONE & GRAVEL WITH CONCRETE FILLED TIMBER CRIB		
REMARKS:	PILE TYPE: _____ PILE LENGTH: _____ N/A N/A

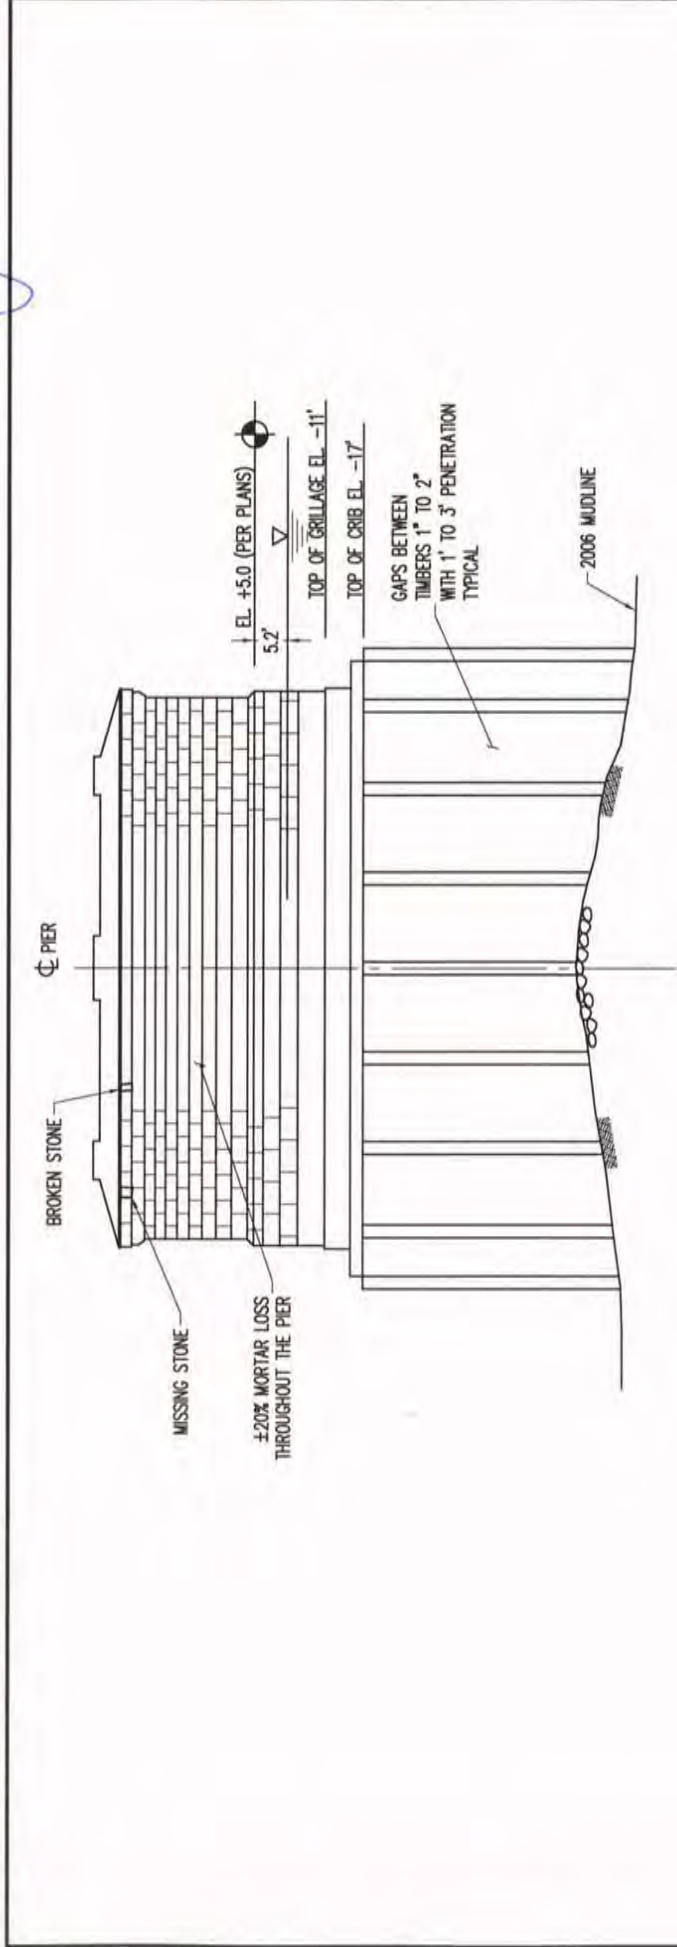
**PIER 5**  
**WEST ELEVATION VIEW**  
 N.T.S.

Depth: (ft) 2006	52.0	45.0	54.0
Depth: (ft) 2002	N/A		
STATION: (ft)	0+00	0+50	1+00
VIDEO TIME:	Not taken due to poor visibility		
UNDERMINE HORIZ./VERT.	NONE		
FOUNDATION TYPE:	STONE & GRAVEL WITH CONCRETE FILLED TIMBER CRIB		
REMARKS:	PILE TYPE: N/A PILE LENGTH: N/A

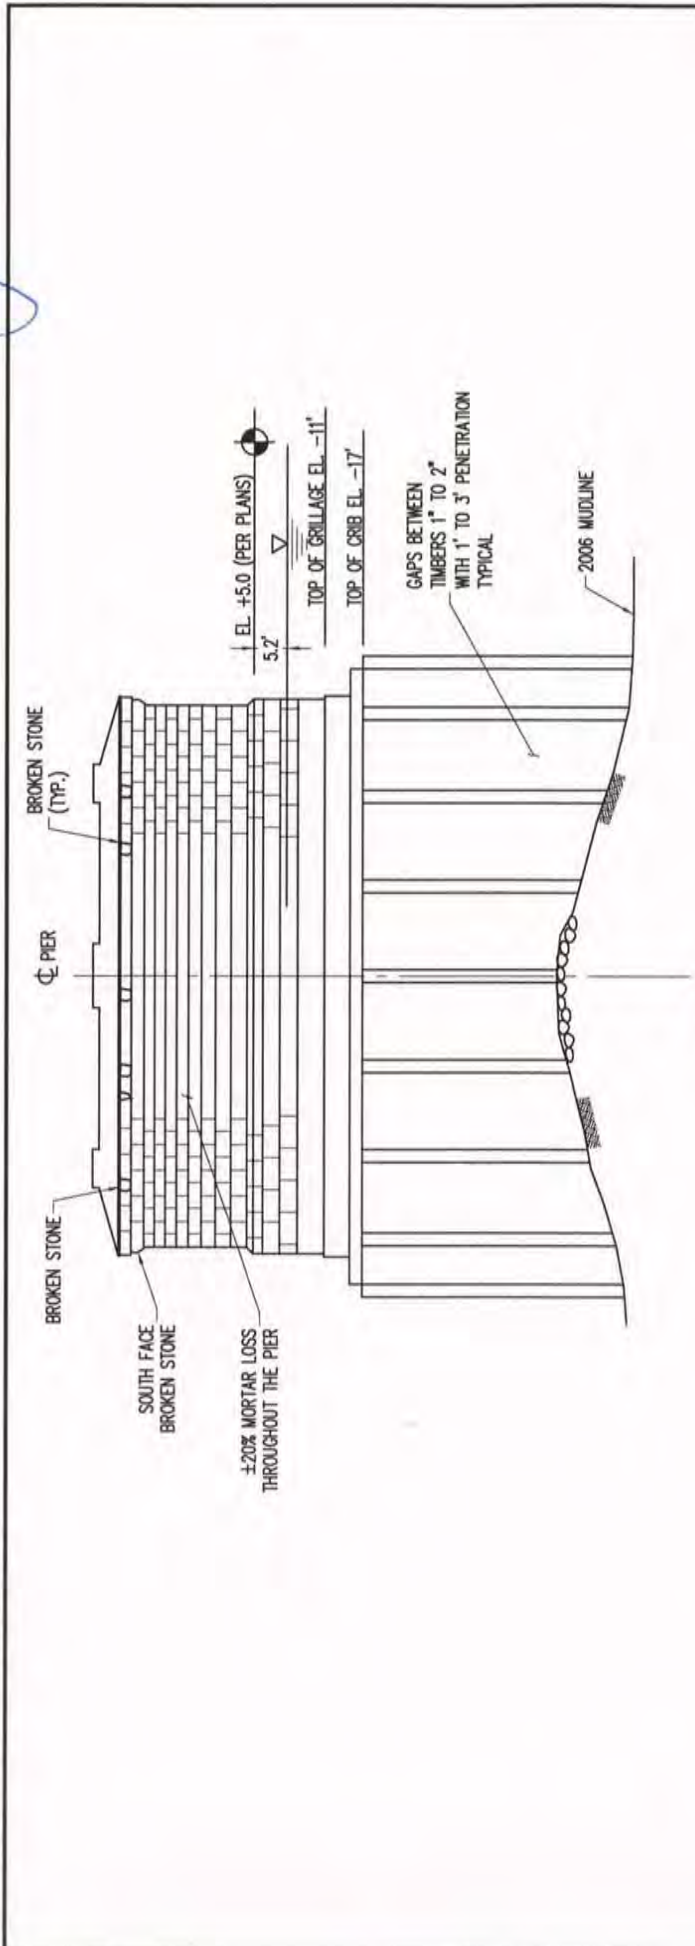
**PIER 5**  
**EAST ELEVATION VIEW**  
N.T.S.

Depth: (ft) 2006	54.0	42.0	53.0	
Depth: (ft) 2002	N/A			
STATION: (ft)	1+00	0+50	0+00	
VIDEO TIME:	Not taken due to poor visibility			
UNDERMINE HORIZ./VERT.	NONE			
FOUNDATION TYPE:	STONE & GRAVEL WITH CONCRETE FILLED TIMBER CRIB			
REMARKS:				PILE TYPE: N/A PILE LENGTH: N/A

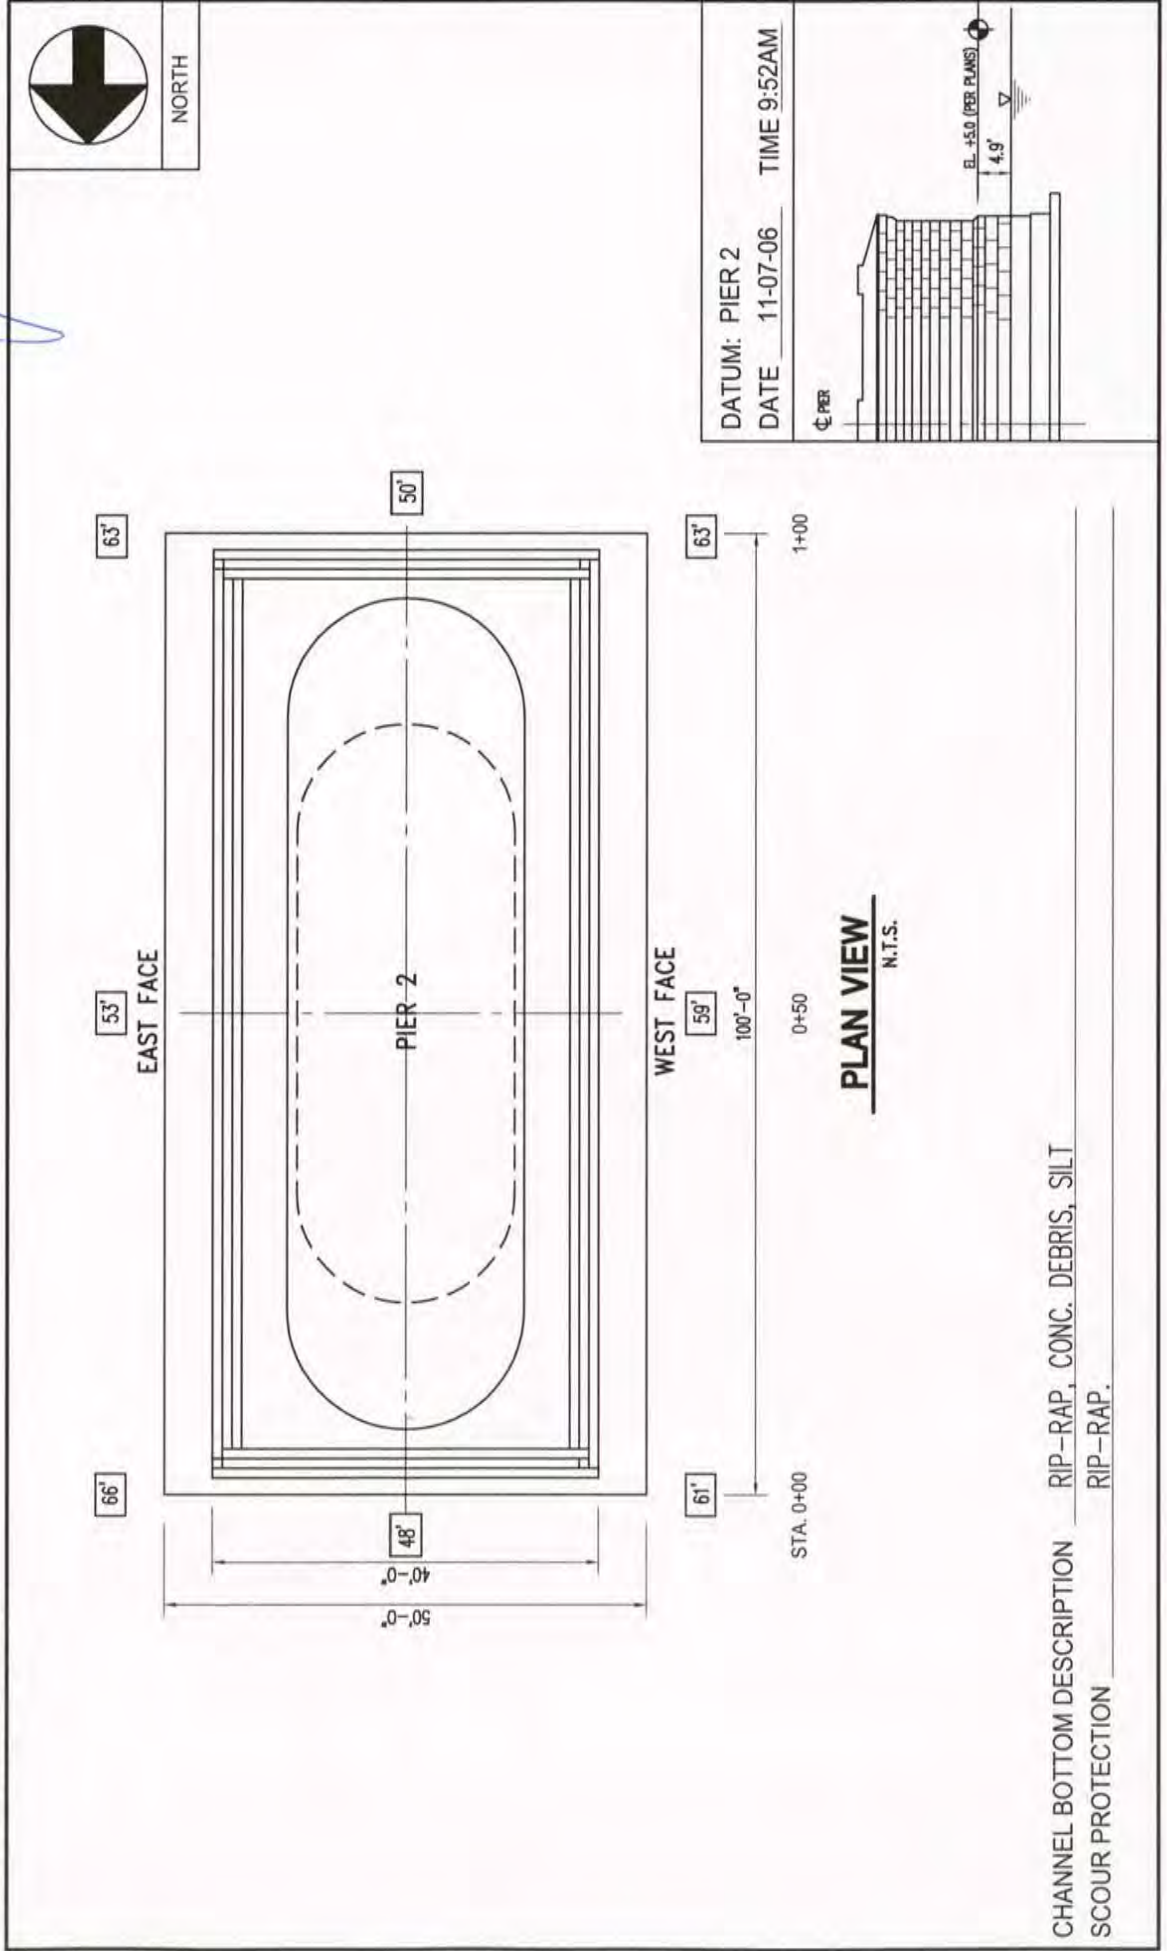
BIN 29.08 REGION 8 COUNTY 6 Sheet 23 of 35  
 FEATURE CARRIED POUGHKEEPSIE RAILROAD BRIDGE FEATURE CROSSED HUDSON RIVER  
 INSPECTED BY James V. Green TITLE P.E./DIVER DATE 11/07/2006  
 UNIT: PIER 2 DIVER'S CONFIRMATION: [Signature]

CHANNEL BOTTOM DESCRIPTION RIP-RAP, CONC. DEBRIS, SILT  
 SCOUR PROTECTION RIP-RAP.

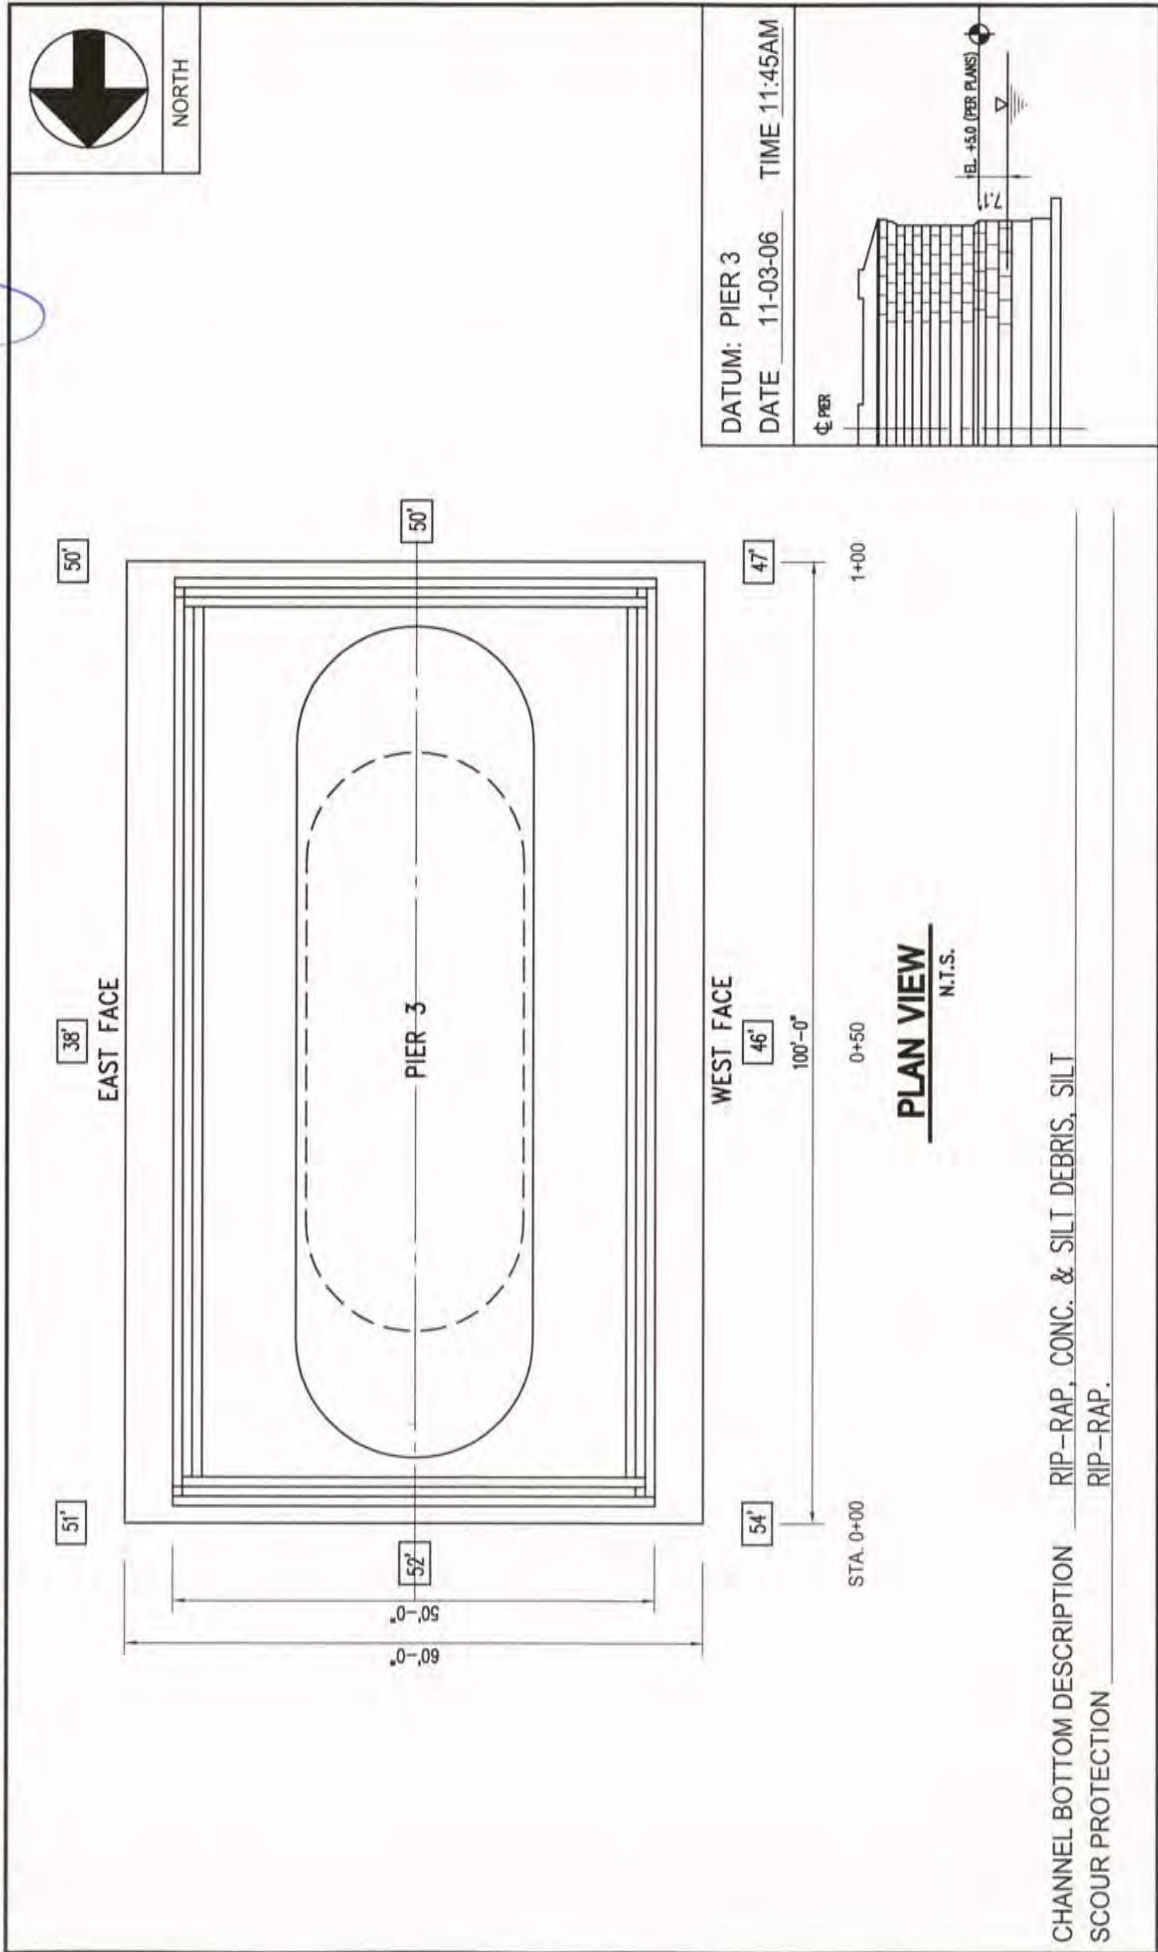
BIN 29.08 REGION 8 COUNTY 6 Sheet 24 of 35  
 FEATURE CARRIED POUGHKEEPSIE RAILROAD BRIDGE FEATURE CROSSED HUDSON RIVER  
 INSPECTED BY James V. Green TITLE P.E./DIVER DATE 11/07/2006  
 UNIT: PIER 3 DIVER'S CONFIRMATION: [Signature]

CHANNEL BOTTOM DESCRIPTION RIP-RAP, CONC. & SILT DEBRIS, SILT  
 SCOUR PROTECTION RIP-RAP.

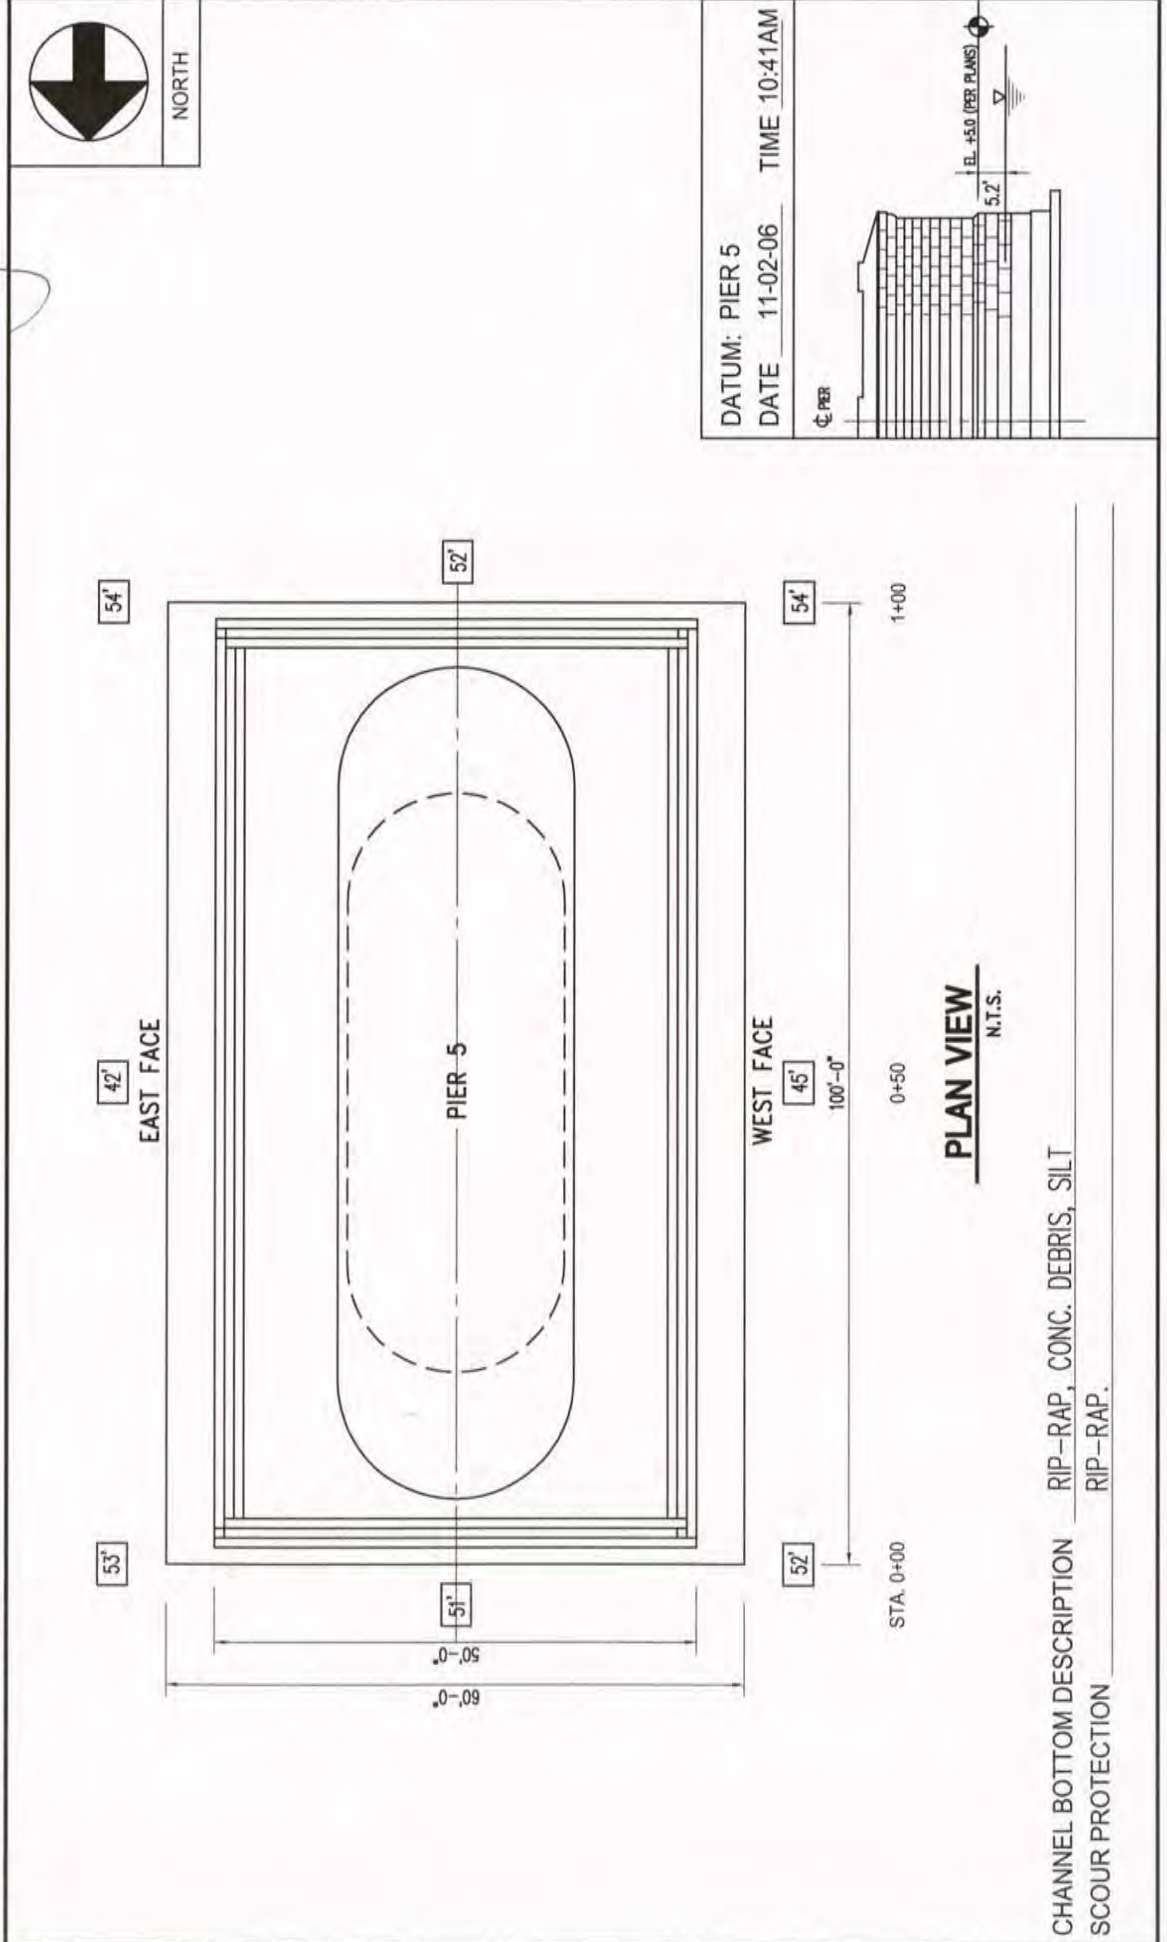
UNIT: PIER 5 DIVER'S CONFIRMATION: [Signature]

CHANNEL BOTTOM DESCRIPTION RIP-RAP, CONC. DEBRIS, SILT  
 SCOUR PROTECTION RIP-RAP.

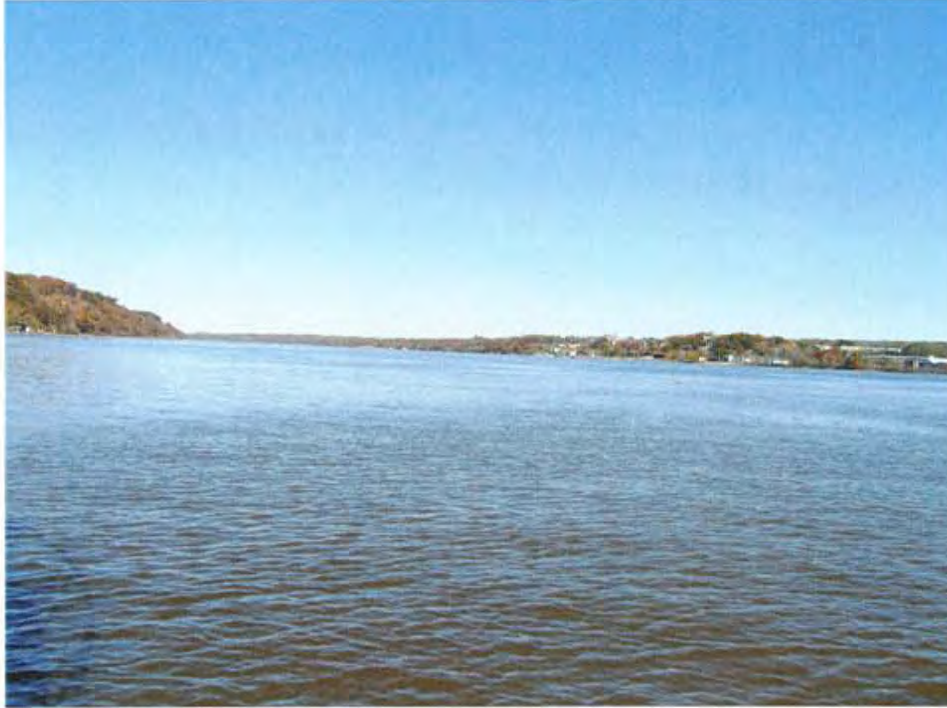
PHOTO NO.: 1  
LOCATION: \_\_\_\_\_  
Upstream

DESCRIPTION: \_\_\_\_\_  
General View  
Looking North

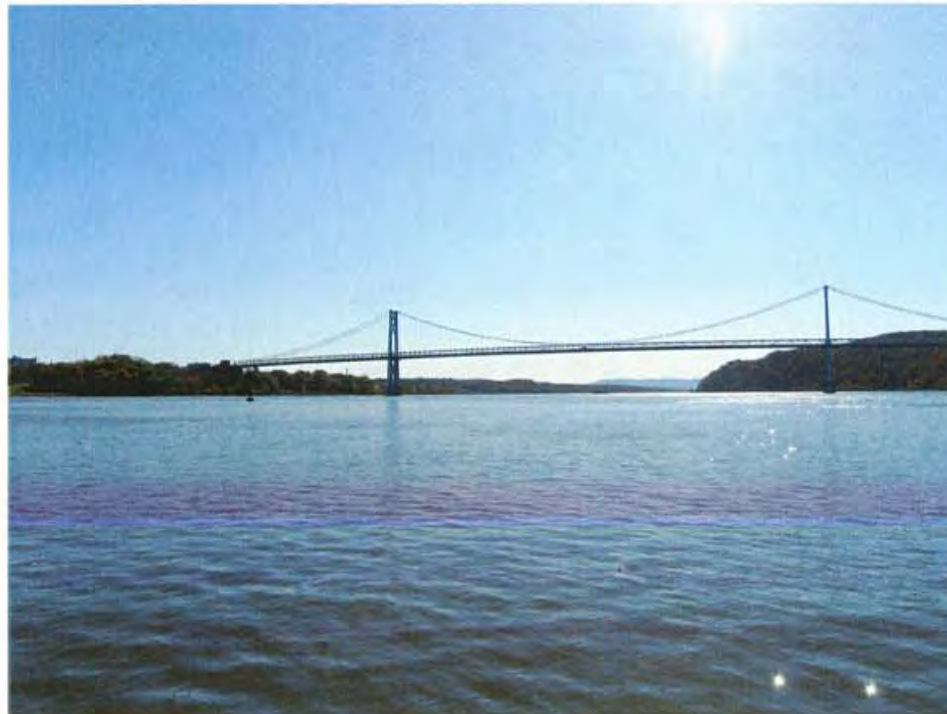
PHOTO NO.: 2  
LOCATION: \_\_\_\_\_  
Downstream

DESCRIPTION: \_\_\_\_\_  
General View  
Looking South

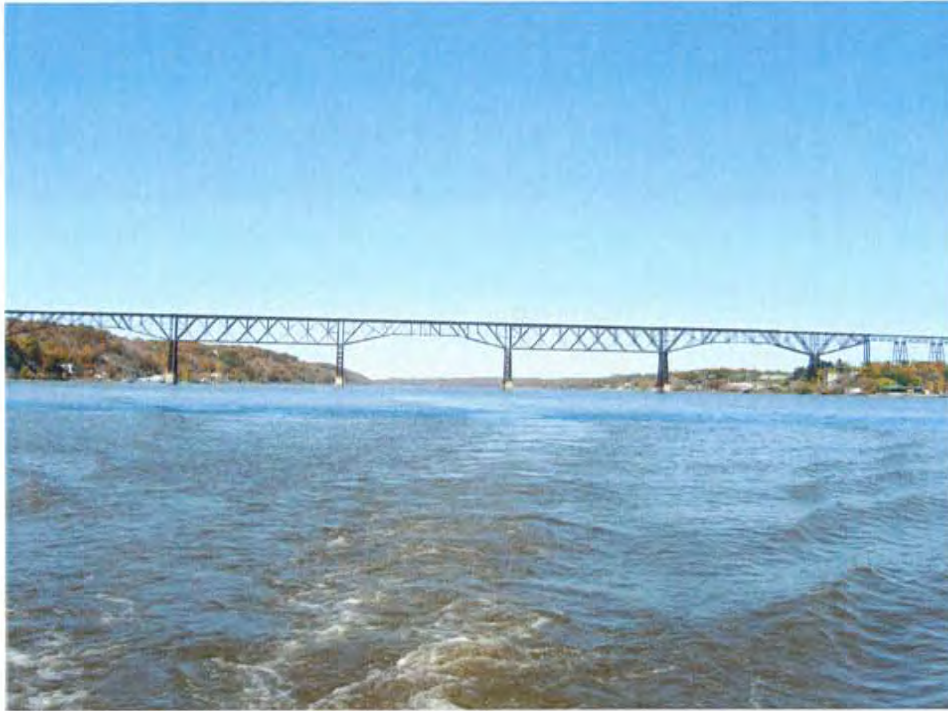
PHOTO NO.: 3  
LOCATION: \_\_\_\_\_  
South Elevation  
\_\_\_\_\_  
\_\_\_\_\_

DESCRIPTION: \_\_\_\_\_  
General View  
Looking North  
\_\_\_\_\_  
\_\_\_\_\_  
\_\_\_\_\_  
\_\_\_\_\_  
\_\_\_\_\_  
\_\_\_\_\_

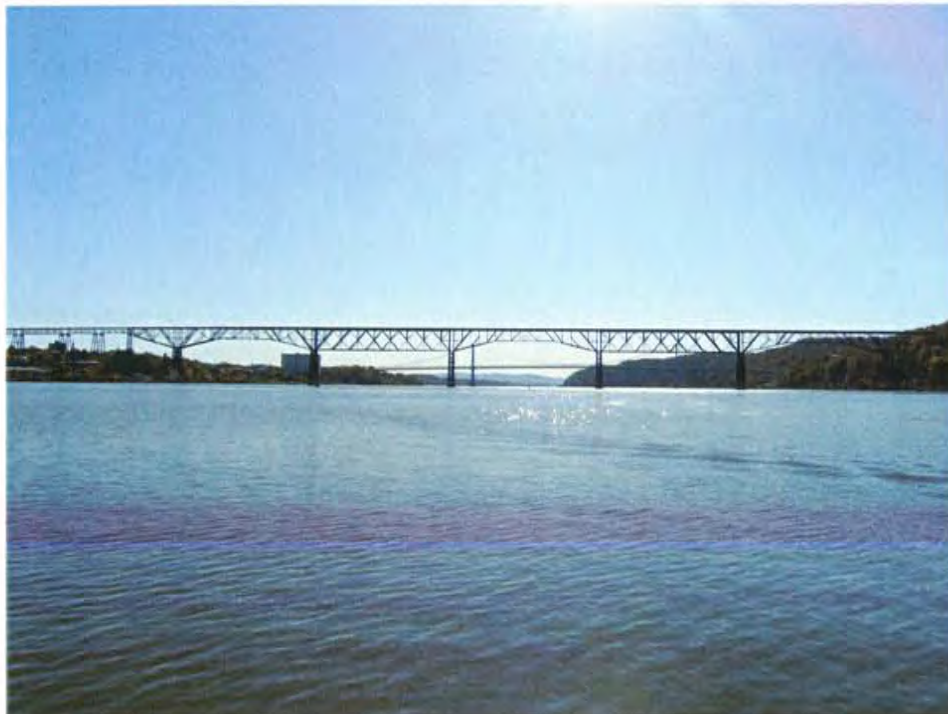
PHOTO NO.: 4  
LOCATION: \_\_\_\_\_  
North Elevation  
\_\_\_\_\_  
\_\_\_\_\_

DESCRIPTION: \_\_\_\_\_  
General View  
Looking South  
\_\_\_\_\_  
\_\_\_\_\_  
\_\_\_\_\_  
\_\_\_\_\_  
\_\_\_\_\_  
\_\_\_\_\_

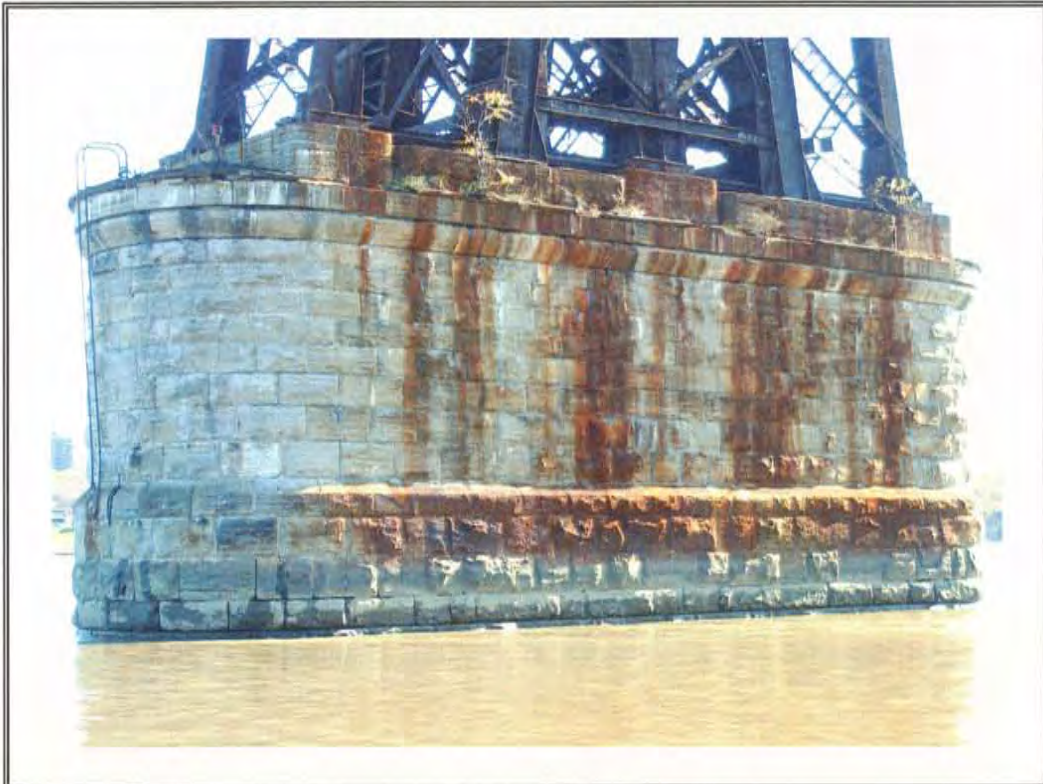
PHOTO NO.: 5  
LOCATION: \_\_\_\_\_  
Pier 2  
\_\_\_\_\_  
\_\_\_\_\_

DESCRIPTION: \_\_\_\_\_  
General View  
Looking Southeast  
\_\_\_\_\_  
\_\_\_\_\_  
\_\_\_\_\_  
\_\_\_\_\_  
\_\_\_\_\_  
\_\_\_\_\_

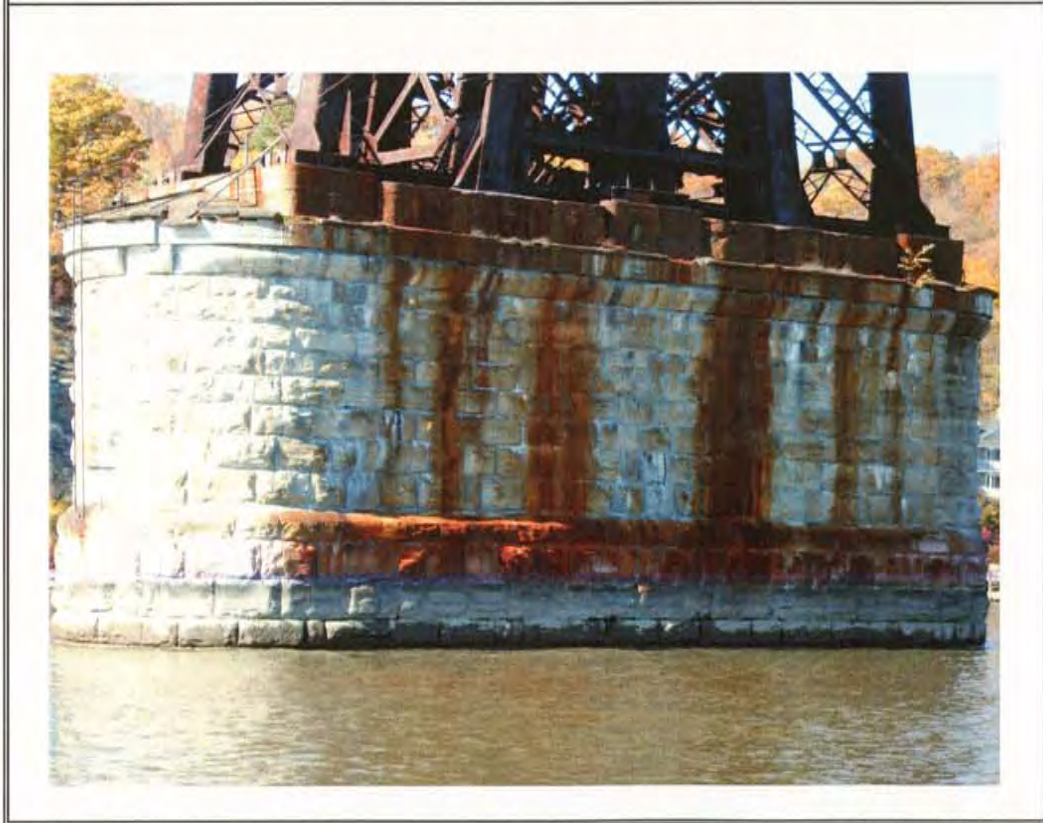
PHOTO NO.: 6  
LOCATION: \_\_\_\_\_  
Pier 2  
\_\_\_\_\_  
\_\_\_\_\_

DESCRIPTION: \_\_\_\_\_  
General View  
Looking Northwest  
\_\_\_\_\_  
\_\_\_\_\_  
\_\_\_\_\_  
\_\_\_\_\_  
\_\_\_\_\_  
\_\_\_\_\_

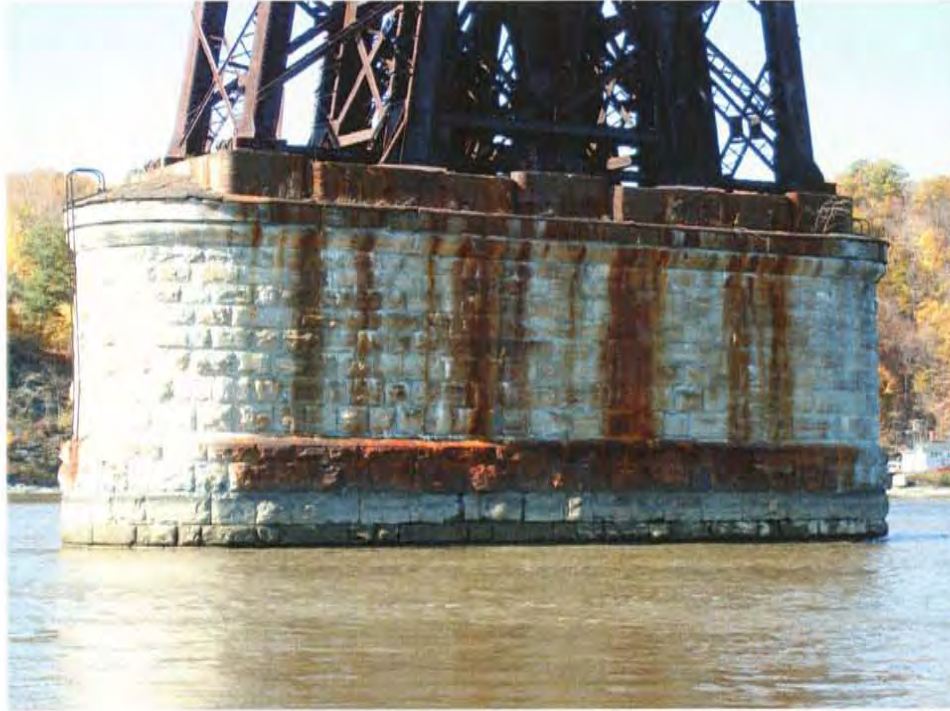
PHOTO NO.: 7  
LOCATION: \_\_\_\_\_  
Pier 3  
\_\_\_\_\_  
\_\_\_\_\_

DESCRIPTION: \_\_\_\_\_  
General View  
Looking Southeast  
\_\_\_\_\_  
\_\_\_\_\_  
\_\_\_\_\_  
\_\_\_\_\_  
\_\_\_\_\_  
\_\_\_\_\_  
\_\_\_\_\_

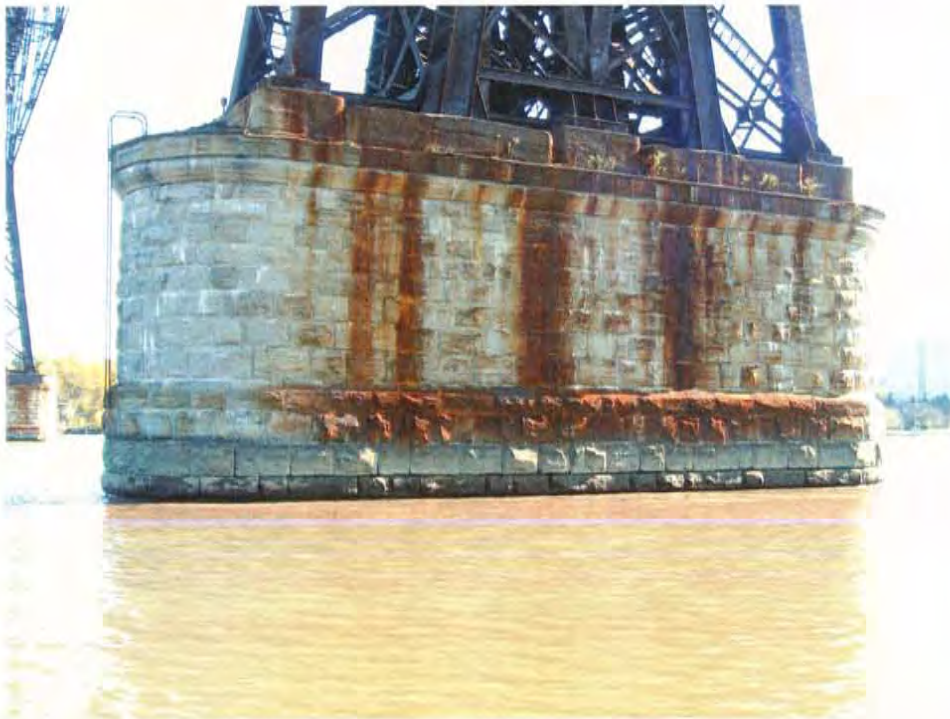
PHOTO NO.: 8  
LOCATION: \_\_\_\_\_  
Pier 3  
\_\_\_\_\_  
\_\_\_\_\_

DESCRIPTION: \_\_\_\_\_  
General View  
Looking Northwest  
\_\_\_\_\_  
\_\_\_\_\_  
\_\_\_\_\_  
\_\_\_\_\_  
\_\_\_\_\_  
\_\_\_\_\_  
\_\_\_\_\_
