## **Diving Inspection Report**

Re: Underwater Investigation of the Poughkeepsie Railroad Bridge  
McLaren File No. 106158

BRIDGE DIVING INSPECTION AND CONDITION REPORT

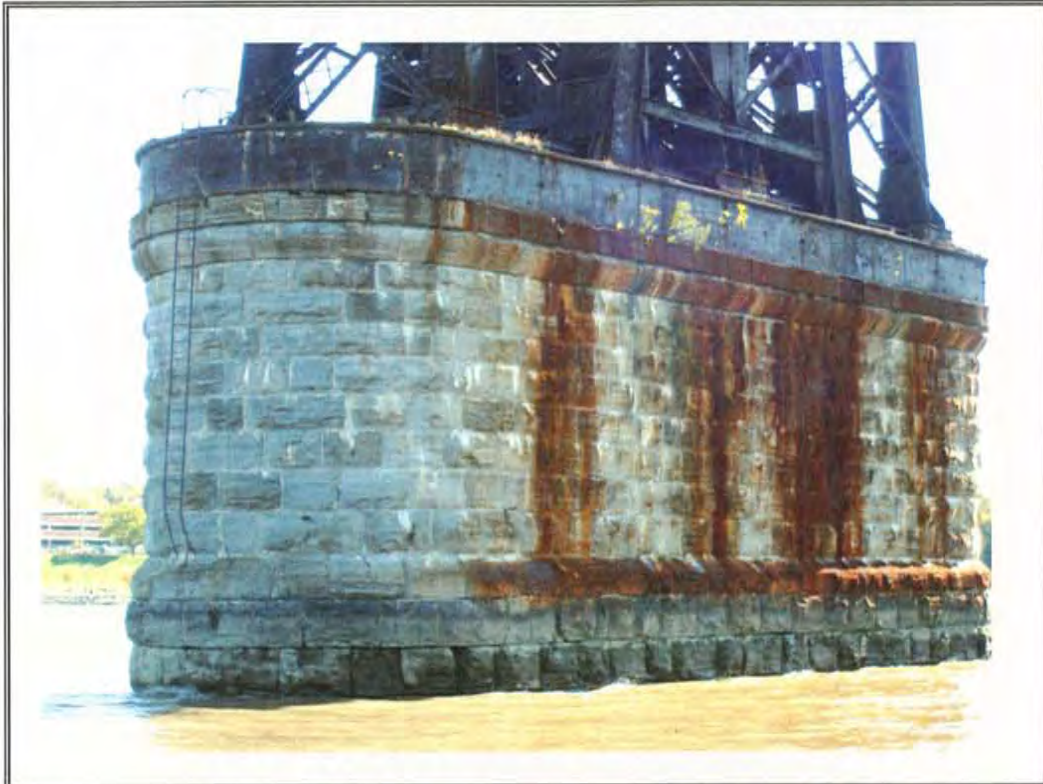
PHOTO NO.: 9  
LOCATION: \_\_\_\_\_  
Pier 4

DESCRIPTION: \_\_\_\_\_  
General View  
Looking Southeast

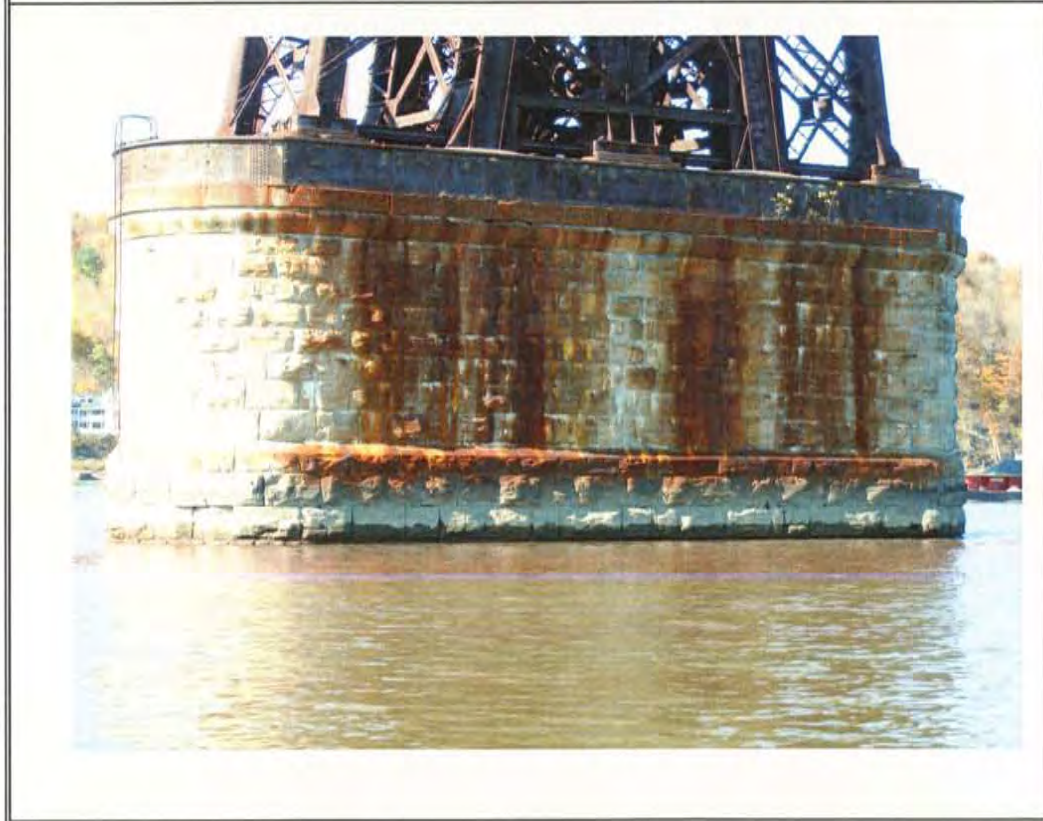
PHOTO NO.: 10  
LOCATION: \_\_\_\_\_  
Pier 4

DESCRIPTION: \_\_\_\_\_  
General View  
Looking Northwest

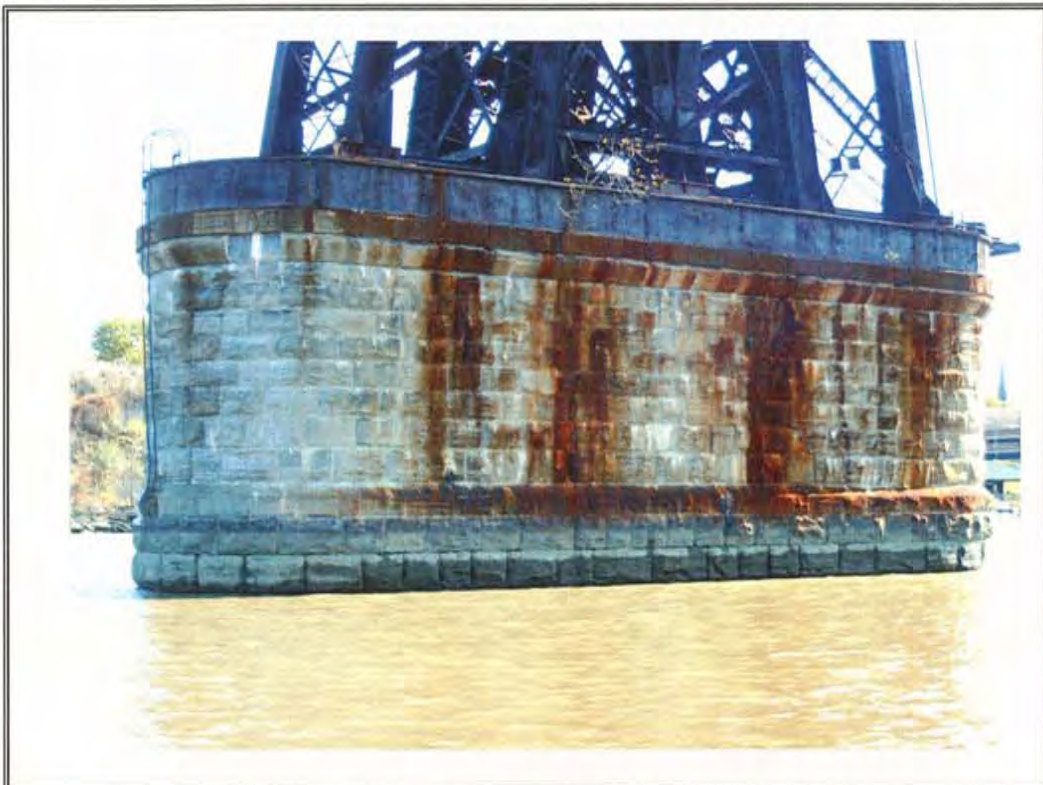
PHOTO NO.: 11  
LOCATION: \_\_\_\_\_  
Pier 5

DESCRIPTION: \_\_\_\_\_  
General View  
Looking Southeast

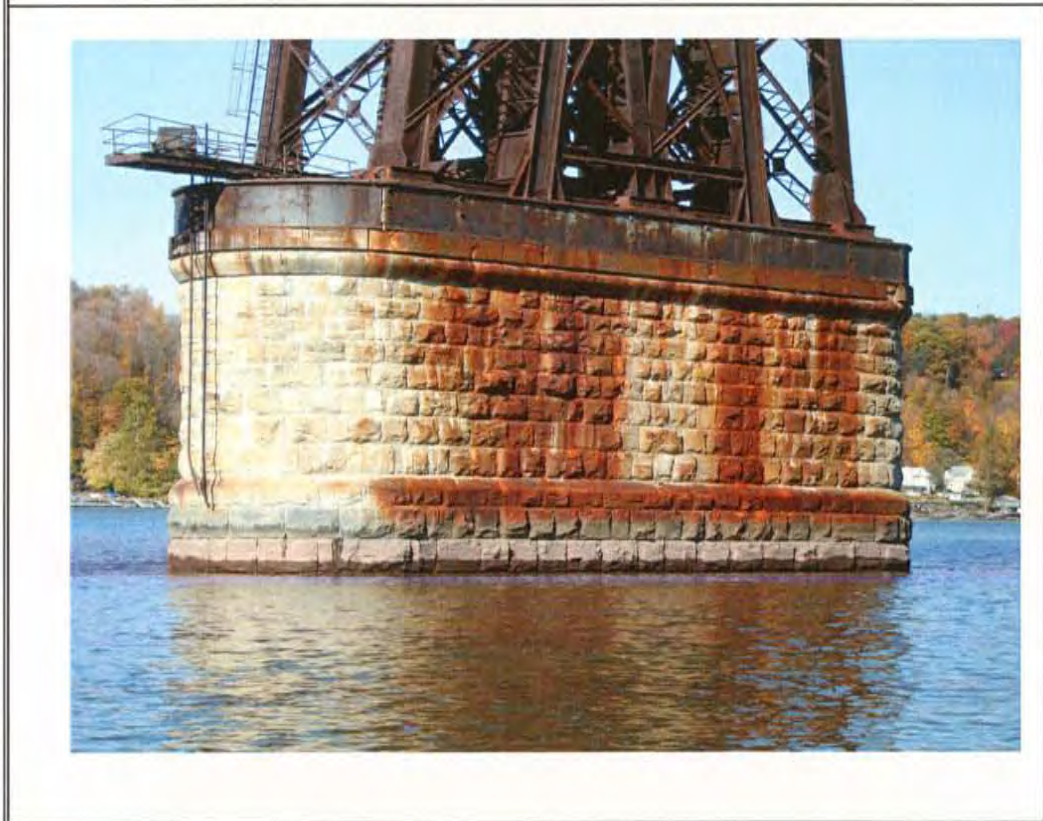
PHOTO NO.: 12  
LOCATION: \_\_\_\_\_  
Pier 5

DESCRIPTION: \_\_\_\_\_  
General View  
Looking Northwest
