A. INTRODUCTION

Hudson Highlands Fjord Trail

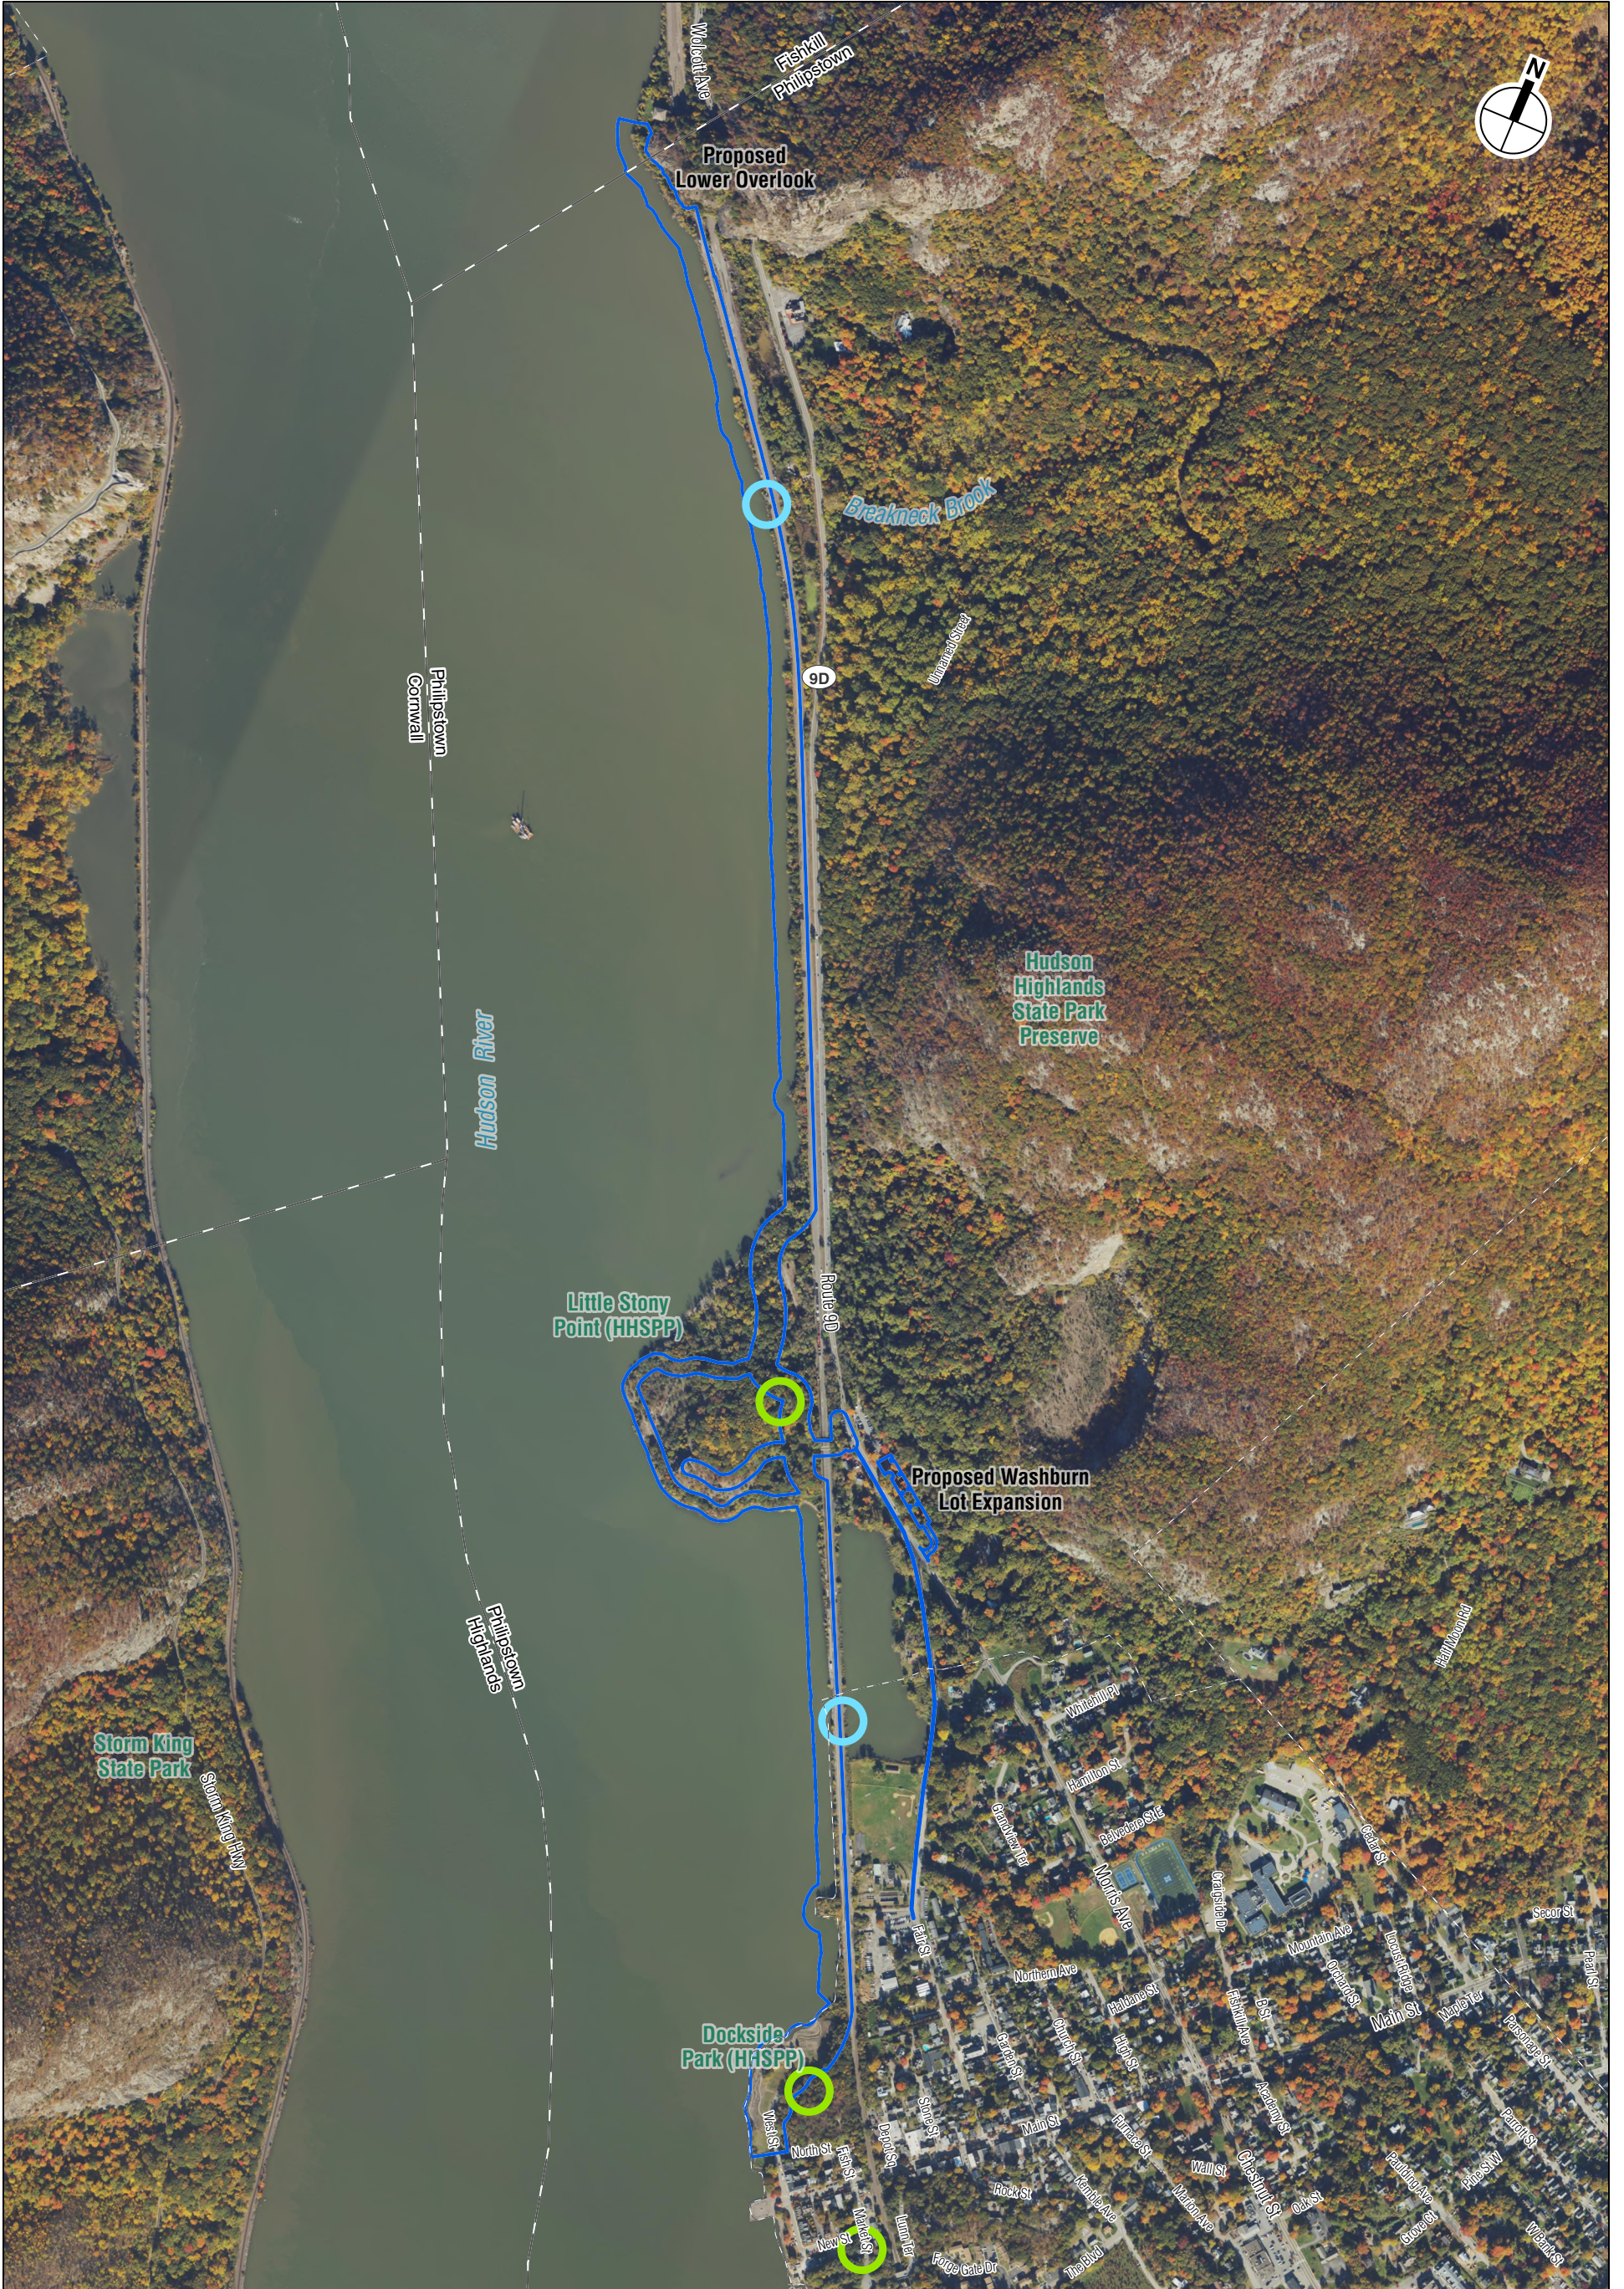
Areas of concern (AOCs) identified by this assessment were primarily related to (1) historic industrial uses, (2) railroad operations, and (3) historic fill. The findings, described in detail in the following sections, are shown on **Figure IV.P-1**.

AOC #1 Historic Industrial Uses
 Potential releases or buried wastes from former manufacturing, lumber yards, coal and petroleum storage, etc.

AOC #2 Railroad Operations
 Potential contamination or buried wastes from track ballasts, railroad ties, track maintenance, transformers, etc.

AOC #3 Historic Fill (Site-wide)
 Potential historic buried material of an unknown origin associated with infilling, residential, railroad and industrial construction and operations.

As shown on **Figure IV.P-1**, Fjord Trail South would require limited ground disturbance and excavation for the development of the new trail alignment in potential areas of concern adjacent to former industrial uses (some with documented subsurface contamination) and/or historic or current railroad operations. Specifically, this would include the installation of piles for the elevated portions of the Trail along the Hudson River shoreline and along the existing MNR tracks, as well as surface disturbance to allow the construction of an Accessible trail in the areas where the trail would be at grade. Notwithstanding, it is not anticipated that the installation of the pile-supported
